Name Of Dam: LOWER BEAVER POND DAM  
Location: CHESTERFIELD COUNTY, VIRGINIA  
Inventory Number: VA. NO. 04106

# PHASE I INSPECTION REPORT

## NATIONAL DAM SAFETY PROGRAM

SCHNABEL ENGINEERING ASSOCIATES, P.C./  
J. K. TIMMONS AND ASSOCIATES, INC.

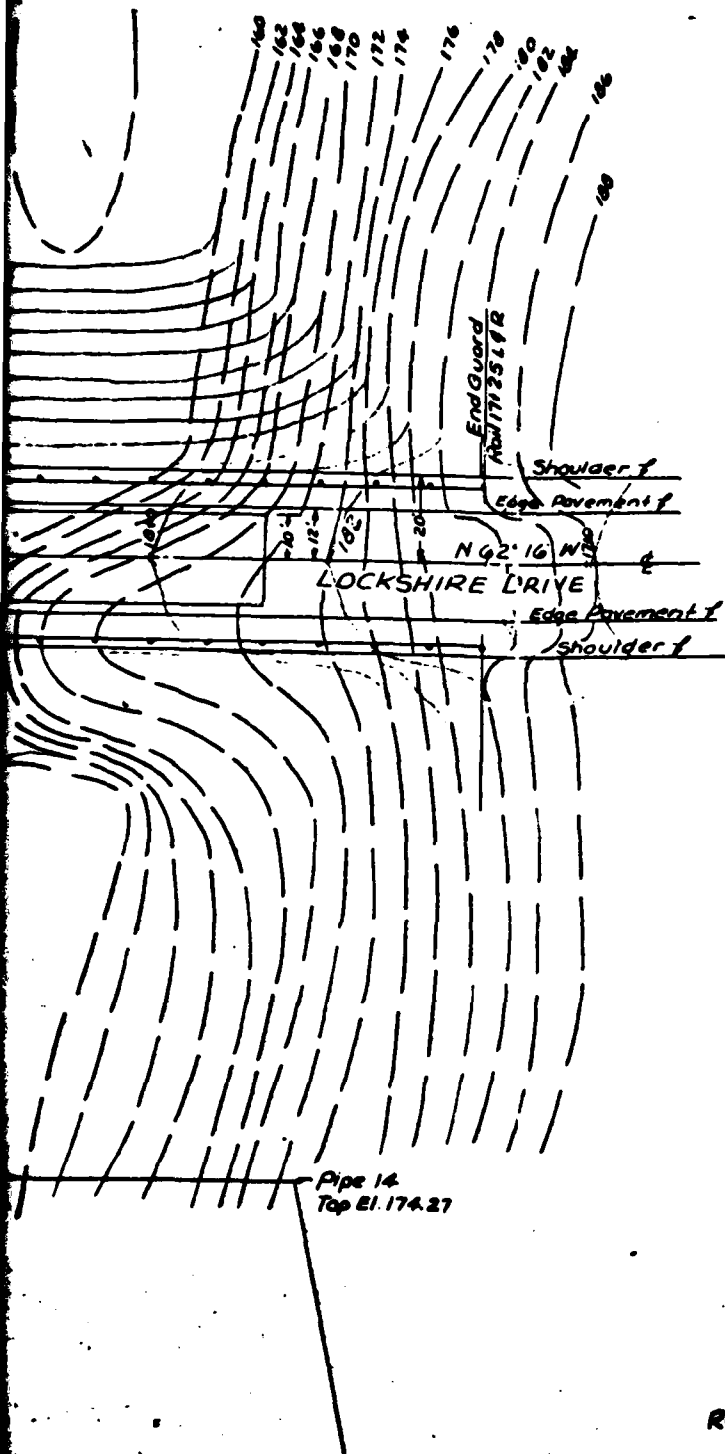
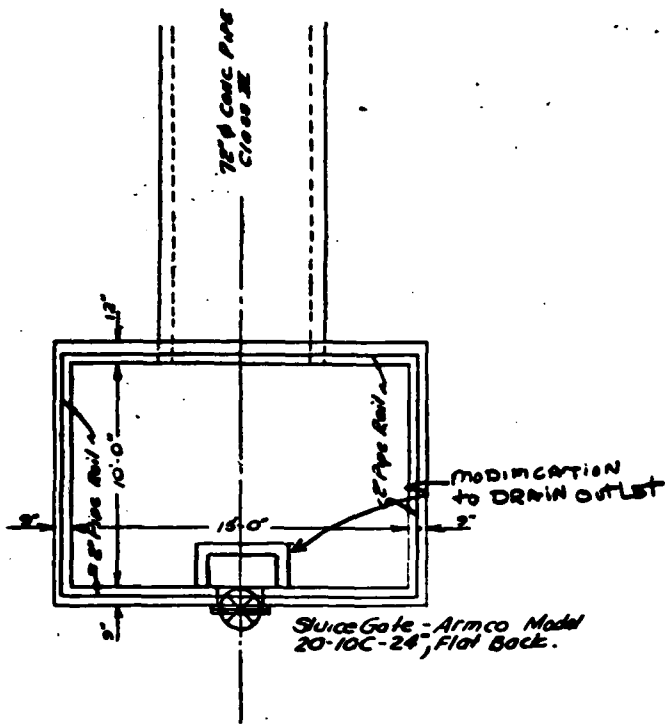
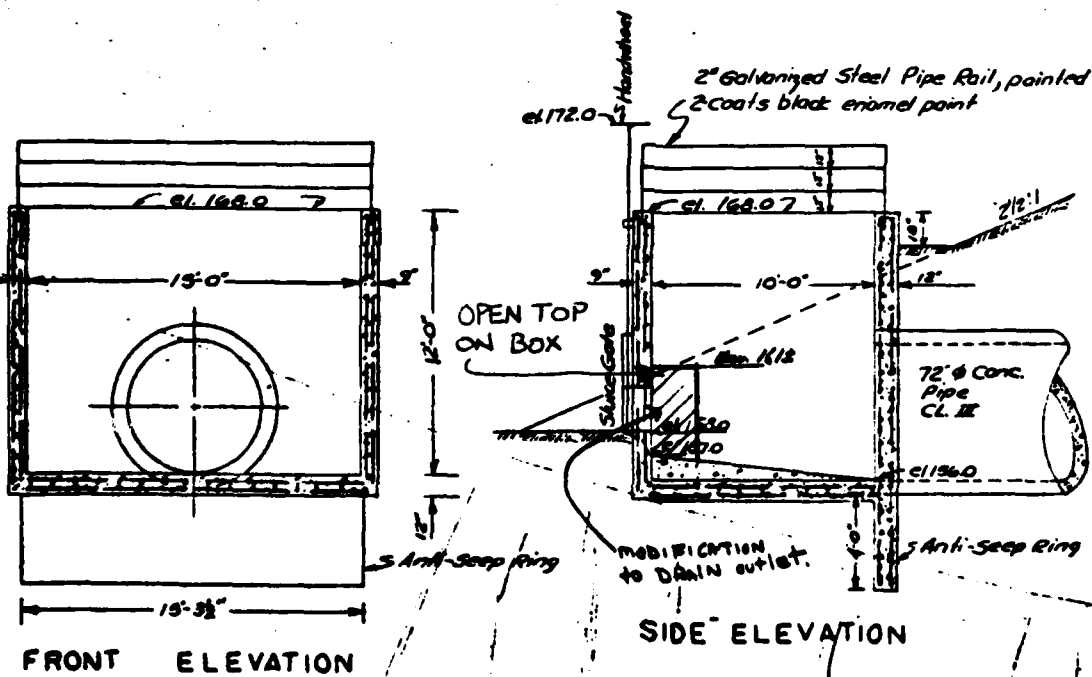
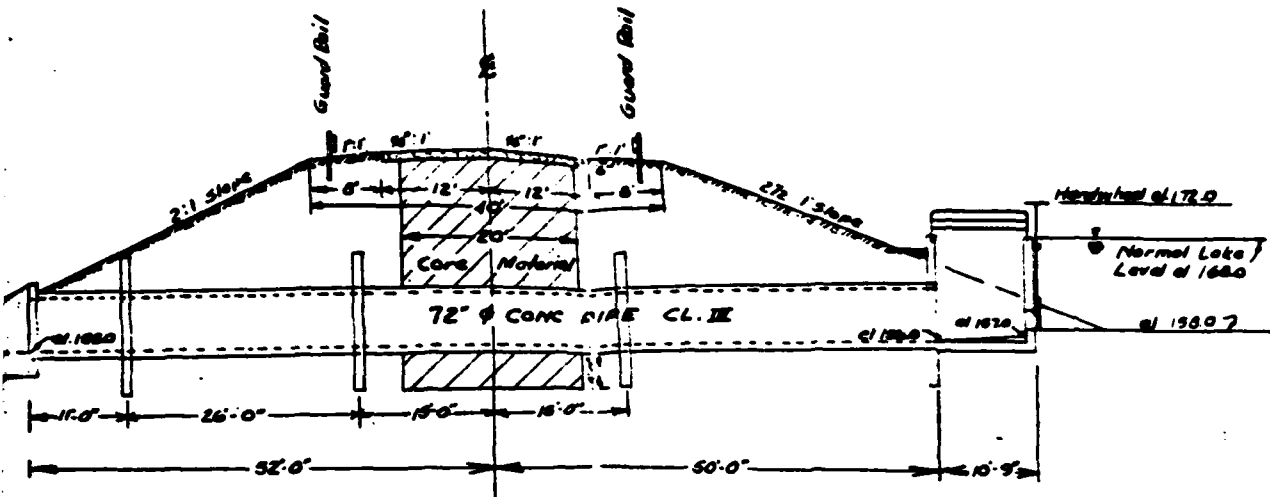
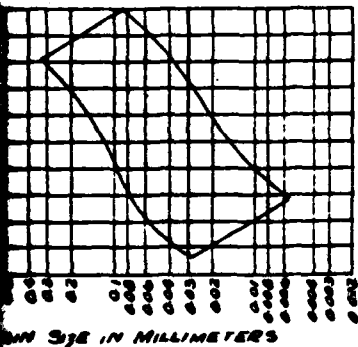
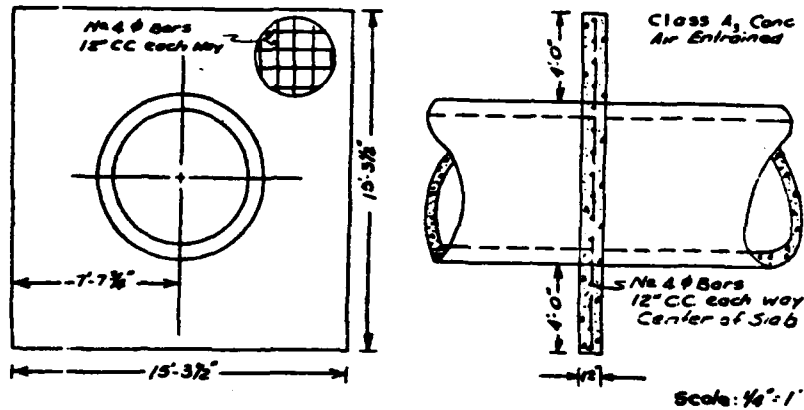
PLATE N°3

The principal spillway consists of a 15 ft x 10 ft reinforced concrete overflow wier box. The box is connected to a 72 inch diameter reinforced concrete outlet pipe which runs through the dam. The crest of the overflow wier is at an elevation of 168 msl which established the normal pool elevation. A 24 inch diameter sluice gate in the wier box at an invert elevation of 158 msl is used to lower the pool level. The outlet pipe has a length of 102 ft and an invert elevation at the outlet structure of 155 msl (Plate No. 3, Appendix I).

A review of test boring data indicates the dam is founded on overburden and includes a cutoff trench which extends into silty clay, sand, and gravel soils near Borings No. 9 and 10, but otherwise into residual soils and decomposed bedrock. Details of the cutoff are provided on Plate No. 3 of Appendix I. An internal drainage system was not included in design.

The principal spillway was designed as a drop inlet structure consisting of a reinforced concrete overflow weir and a 72 inch diameter reinforced concrete outlet pipe. A 24 inch diameter drain gate was installed on the inlet structure for purposes of lowering the pool. Details are shown on Plate No. 3, Appendix I. Four (4) anti-seep rings or collars were included in order to prevent piping of soil along the 72 inch pipe.

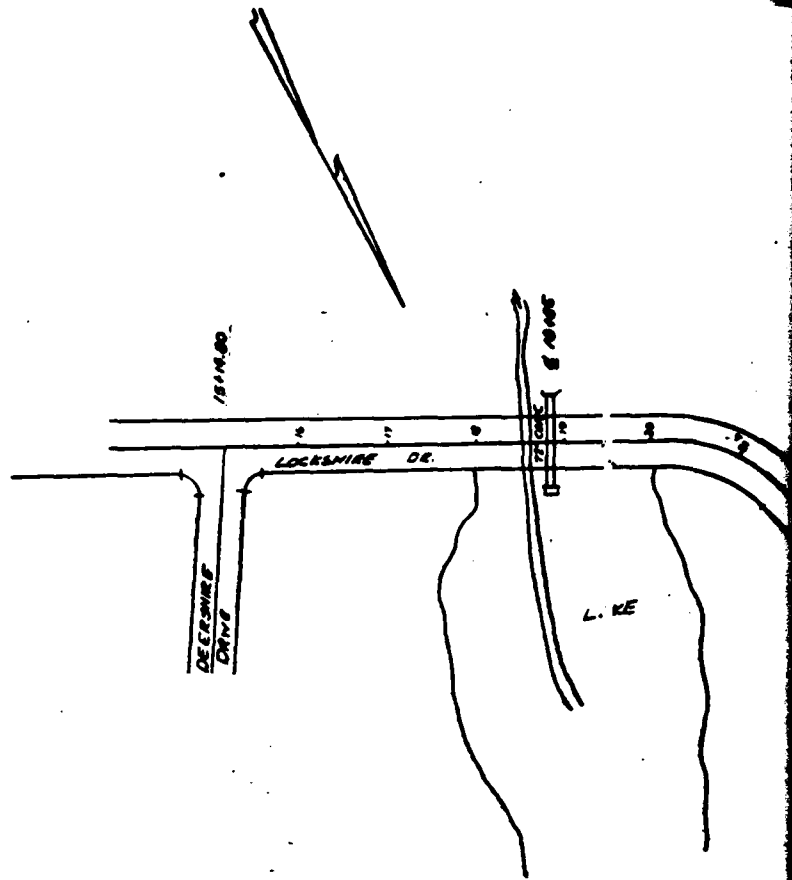
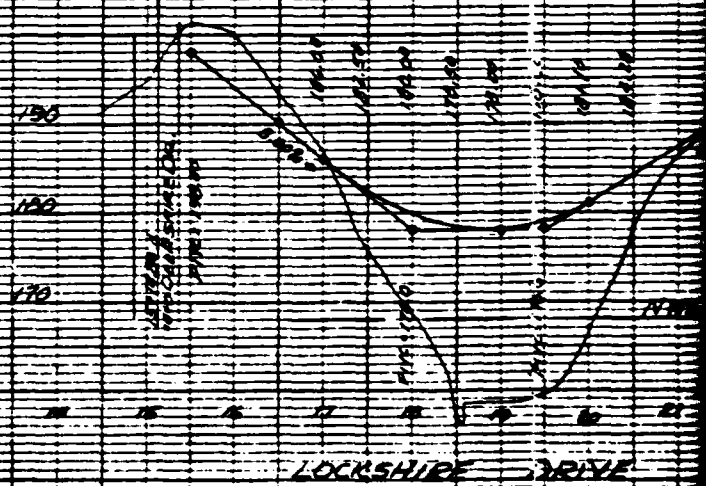
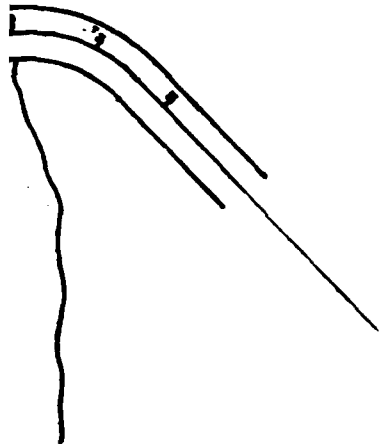
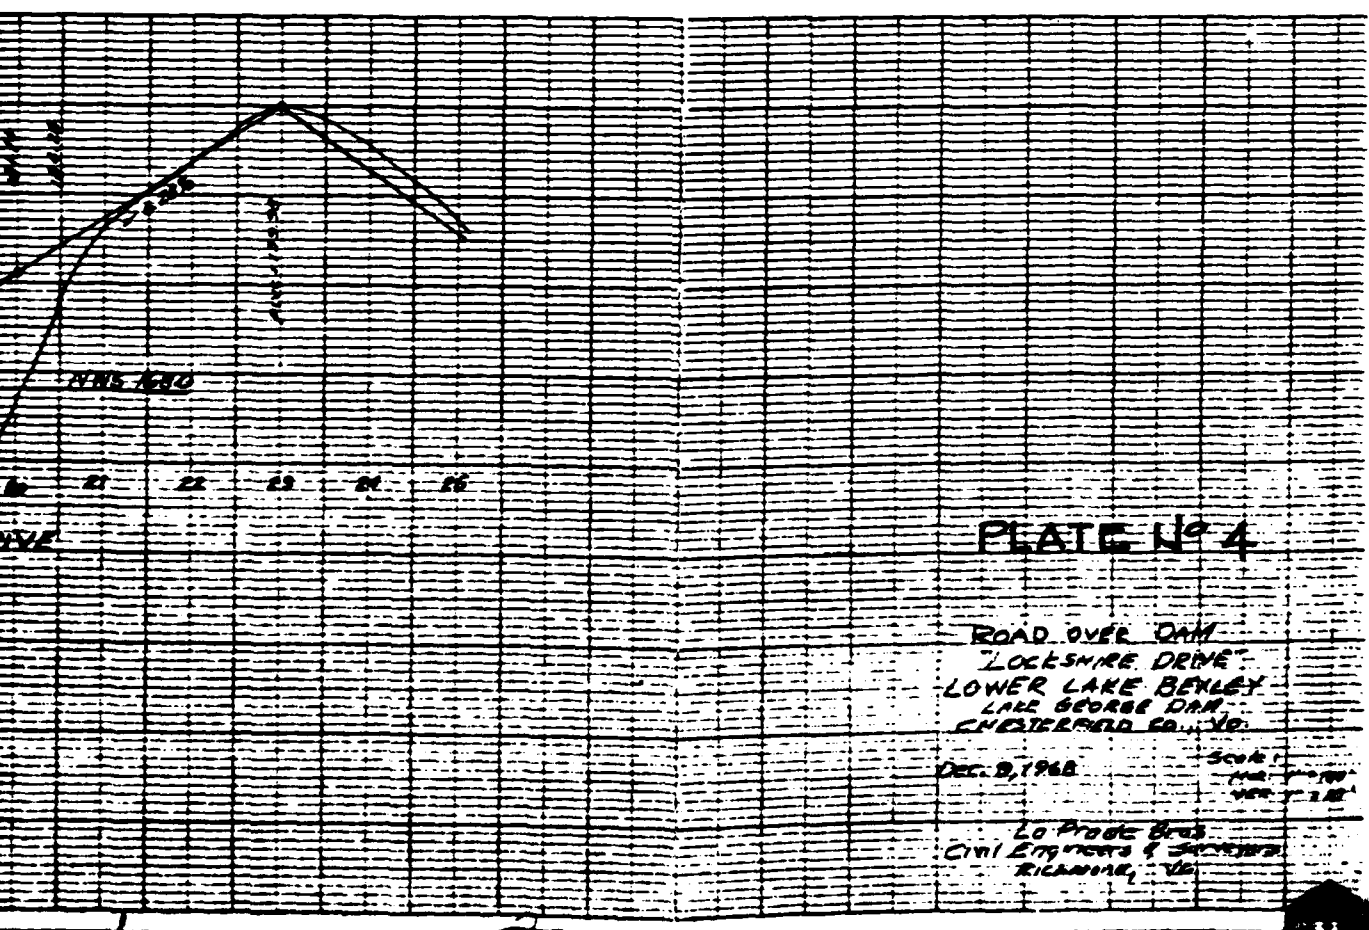
**PLATE No 4**

The top of the dam was designed to conform to a roadway section and is constructed on a vertical curve (Plate No. 4, Appendix I).
