4. TITLE (and Subtitle) Phase I Inspection Report National Dam Safety Program Silver Lake Dam Rockingham County, Virginia		5. TYPE OF REPORT & PERIOD COVERED Final

NAME OF DAM: SILVER LAKE DAM  
 LOCATION: ROCKINGHAM COUNTY, VIRGINIA  
 INVENTORY NUMBER: VA. NO. 16508

PHASE I INSPECTION REPORT  
 NATIONAL DAM SAFETY PROGRAM

PHASE I INSPECTION REPORT  
NATIONAL DAM SAFETY PROGRAM  
SILVER LAKE DAM  
VA. NO. 16508

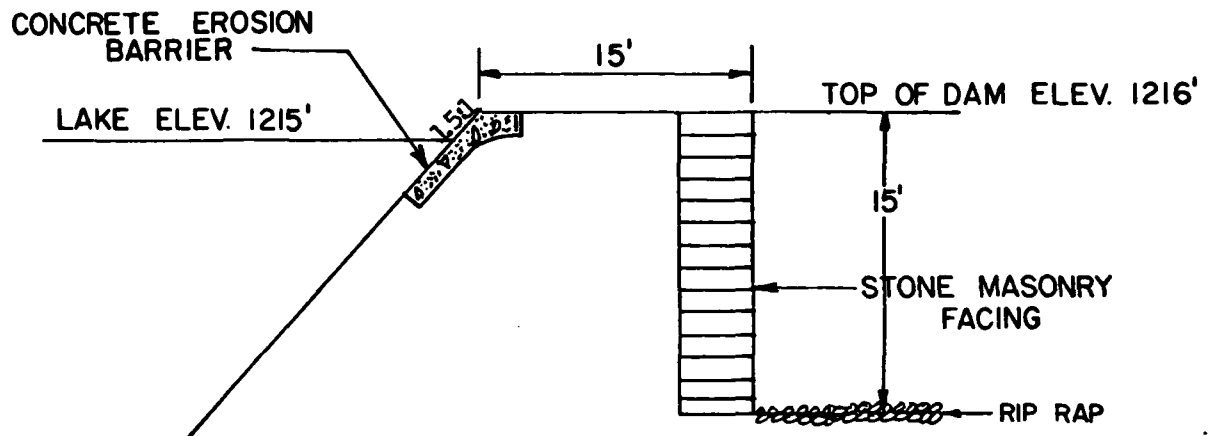
TYPICAL SECTION  
SILVER LAKE DAM

1.2.1 Dam and Appurtenances: Silver Lake Dam is a stone masonry/earth structure approximately 400 ft long and 15 ft high.\* The top of the dam is 15 ft wide and is at elevation 1216 msl. The downstream side is vertical and the upstream face is estimated at about 1 horizontal to 1 vertical (1H:1V) (See Plate No. 2, Appendix I). It is unknown if the dam is keyed into the foundation or if a drainage system exists. There are no foundation drain outlets. The downstream slope is vegetated and the upstream slope includes a thin concrete cover for protection.
