Name Of Dam: NEWMAN LAKE DAM

Location: HARRISONBURG, VIRGINIA

Inventory Number: VA. NO. 66001

PHASE I INSPECTION REPORT NATIONAL DAM SAFETY PROGRAM

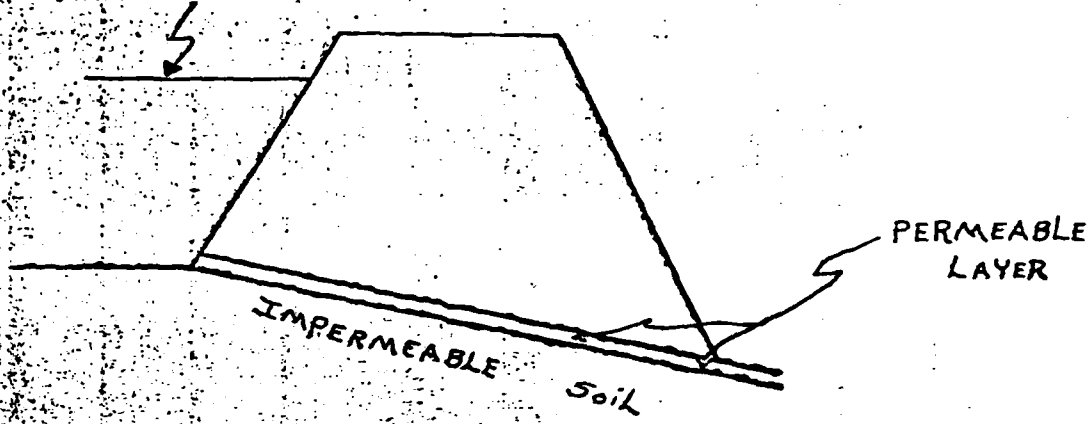
FIG. 1

2. Preliminary investigation indicates that the dam rests on a thin layer of permeable topsoil over an almost impermeable subsoil, as shown in Figure 1. Water is moving through the permeable layer and emerging near the downstream toe.

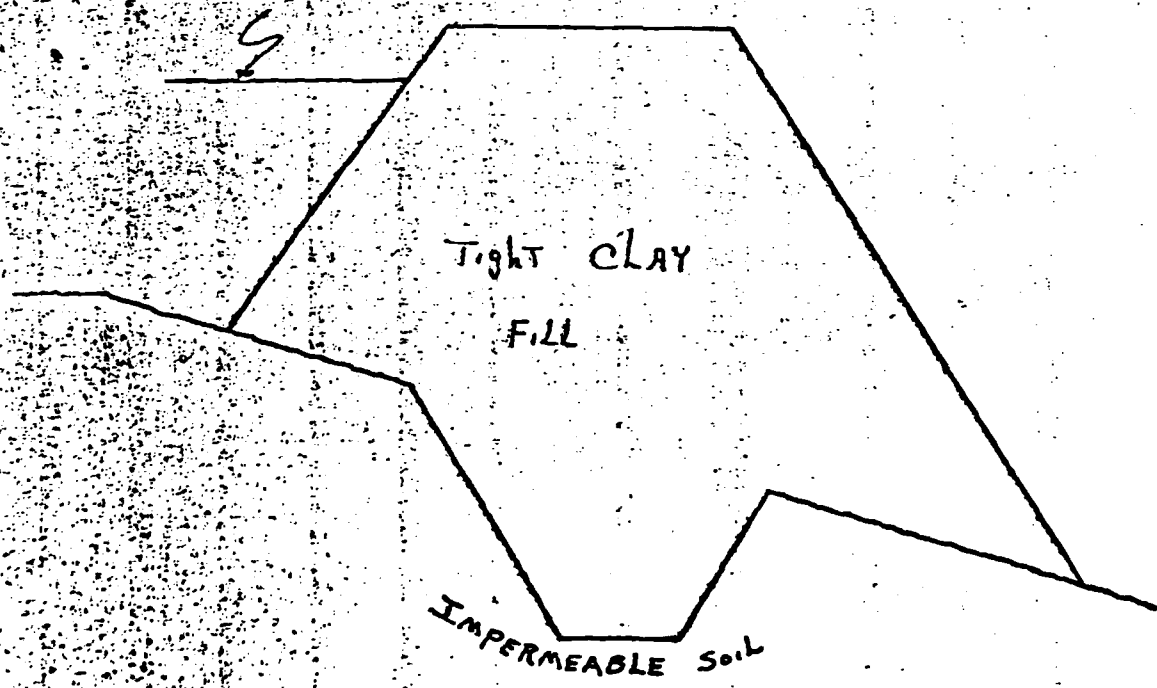
FIG. 2

3. If the permeable topsoil had been stripped off and the structure keyed into the impermeable layer as shown in Figure 2, then with the good fill material available at this site and the relatively low water levels involved, probably no appreciable seepage would have occurred.
