⑥ National Dam Inspection Program,
Number
DOVERSPIKE NO. 2 DAM
(NDI I.D. PA-00810,
DER I.D. 33-57), Ohio River Basin,
Caylor Run, Jefferson County,
Pennsylvania.
PHASE I INSPECTION REPORT,
NATIONAL DAM INSPECTION PROGRAM

NAME OF DAM: Doverspike No. 2 Dam
STATE LOCATED: Pennsylvania
COUNTY LOCATED: Jefferson
STREAM: Caylor Run, Tertiary Tributary of Mahoning Creek
SIZE CLASSIFICATION: Intermediate
HAZARD CLASSIFICATION: Significant
OWNER: J. C. Enterprises
DATE OF INSPECTION: April 24, 1980 and May 1, 1980

PHASE I REPORT
NATIONAL DAM INSPECTION PROGRAM
DOVERSPIKE NO. 2. DAM
NDI I.D. PA-810
DER I.D. 33-57

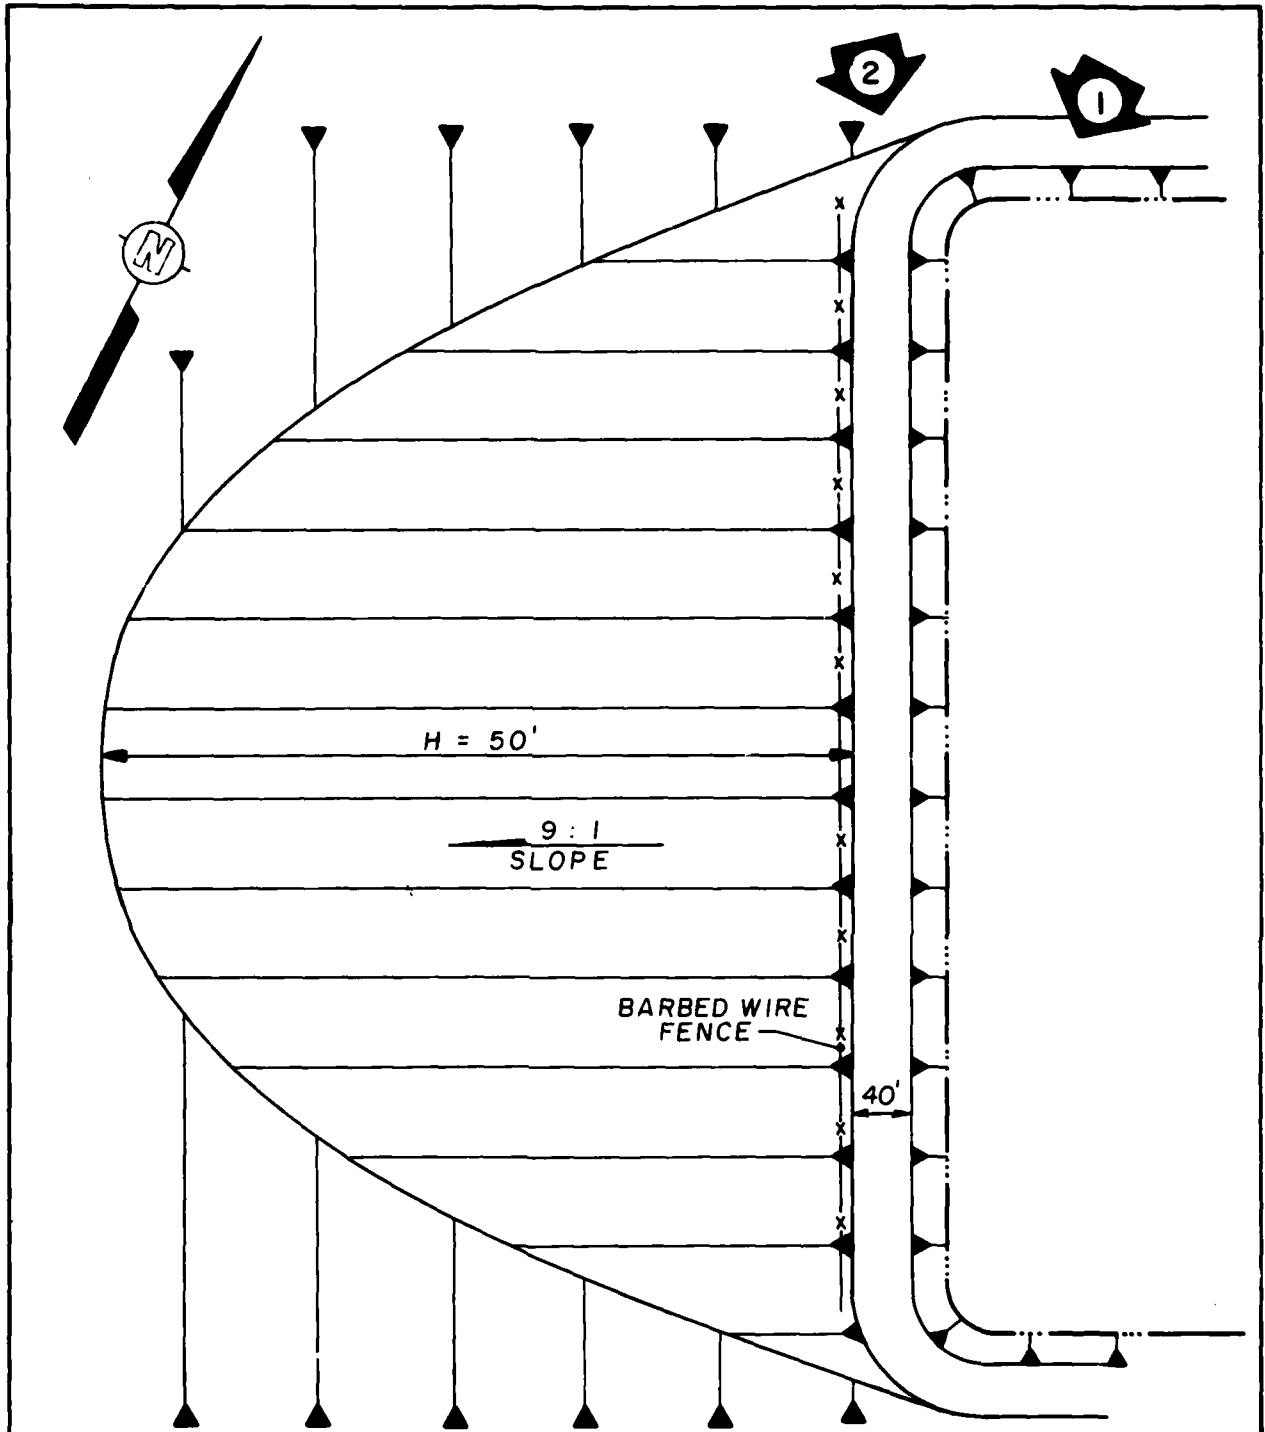
Photograph No. 2
Crest (looking southeast). For ground: low area
on crest, possible emergency spillway.

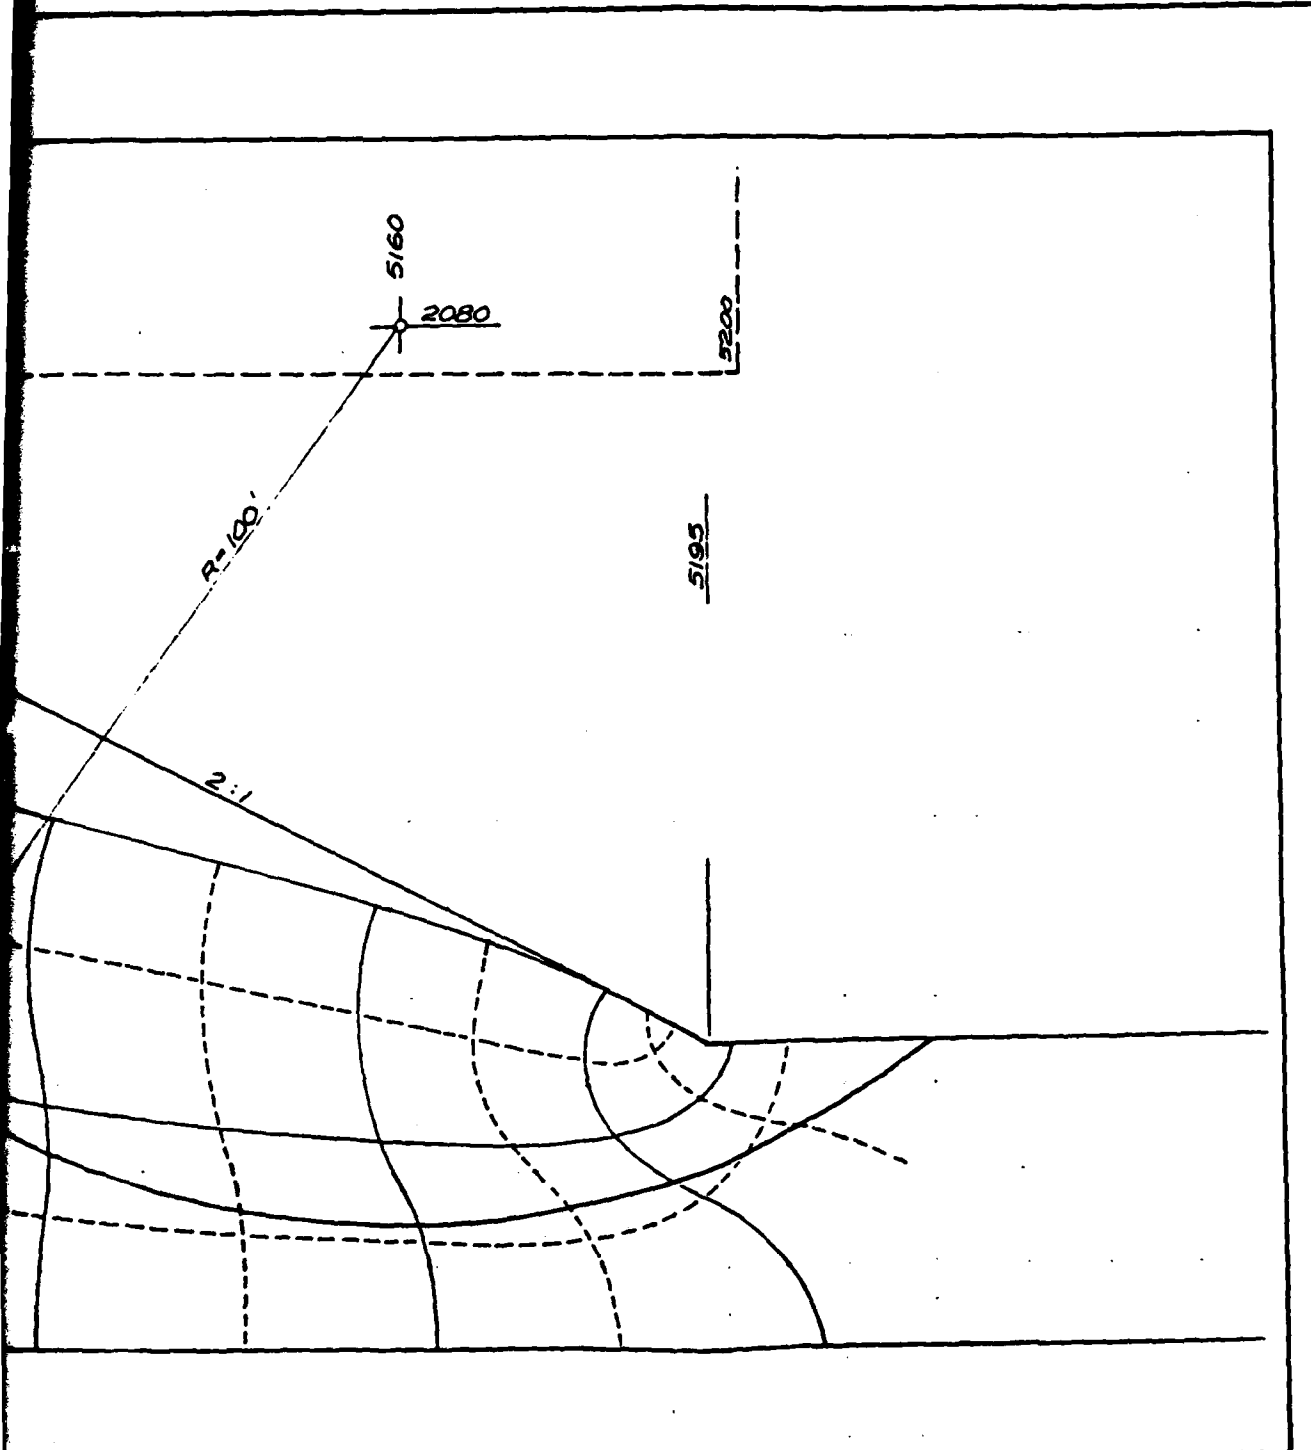
PLATE 2

(1) Embankment. The visual observations indicate that the typical cross section of the embankment had been significantly modified during construction. The proposed dam, as shown in Plate 2, consisted of a homogeneous embankment with a 2H to 1V downstream slope, a 1.5H to 1V upstream slope, and a crest width of 20 feet. Presently, the downstream slope is approximately 9H to 1V and the crest is about 40 feet wide. The design of the proposed embankment consisted of subsurface investigation, laboratory and materials testing, and engineering analysis. The slope stability factor of safety of the proposed dam was reported to be in the range of 1.4 to 1.5. Based on visual observations, the static stability of the existing embankment is considered to be adequate.
