BERGER ASSOCIATES INC HARRISBURG PA
NATIONAL DAM INSPECTION PROGRAM. LAKE HAMILTON DAM (NDI-ID NUMB--ETC(U)
AUG 80 H JONGSMA

PHASE I REPORT
NATIONAL DAM INSPECTION PROGRAM

LAKE HAMILTON DAM

NDI-ID PA-01031
DER-ID 64-157

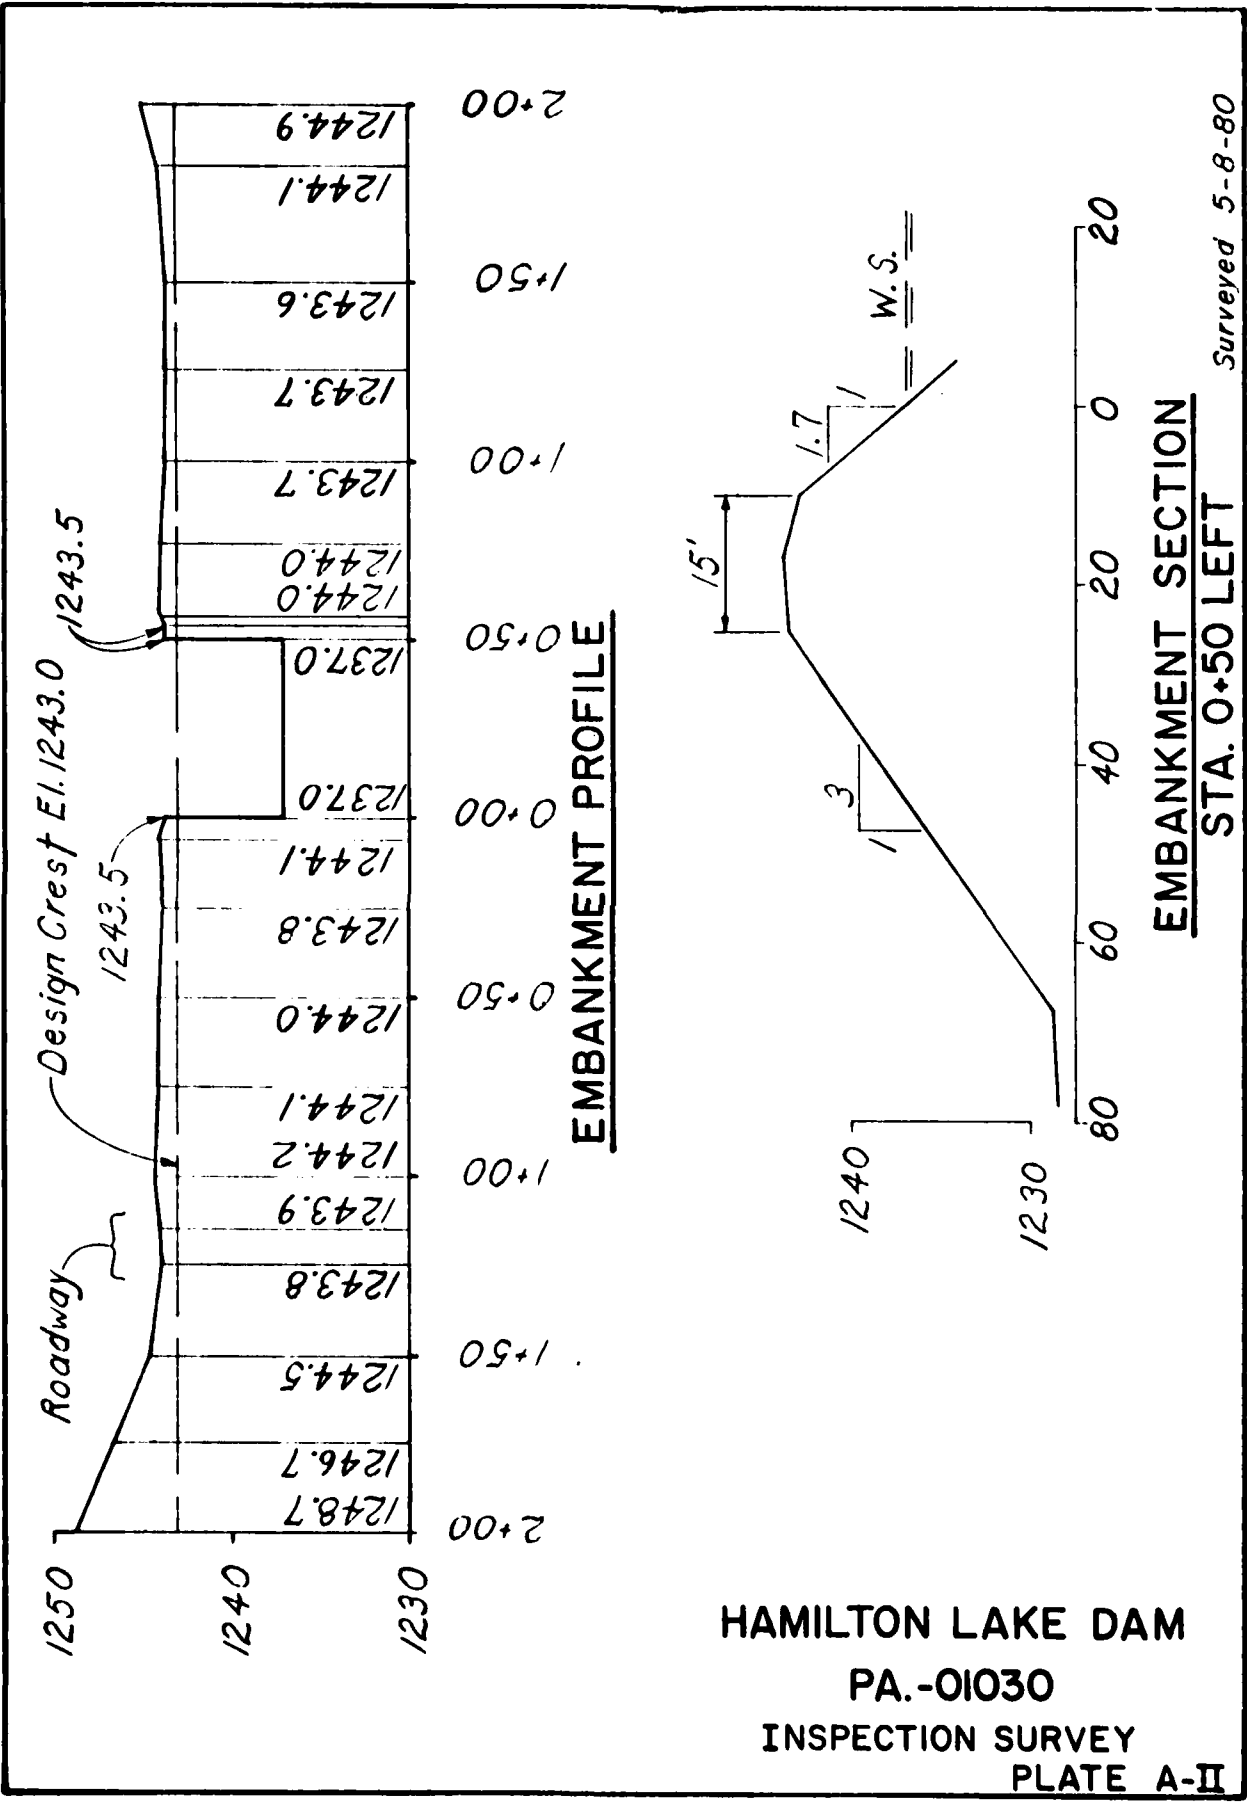
HAMILTON LAKE DAM
 PA.-01030
 INSPECTION SURVEY
 PLATE A-II

Surveyed 5-8-80
