COMET LAKE DAM

(NDI ID. No. PA-00796, ^{Number}
PENNDER ID. No. 28-103) ^{Number}

Potomac River Basin,
Spring Run, Franklin County, Pennsylvania

~~DATE: 11-10-80~~
PHASE I INSPECTION REPORT,
NATIONAL DAM INSPECTION PROGRAM

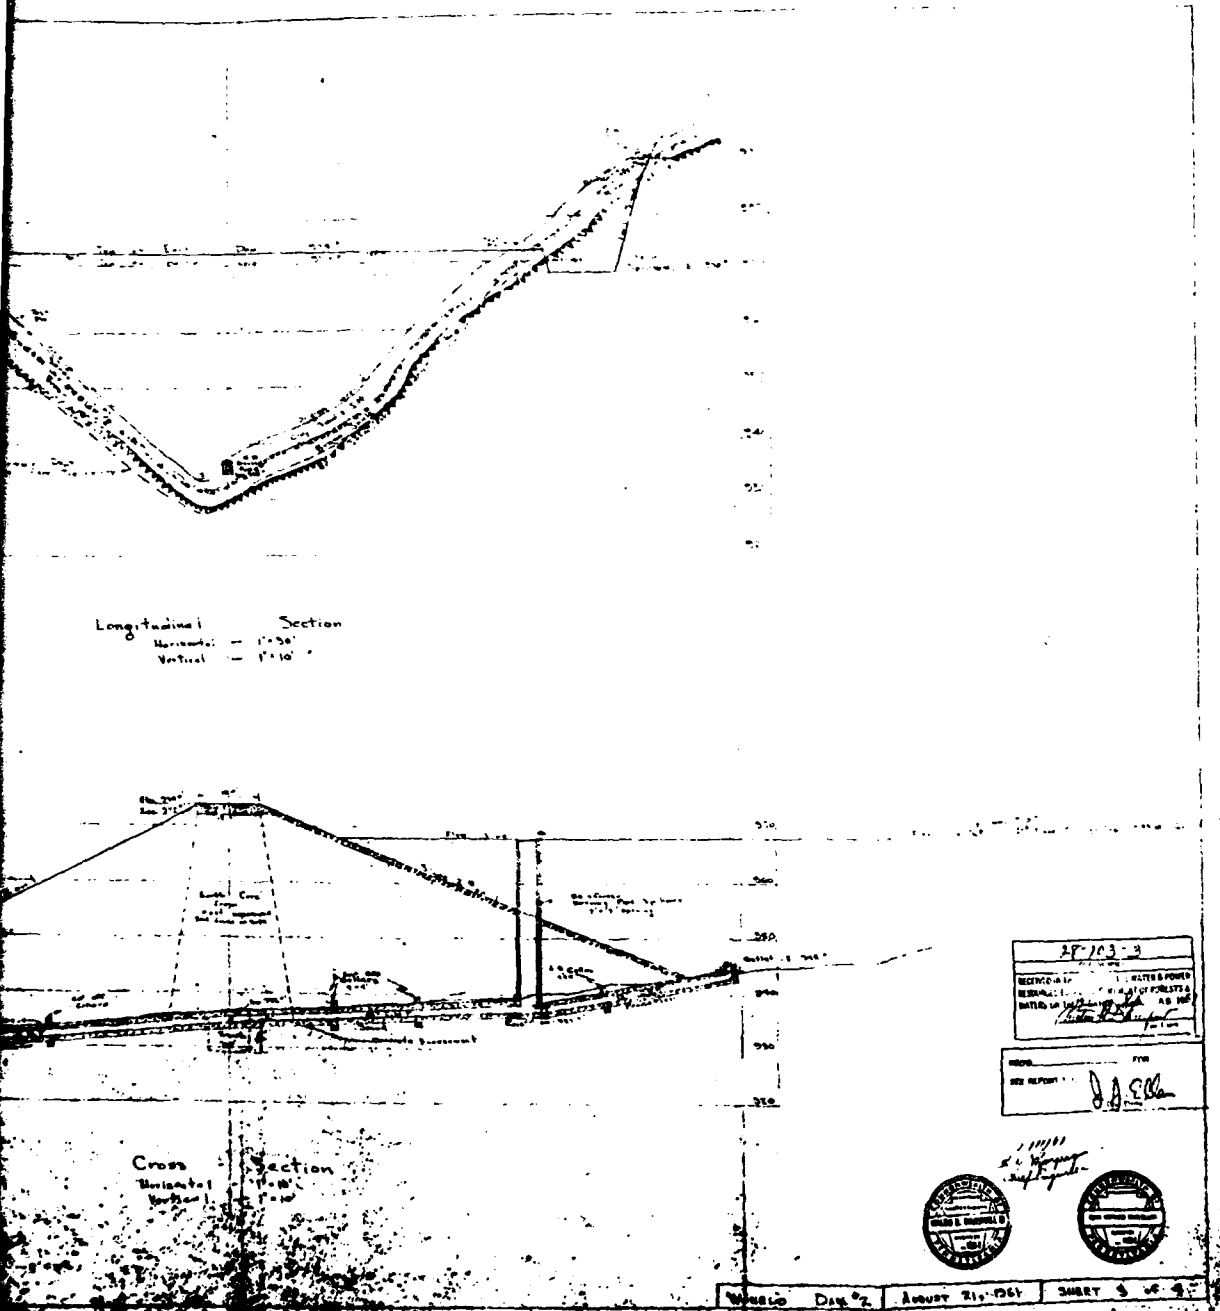
gai
 CONSULTANTS, INC.
 FIGURE 3

by semi-pervious outer shells comprised of a soil/clay-shale mixture (see Figure 3).
	Impervious Core	Core section with 24-foot bottom width extending to within two feet of the embankment crest (see Figure 3).
	Cutoff	8-foot wide cutoff trench along embankment centerline reportedly extends six feet into bedrock (see Figure 3).
	Grout Curtain	None indicated.
h.	<u>Diversion Canal and Regulating Tunnels.</u>	None.
i.	<u>Service Spillway.</u>	
	Type	Small, drop inlet type concrete riser with a 12-inch diameter concrete encased, corrugated metal discharge conduit (see Figures 3 and 4).
	Crest Elevation	968.0 feet.
j.	<u>Emergency Spillway.</u>	
	Type	Uncontrolled, trapezoidal shaped, rock cut channel with no regulating weir.
	Crest Elevation at Control	968.8 feet.
	Base Width at Control	9 feet.
	Top Width at Control	35 feet.

1. Embankment. Information contained in PennDER files indicates the embankment is a zoned earth structure constructed with an impervious central core and semi-impervious outer shells. Figure 3 indicates the structure is provided with a cutoff trench along the embankment centerline that extends six feet into bedrock. The design slopes were set at 2H:1V and 2.5H:1V for the downstream and upstream slopes; however, field measurements reveal these slopes to be closer to 1.75H:1V and 1.5H:1V, respectively. The embankment crest has been covered with a bituminous surface.
