OHIO RIVER BASIN  
ROWES RUN  
FAYETTE COUNTY

NDI No. PA 00220  
PENN DER No. 26-41

ROYAL RESERVOIR DAM

PHASE I INSPECTION REPORT  
NATIONAL DAM INSPECTION PROGRAM

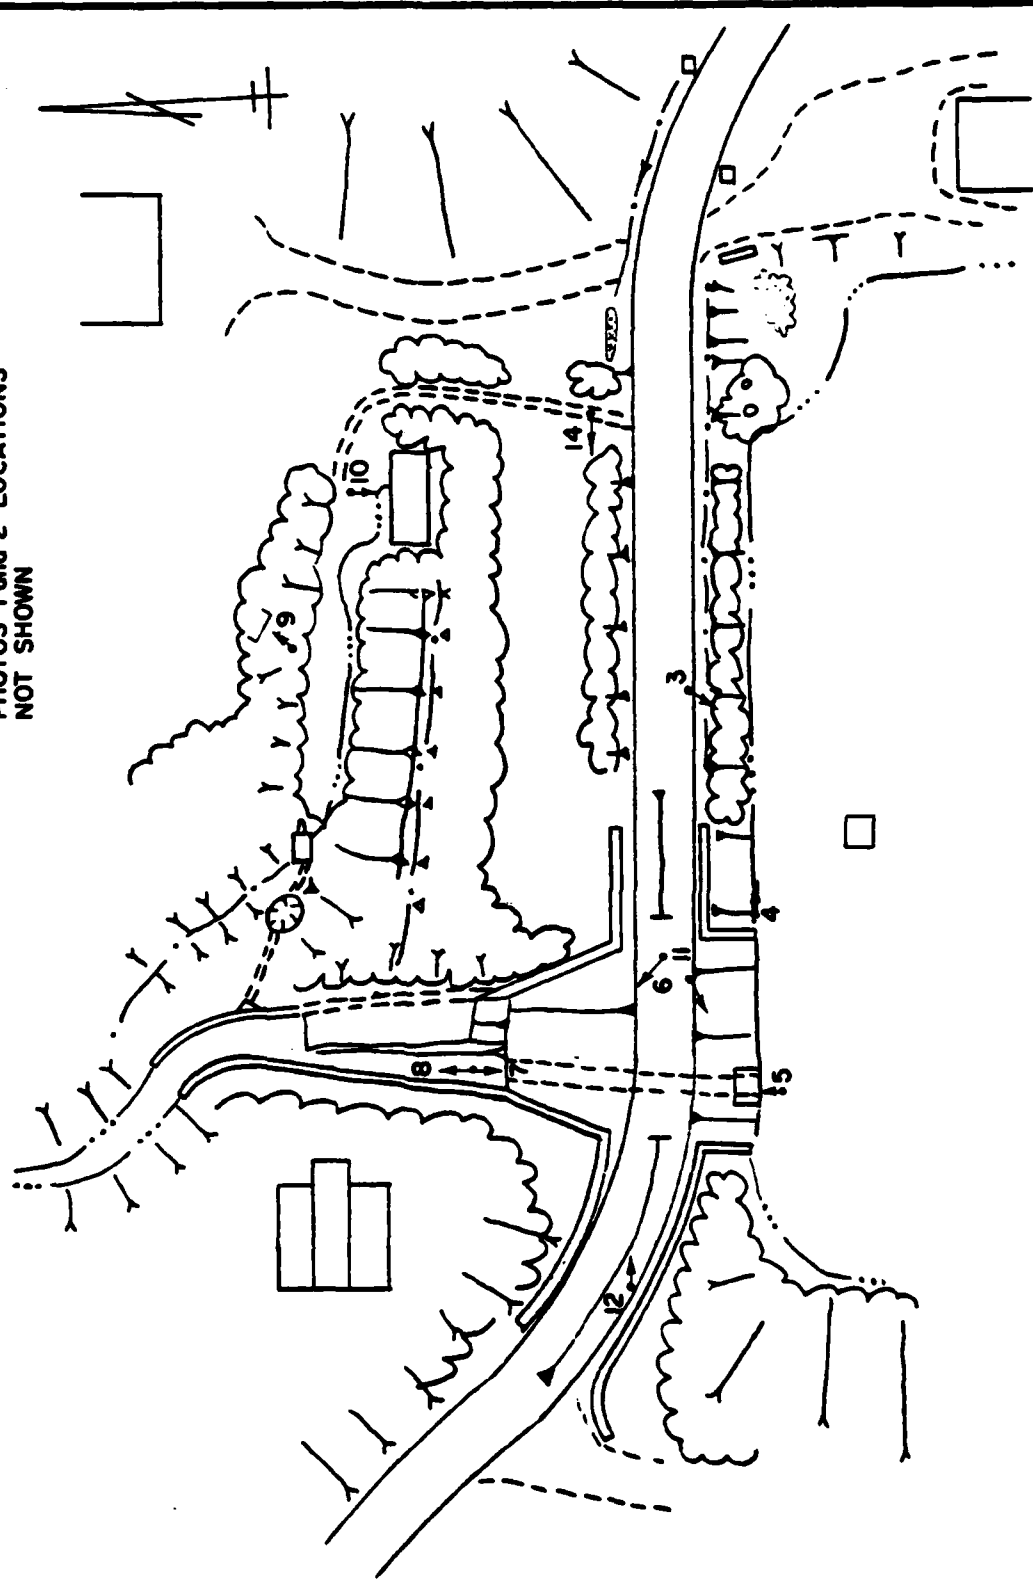
DATE: JULY 1980		ROYAL RESERVOIR DAM NATIONAL DAM INSPECTION PROGRAM		PHOTO KEY MAP
SCALE: NONE				
DR: JF	CK:	A. C. ACKENHEIL & ASSOCIATES, INC. CONSULTING ENGINEERS PITTSBURGH, PA., CHARLESTON, W. VA. & BALTIMORE, MD.		
DWG. NO.

- Photo 1 Dike at upper end of lake.
- Photo 2 Discharge Channel through isthmus at upper end of lake.
- Photo 3 Intake Structure for outlet works. Note lack of surface disturbance.
- Photo 4 Upstream Slope as seen from spillway.
- Photo 5 Principal Spillway Inlet.
- Photo 6 Emergency Spillway discharge channel. Note roadway in foreground.
- Photo 7 Principal Spillway Outlet. Note pipe sag and discharge.
- Photo 8 Emergency Spillway chute, below principal spillway outlet. Right wall collapsed.
- Photo 9 Mine Portal immediately downstream of dam.
- Photo 10 Unknown Building at toe of dam.
- Photo 11 Principal and Emergency Spillway Inlets.
- Photo 12 Crest of dam showing road and emergency spillway.
- Photo 13 Downstream Slope near toe.
- Photo 14 Downstream Slope showing extensive bench below roadway as seen from right abutment.
