NDI No. PA 00907

CRABAPPLE DAM

PHASE I INSPECTION REPORT NATIONAL DAM INSPECTION PROGRAM

JULY 1980

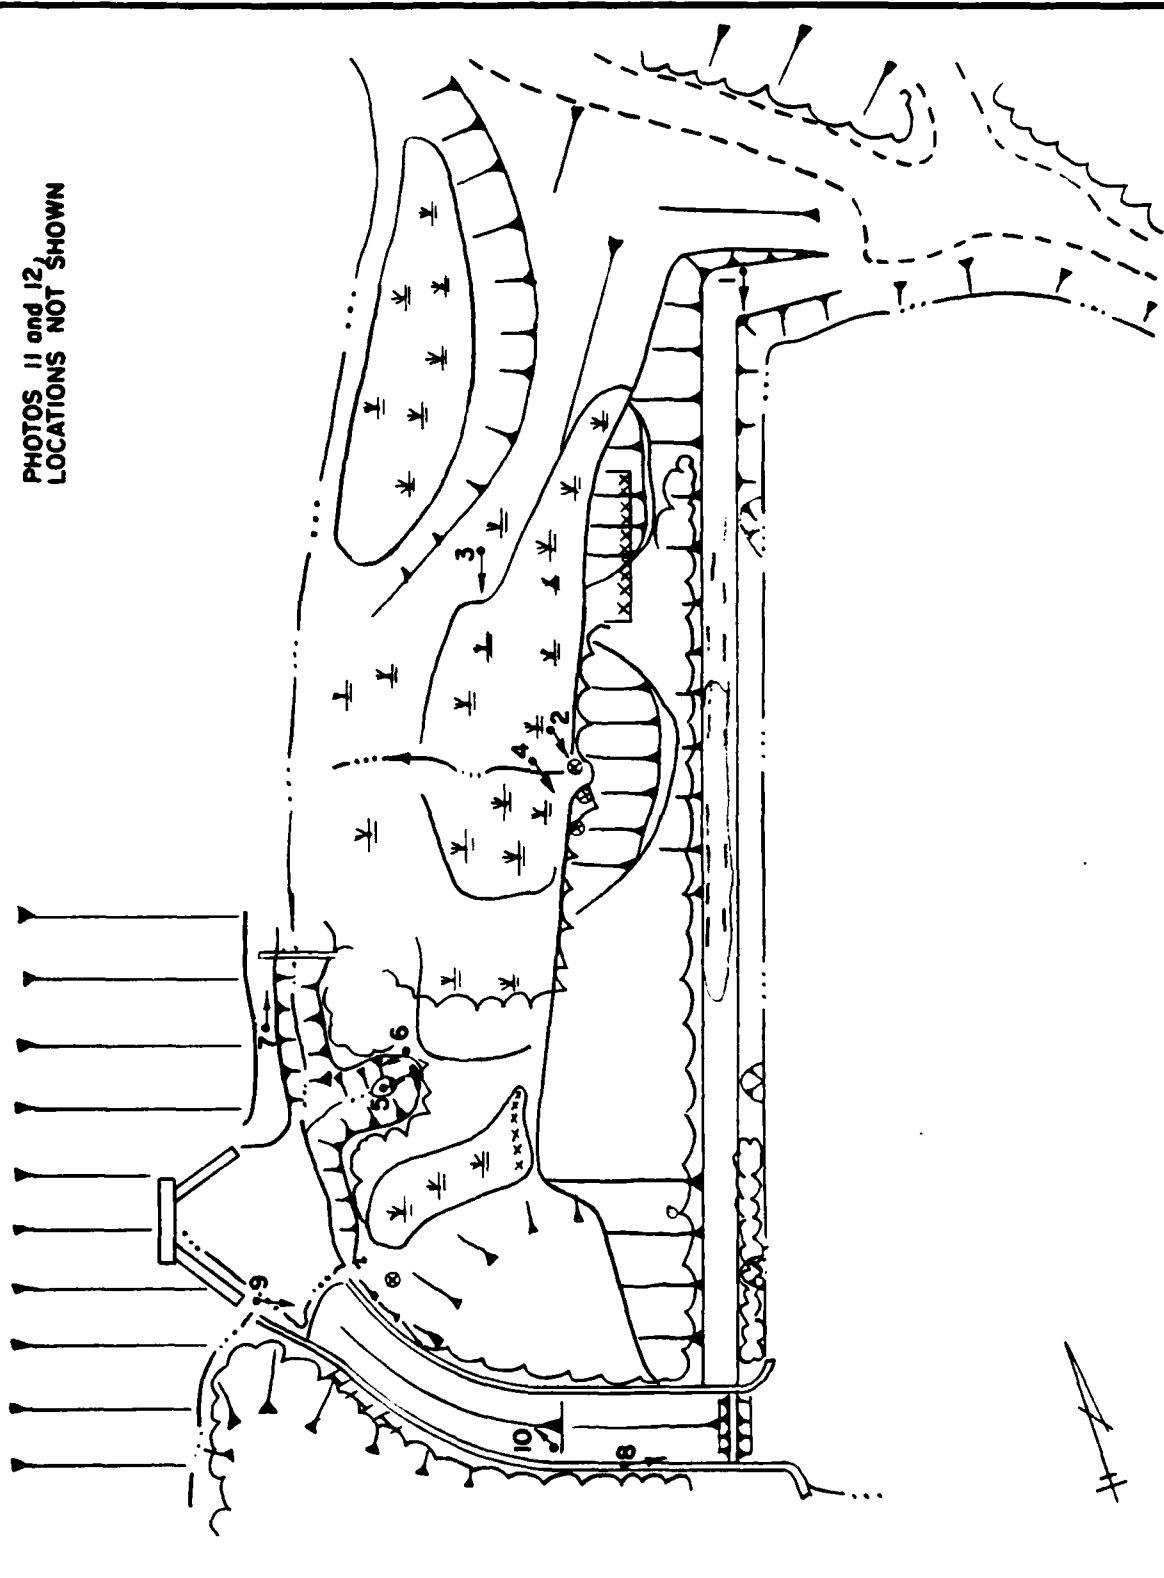
DATE: JULY 1980		CRABAPPLE DAM NATIONAL DAM INSPECTION PROGRAM	PHOTO KEY MAP
SCALE: NONE			
DR: JF	CK:	A. C. ACKENHEIL & ASSOCIATES, INC. CONSULTING ENGINEERS PITTSBURGH, PA., CHARLESTON, W. VA. & BALTIMORE, MD.

- Photo 1 Crest of dam as seen from right abutment.
- Photo 2 Spring at toe of dam.
- Photo 3 Swamp beyond toe of dam.
- Photo 4 Downstream Slope showing tree cover and swampy conditions at toe.
- Photo 5 Pond Drain Outlet.
- Photo 6 Pond Drain Discharge Channel. Note Route 51 culvert in background.
- Photo 7 Water Supply Pipeline at creek crossing at toe of Rt. 51 embankment.
- Photo 8 Principal Spillway showing flow control weir.
- Photo 9 Principal Spillway Discharge Channel outfall looking upstream.
- Photo 10 Principal Spillway Discharge Channel looking downstream, showing Rt. 51 culvert below.
- Photo 11 Route 51 Culvert, downstream end.
- Photo 12 Downstream Hazard. Note creek at center of photo.
