This report was prepared by the TRW Defense and Space Systems Group, Redondo Beach, CA 90278, under Contract F04701-80-C-0022 with the Headquarters, Air Force Space Division, Deputy for Space Communications Systems, P.O. Box 92960, Worldway Postal Center, Los Angeles, CA 90009. It was reviewed and approved for TRW Defense and Space Systems Group by R. H. Alborn, Manager, DSCS II Orbital Operations. Capt. Gerald D. Nordley was the project engineer.

IISCSII SATELLITE 9444 TELEMETRY TRANSMITTER

ANOMALY REPORT.

o. 36060-AR-022-01

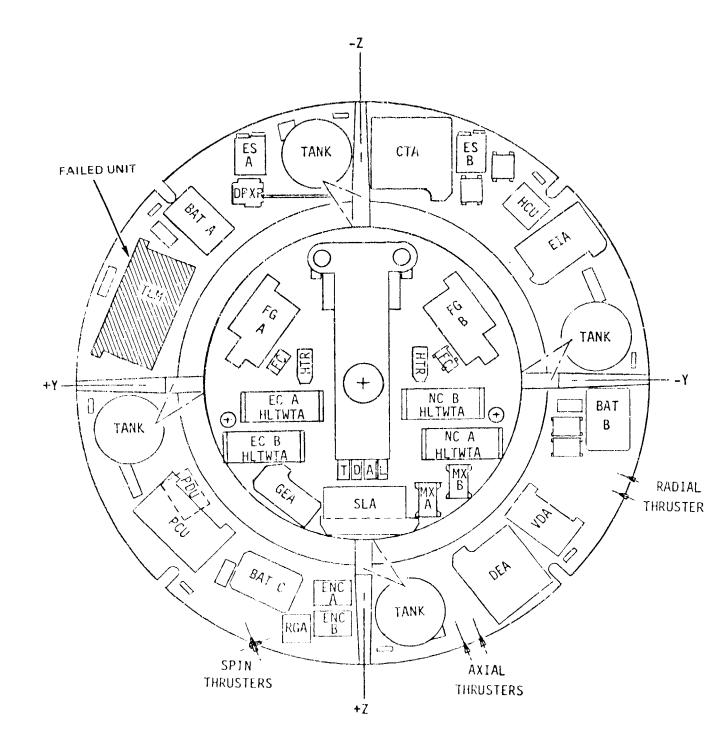
Figure 2-2. Spacecraft Component Layout

The downlink transmission path through the TT&C subsystem begins with the individual sensing element which is connected to the pulse code modulation (PCM) encoder and/or multiplexer. The encoder accepts all telemetry data (analog, bi-level and digital) from the spinning section, whereas the multiplexer (located on the despun platform) receives all data from the despun platform. The serial data stream from the multiplexer is routed through the slip ring assembly to the PCM encoder. The encoder and multiplexer operate in synchronism to encode and format all inputs into one PCM bit stream. Normally, the re ulting digital data output at 250 bits per second is routed to the encrypter for encryption. An encrypter bypass is provided, upon command, which will route the data directly from the encoder to the baseband assembly. The PCM data stream fed to the baseband assembly, either from the encrypter or encoder, is phase modulated on a 1.024 MHz subcarrier and combined with a ranging code into a composite output signal. This composite telemetry signal is then routed to the transmitter where it modulates the phase of the RF carrier. A spacecraft component layout, showing the location of the telemetry transmitter is shown in Figure 2-2.
