MISCELLANEOUS PAPER SL-80-19

CONCRETE DETERIORATION IN SPILLWAY WARM-WATER CHUTE RAYSTOWN DAM, PENNSYLVANIA

Structures Laboratory
U. S. Army Engineer Waterways Experiment Station
P. O. Box 631, Vicksburg, Miss. 39180

December 1980
Final Report

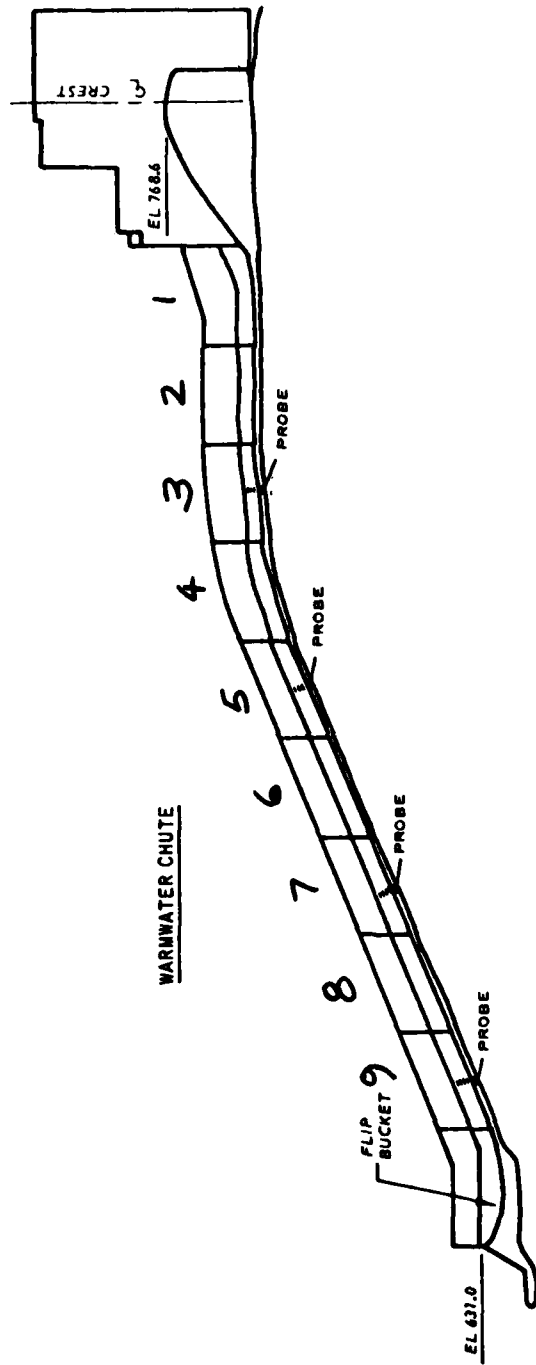
Figure 8. Schematic showing numbering of monoliths referred to in Table 2
 (from Fagerburg, 1979)

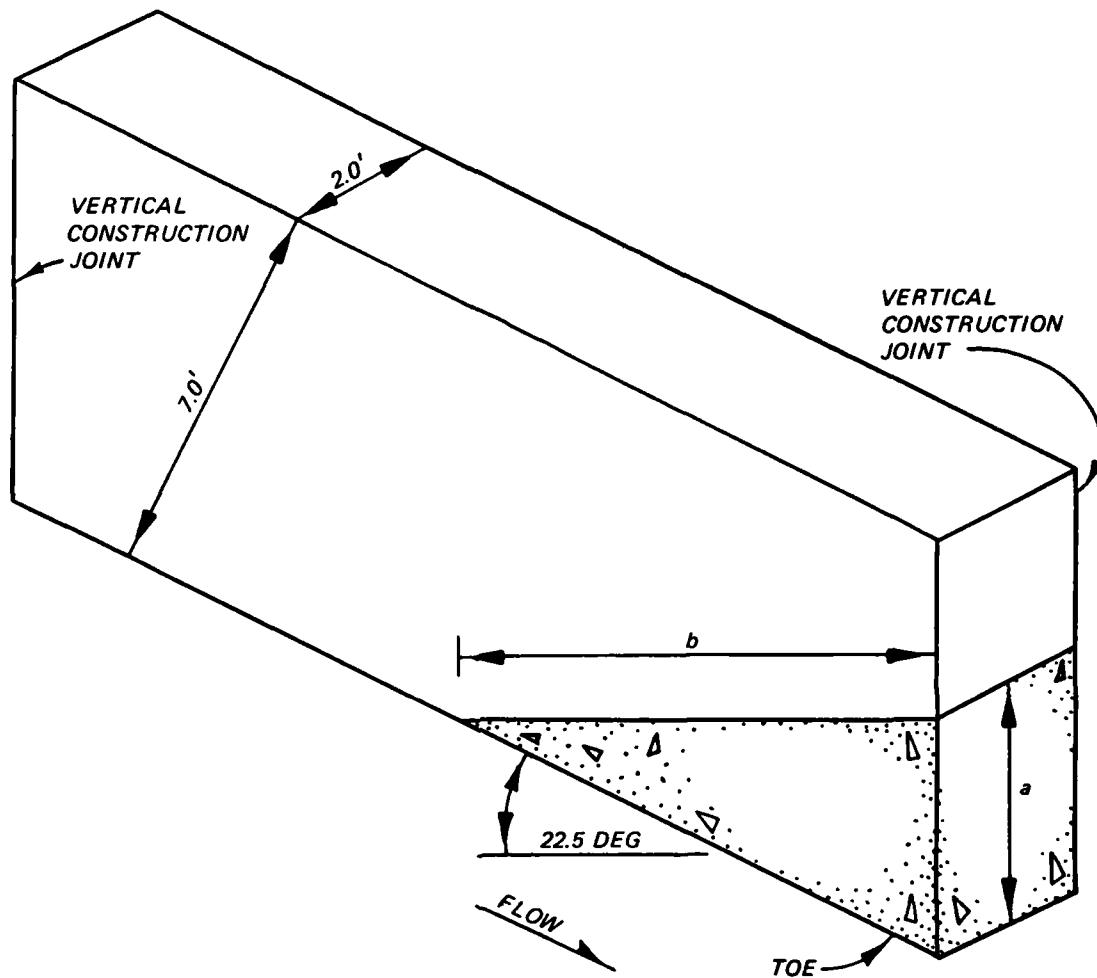
Figure 15. Warm-water chute wall construction technique

surface which is apparently a shear key. Figure 15 compares the contract drawings and the actual construction. The construction technique as shown has allowed water to flow under and inside the walls of the warm-water chute.

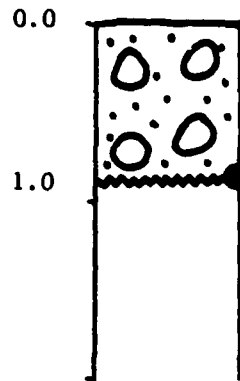
Top surface essentially as formed with etching of limestone coarse aggregate particles up to 1/16 in. deep. New break at 0.95 ft. End of core.

Limestone coarse aggregate, about 3-in. maximum size. Steel reinforcing bar about 7/8-in. diameter at bottom of core.

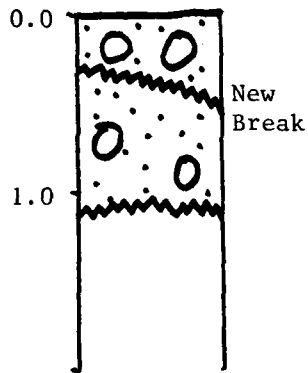
PLATE B5

The outer end is the roughened original surface with the limestone coarse aggregate particles etched to a depth of about 1/16 in.

New break at 1.1 ft. End of core.
