O'BRIEN AND GERE ENGINEERS INC PHILADELPHIA PA F/G 13/13  
NATIONAL DAM SAFETY PROGRAM. LAKE COMO DAM (DE 00028), DELAWARE--ETC(U)  
NOV 80 J J WILLIAMS DACW61-80-0-0013

4. TITLE (and Subtitle) Phase I Inspection Report National Dam Safety Program Lake Como Dam Kent County, Delaware	5. TYPE OF REPORT & PERIOD COVERED FINAL

Based on visual observations made during the inspection (which followed overtopping and partial failure of the dam on July 29, 1980), information provided by the Town of Smyrna, and conversations with town officials, Lake Como Dam is considered to be in poor overall condition.

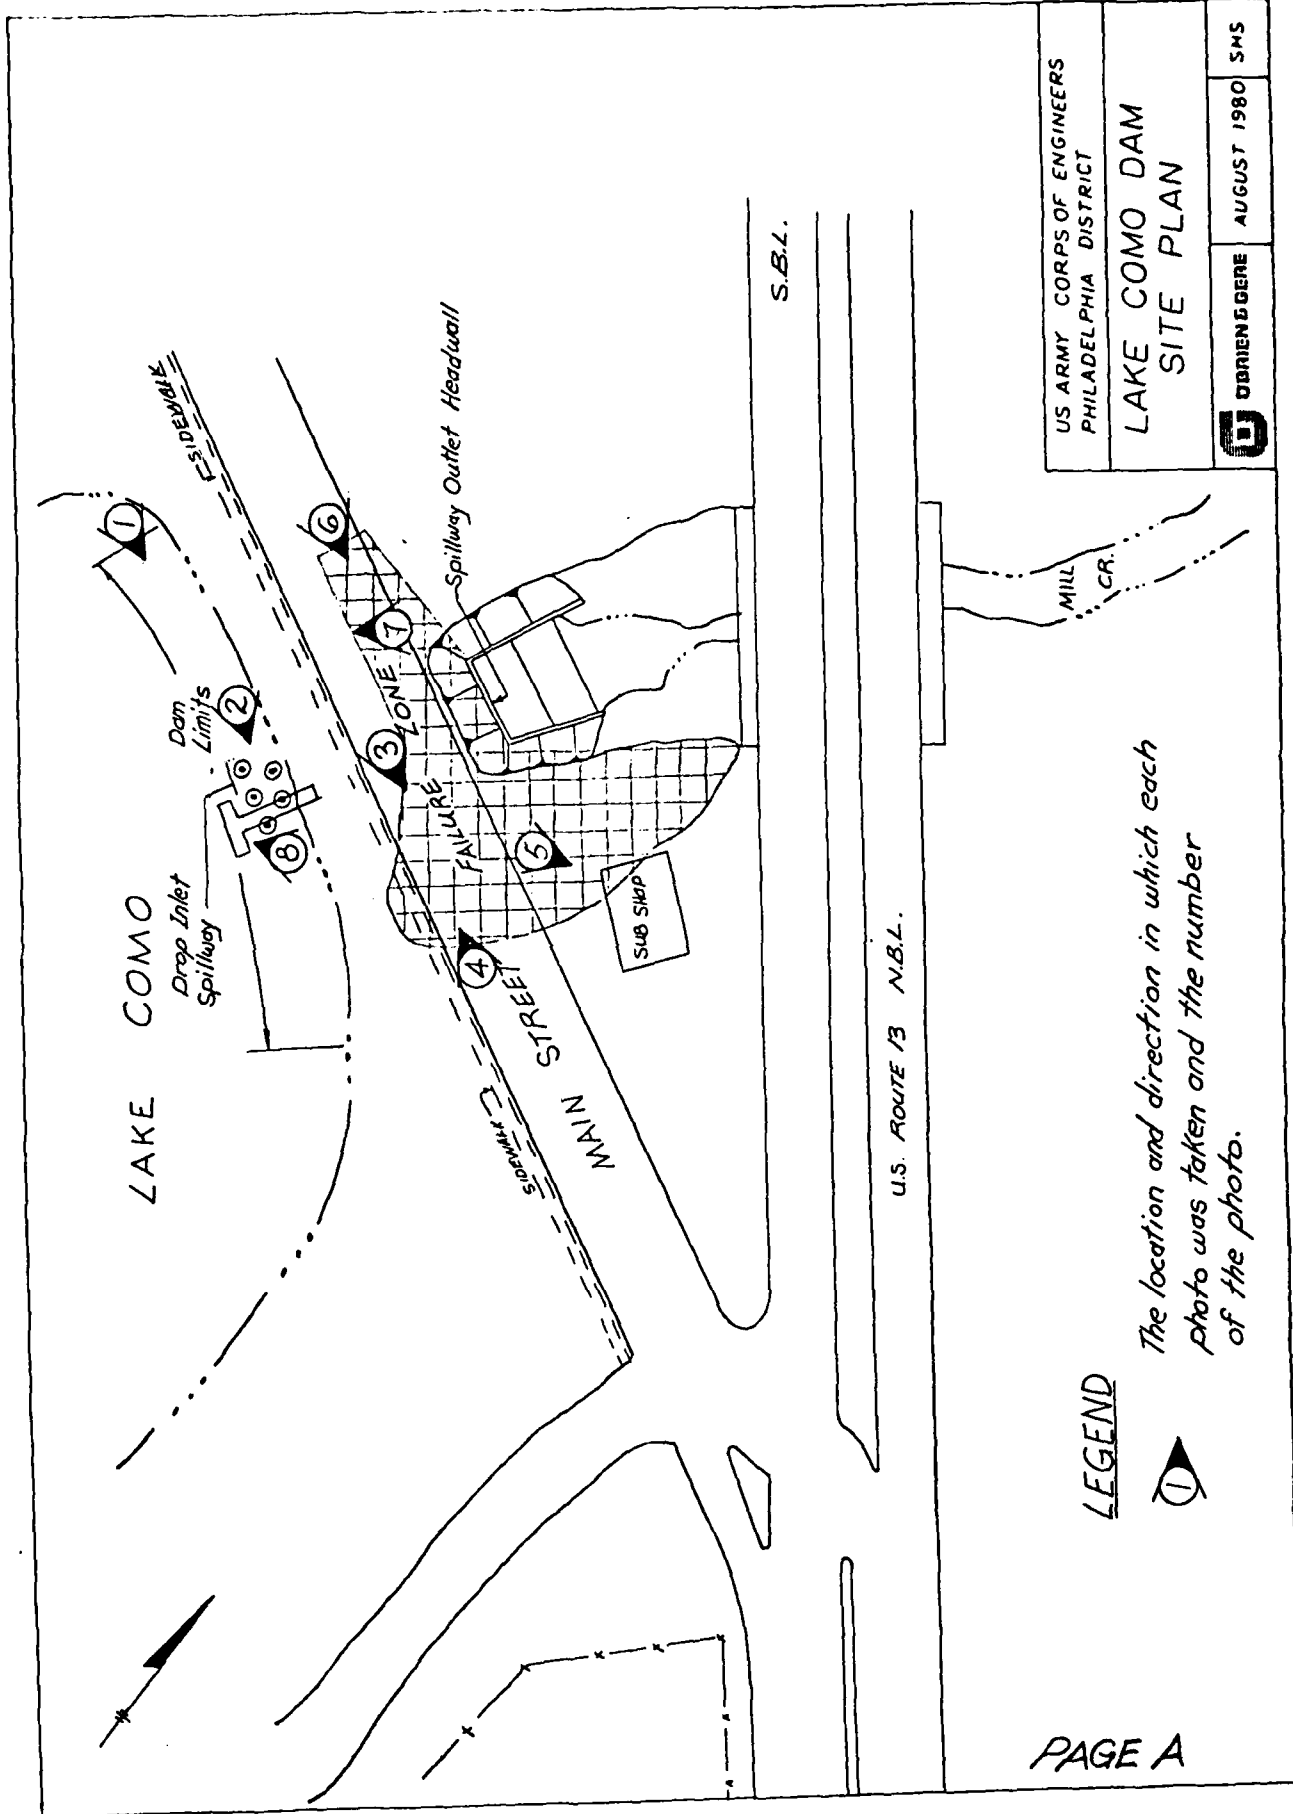
US ARMY CORPS OF ENGINEERS PHILADELPHIA DISTRICT	
LAKE COMO DAM SITE PLAN	
OBRIENBERGER	AUGUST 1980 SMS

i. URGENCY CATEGORY: UNSAFE, Non-Emergency, Significant Hazard.  
CONDITION OF DAM RESULTING IN UNSAFE ASSESSMENT: Dam was overtopped and suffered severe erosion of downstream embankment and outlet channel.
