**DEPARTMENT OF DEFENCE
DEFENCE SCIENCE AND TECHNOLOGY ORGANISATION
AERONAUTICAL RESEARCH LABORATORIES**

Structures Technical Memorandum 327

A REVIEW OF AUSTRALIAN INVESTIGATIONS ON
AERONAUTICAL FATIGUE DURING THE PERIOD
APRIL 1979 TO MARCH 1981

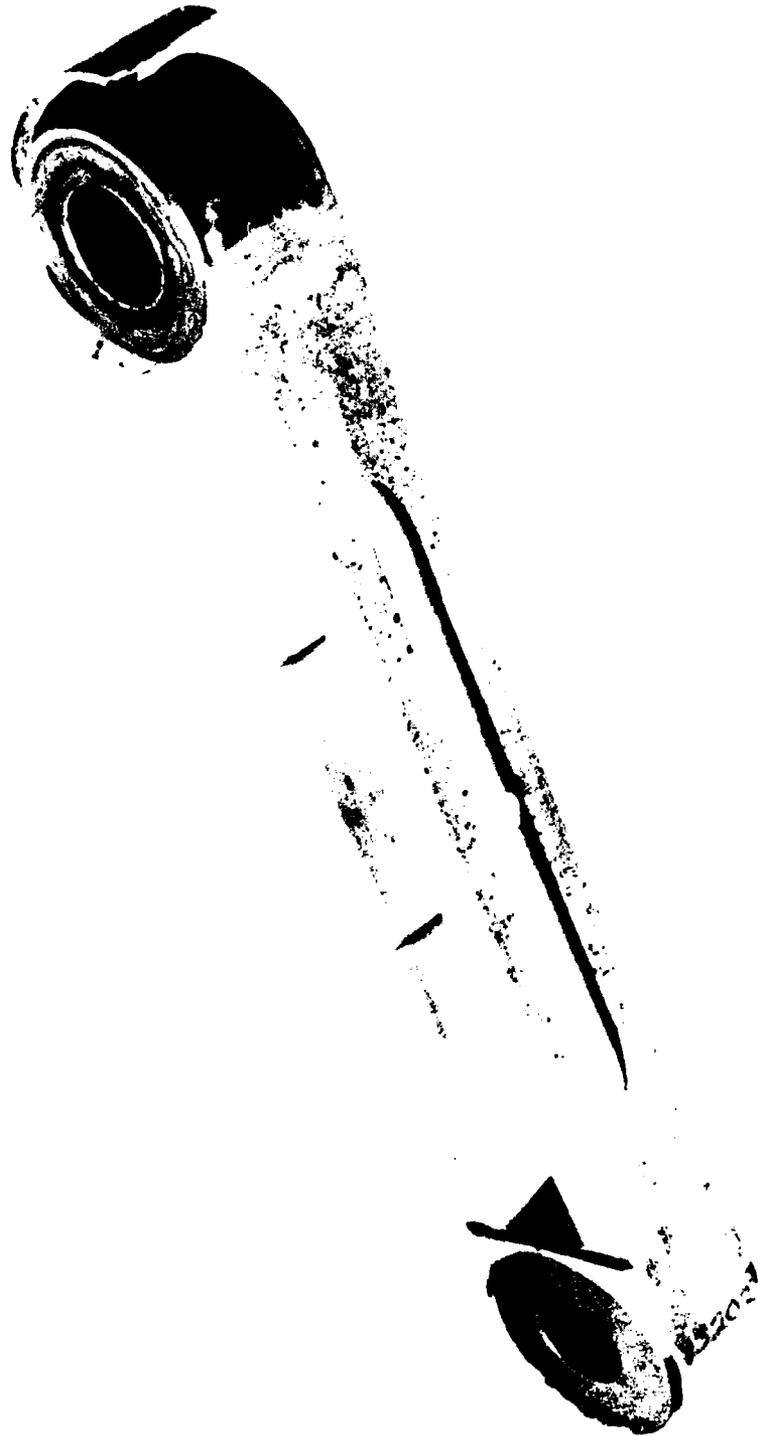
FIG. 9.16 BELL MAIN ROTOR BLADE TENSION/TORSION RETENTION STRAP

However, in April 1980 advice was received of an accident to a Bell 212 helicopter in which one of the new straps was found to be broken, Fig. 9.16. The metallurgical examination of 16000 fractured 0.15 mm dia. wire ends is a formidable task and will take some time to complete. In the meantime the life of the new type straps has been reduced to 1200 hours and a 24 months calendar limit placed on all models.

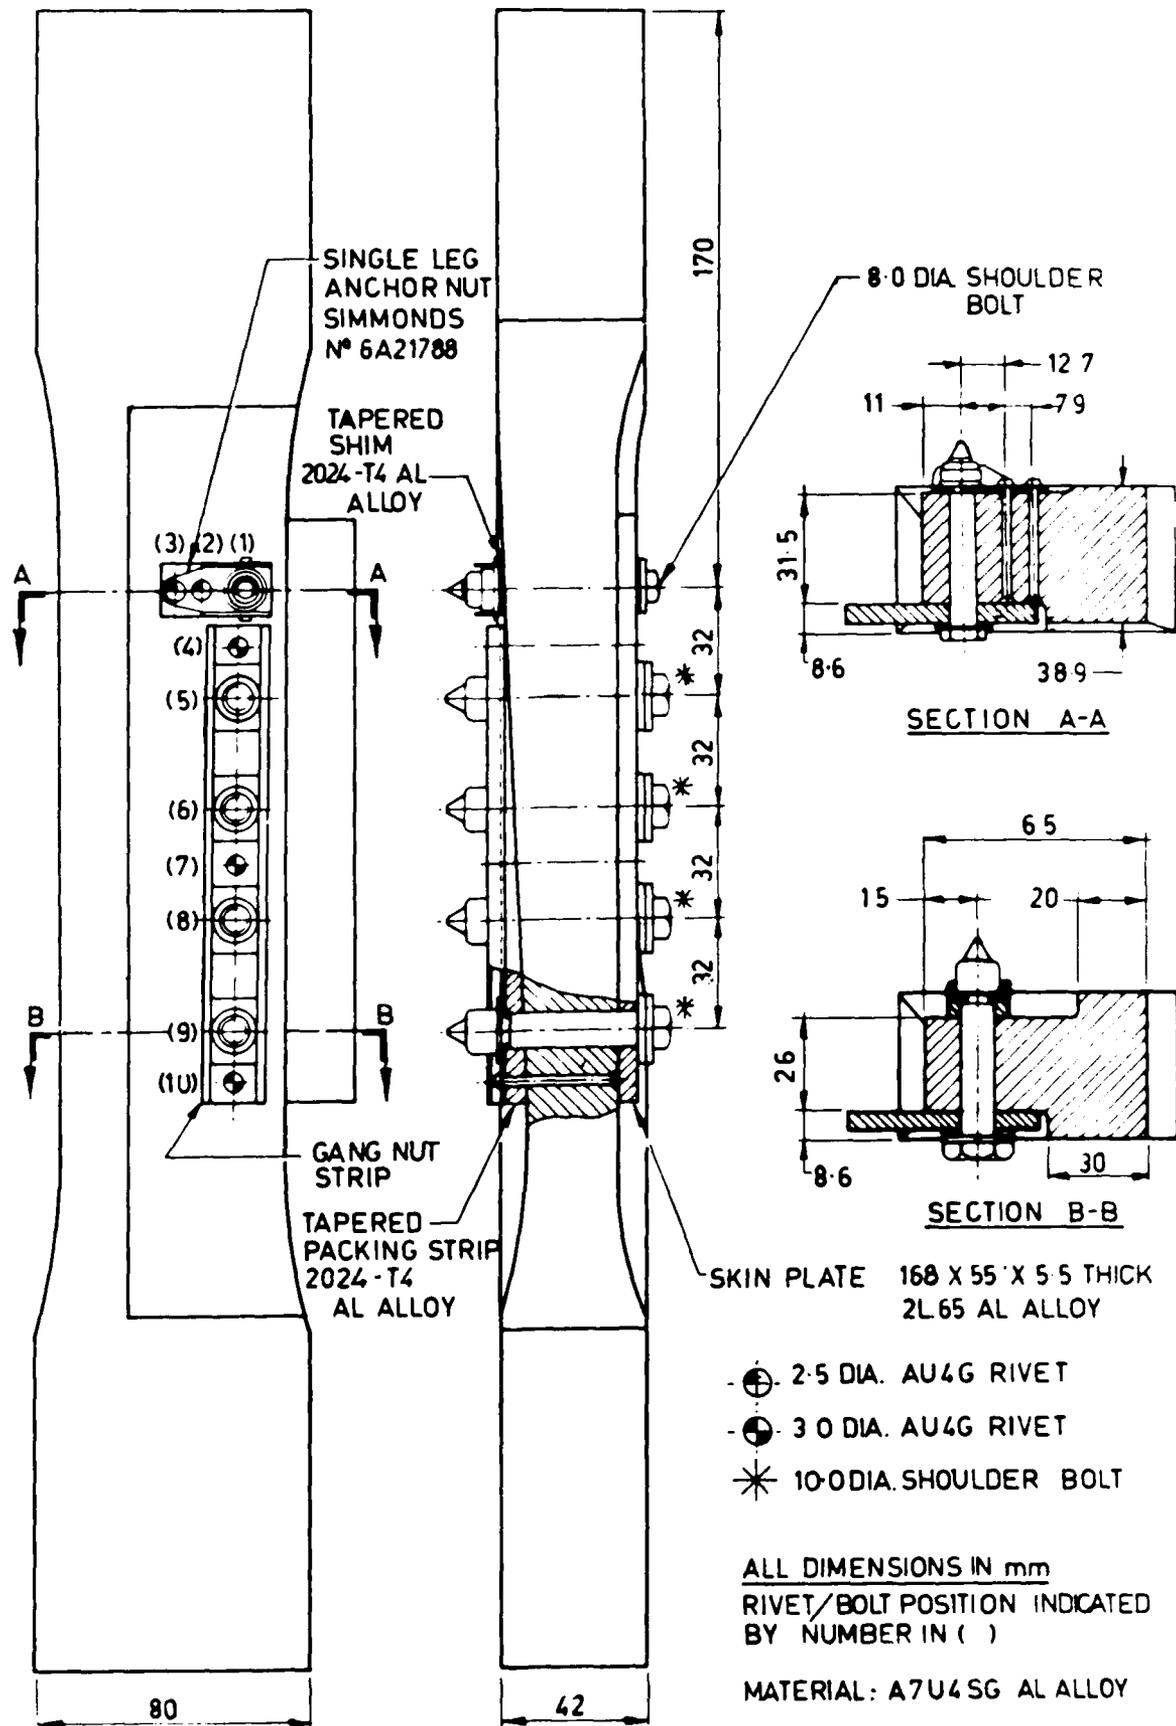
FIG. 9.17 MIRAGE SPAR LOWER REAR FLANGE FATIGUE SPECIMEN

A comprehensive series of fatigue tests on large specimens of a size and geometry closely representing the critical section of the spar was undertaken at ARL. At the commencement of the investigation the development of a refurbishment scheme was based upon a "standard" test specimen, Fig. 9.17, designed directly from the drawings of the spar. However, subsequent detailed examination of spars from crashed aircraft and other wings indicated a number of serious discrepancies between the actual spars and the drawings at the critical section. The most significant of these were the use of 0.125 inch (3.175 mm) 2117 rivets instead of 2.5 mm A-U4G rivets to hold the Single Leg Anchor Nut (SLAN), and that the SLAN rivet holes often tended to converge towards the 8 mm bolt hole at the outer surface of the spar rather than be parallel to it. These differences required that certain aspects of the refurbishment be investigated in much greater detail than was originally anticipated. Because of continuous up-dating of "in-service" information on cracking and wing conditions, the task has broadened to include the determination of crack propagation rates and residual static strengths with cracks of different sizes, and the effects on fatigue life and crack growth rates of spectrum truncation.
