National Dan Inspection Program. ROBINSON DAM (NDI ID DA PA-00165 DER ID NGA" 64-136), LEISURE-LIFE CORP. OF AMERICA Deloward River Basin, Tributary of middle Creek Wayne County, Pennsylvania.

PHASE J INSPECTION REPORT . NATIONAL DAM INSPECTION PROGRAM

4 November 1980

Robinson Dam NDI ID No. PA-00165 DER ID No. 64-136

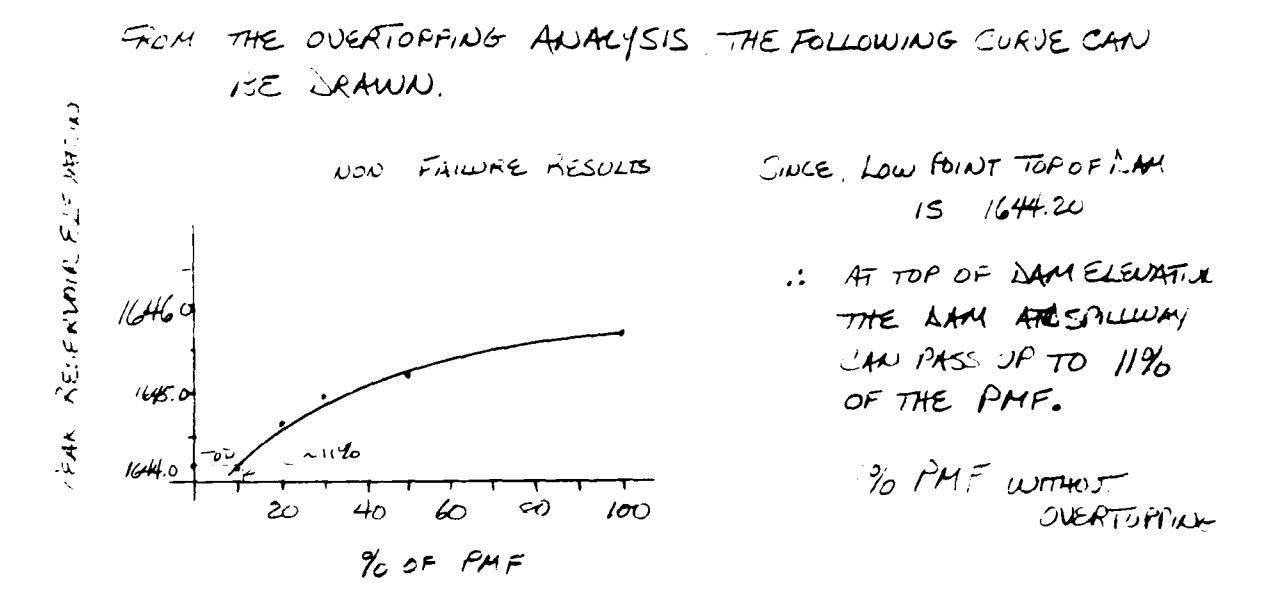
NOTE: SINCE THE LAND IS A HIGH HAZARD, AND IT IS FELT THAT THE 50% PMF WOULD CAUSE FAILURE A BREACH ANALYSIS IS REQUIRED. THE BREACH ANALYSIE WOULD EXAMINE THE SIGNIFICANCE OF FAILURE AND NON-FAILURE CONDITIONS FOR ~ 25% PMF.
