VALLEY VIEW LAKE DAM

NDI ID No. PA-01006
DER ID No. 19-75

PHASE I INSPECTION REPORT

(11) FEBRUARY 1981

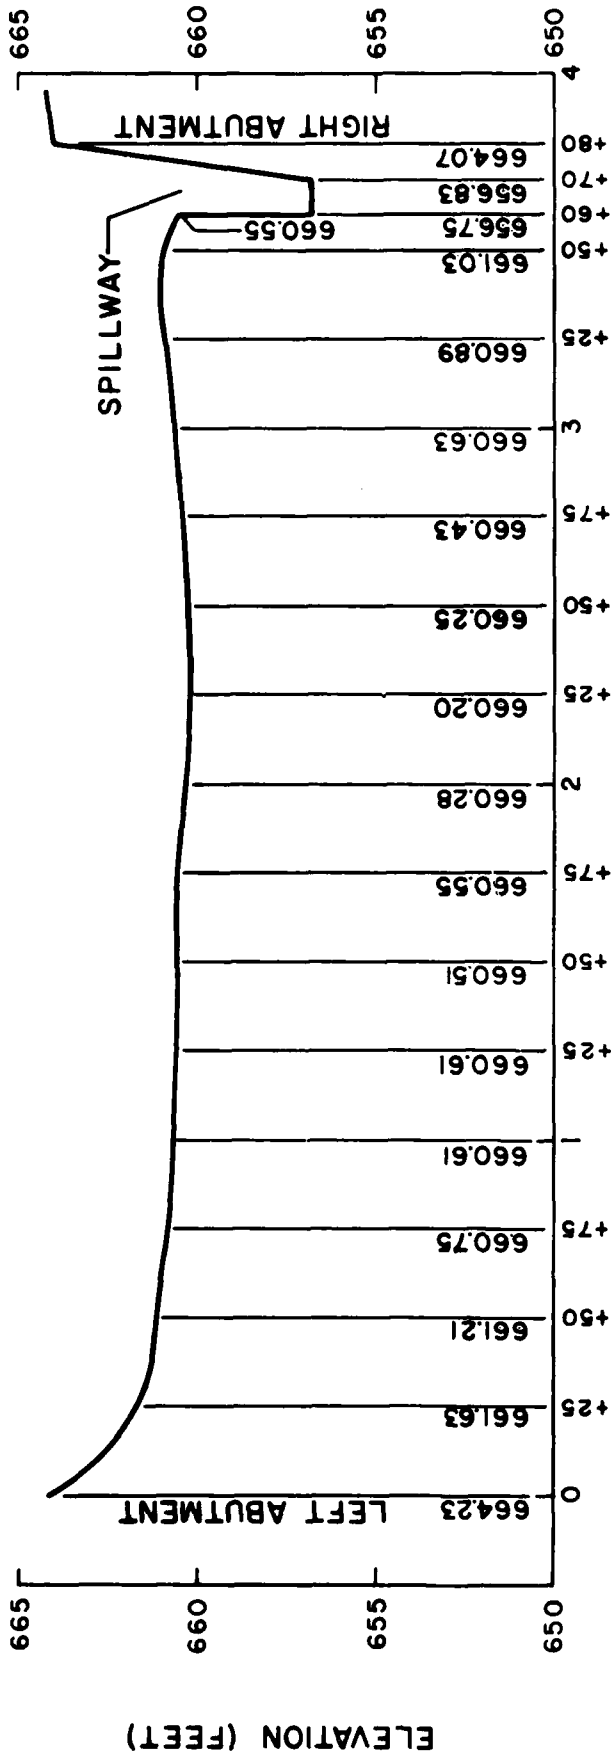
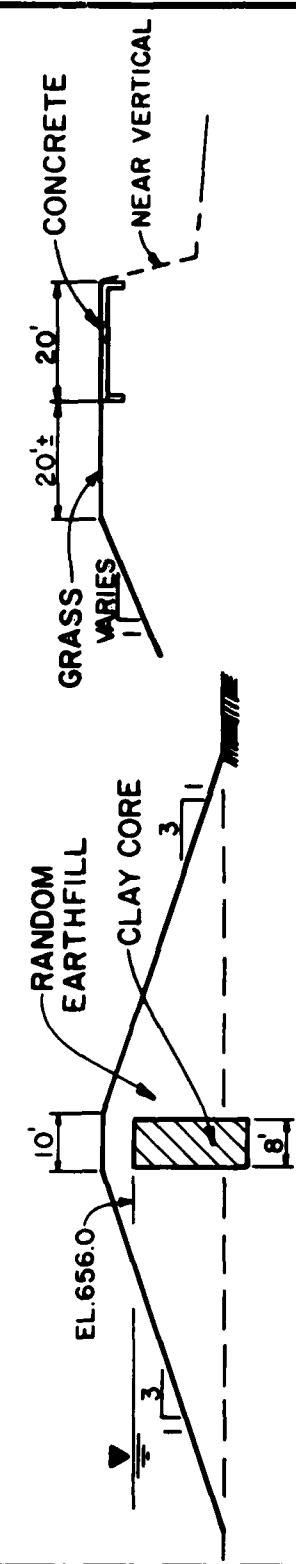
PHASE I INSPECTION REPORT
 NATIONAL DAM INSPECTION PROGRAM
 VALLEY VIEW LAKE DAM
 VALLEY VIEW LAKE ASSN.
 FIELD SKETCH
 EXHIBIT A-1

b. Embankment. The horizontal alignment of the dam is good; however a crack, about 40 feet long, is forming on the downstream face near the left abutment. The junction of the dam and left downstream abutment form a drainage channel which is eroding and causing the adjacent embankment to slough sufficiently to form the crack. A large clump of briars is growing upslope of the crack. The downstream face and the upper 18 inches of the upstream face are grass covered. The crest, which is used as a roadway, and the remainder of the upstream face are covered with small gravel and shale bedding respectively. Trees and brush are growing along the downstream abutment contacts. Clear seepage is flowing at the rate of about 8 gpm from two locations at the toe between the midpoint of the dam and the left abutment contact. The source is unknown but may be springs since the lake is reported to be spring-fed. The vertical alignment of the crest is fair, with a maximum variation of 0.7 feet; however the low point which is located at the dam's right center is one foot below the design crest elevation of 661.25.
