# BRONSON POND DAM

NDI ID NO. PA-00143  
DER ID NO. 64-42

## PHASE I INSPECTION REPORT NATIONAL DAM INSPECTION PROGRAM

(11) FEBRUARY 1981

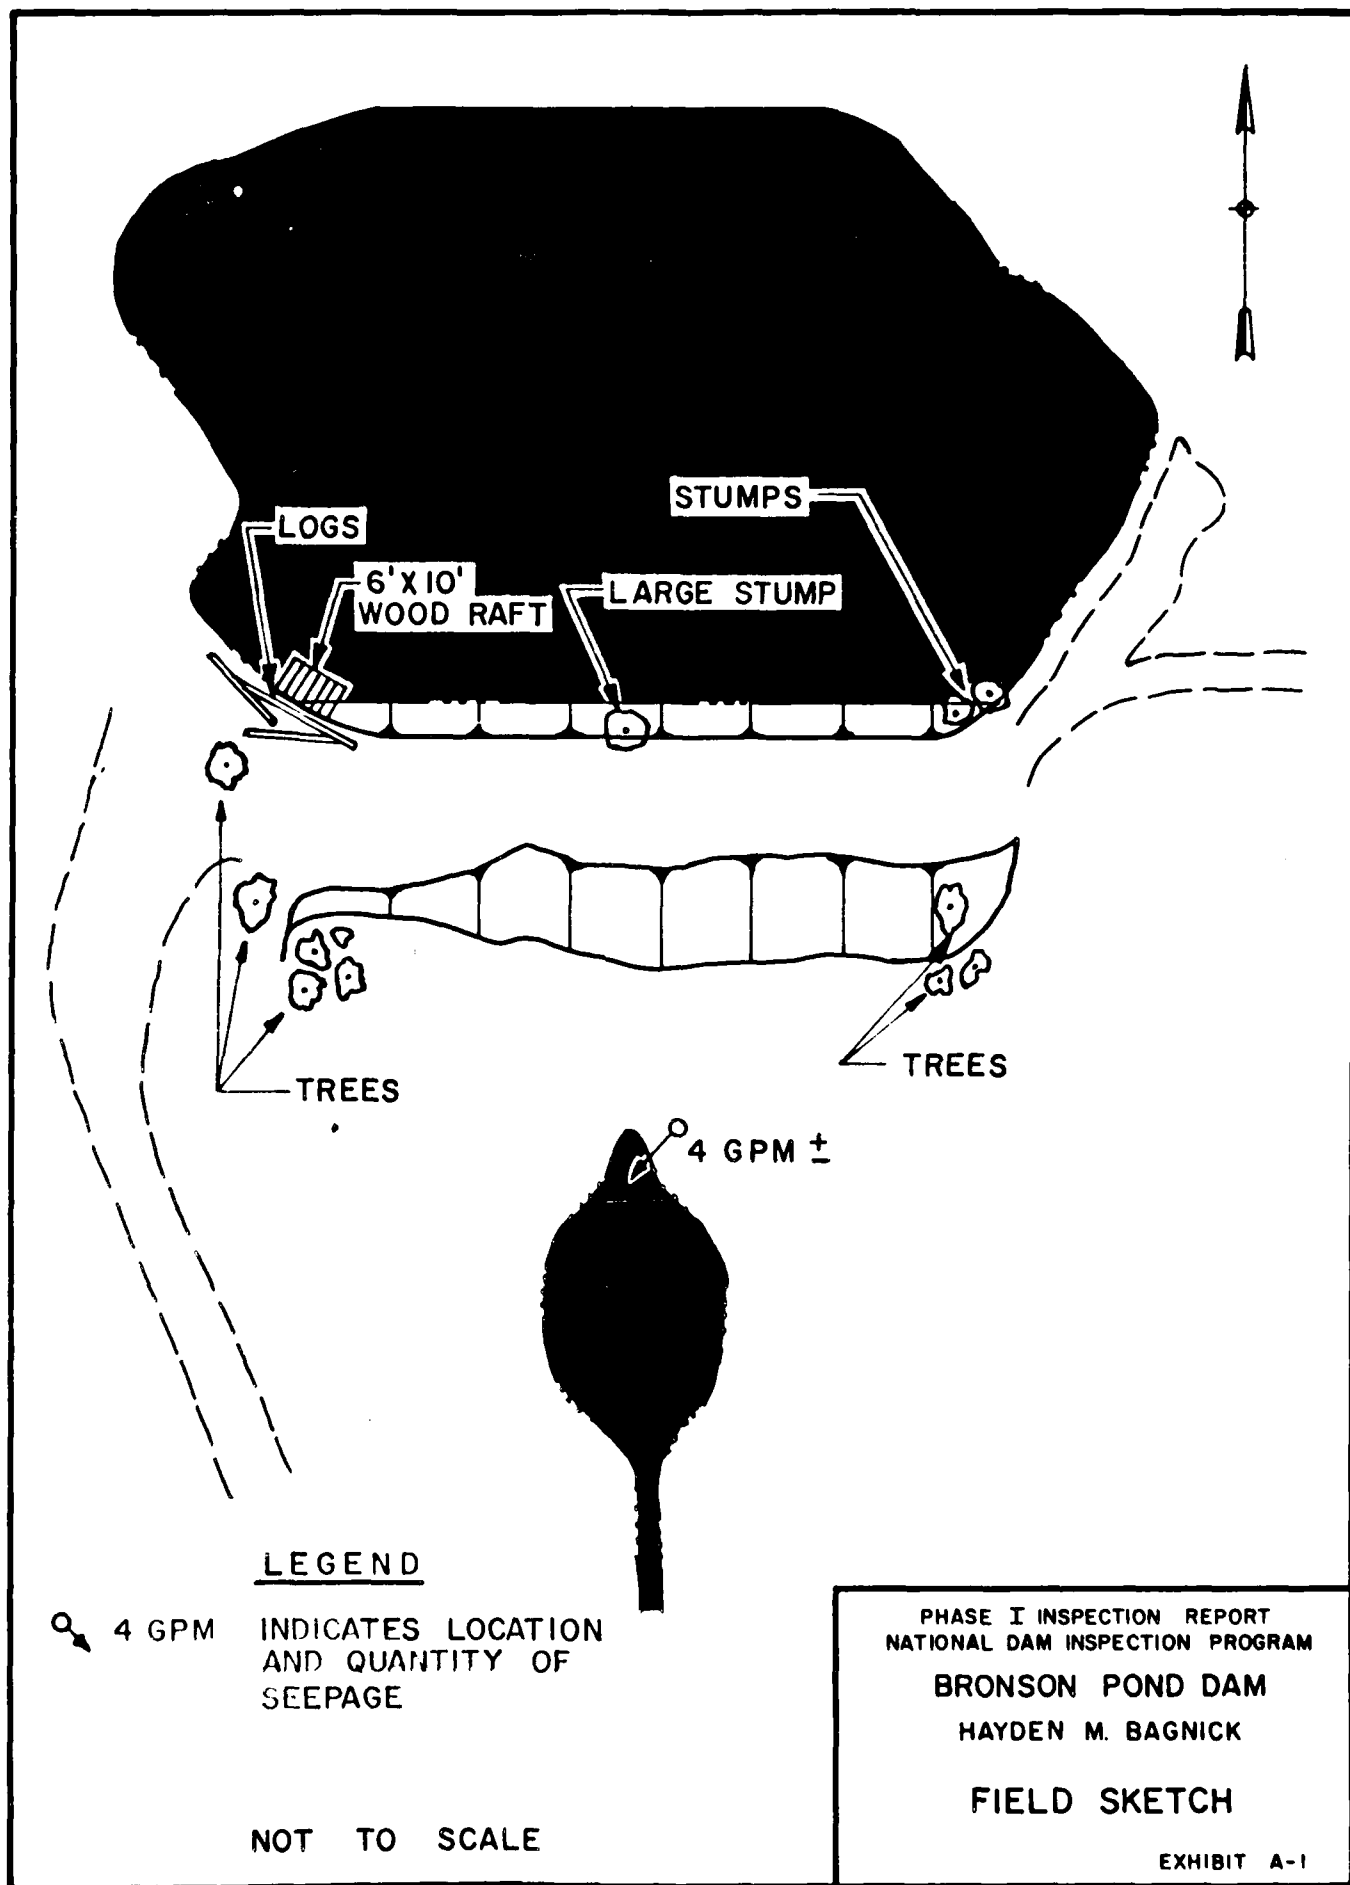
# DOWNSTREAM CHANNEL

VISUAL EXAMINATION OF	OBSERVATIONS
CONDITION: Obstructions	Trees along stream banks. Small dam 1,200' downstream and large highway culvert 1,700' from dam; road crossing @ 4,500' from dam. Lake Quinn is 1.0 mile downstream of Bronson Pond Dam.
SLOPES: Channel Sides	Flat in channel. Flat to 1V:2H.
APPROXIMATE NUMBER OF HOMES	Two houses 4,400 feet downstream approximately 9 feet above streambed.

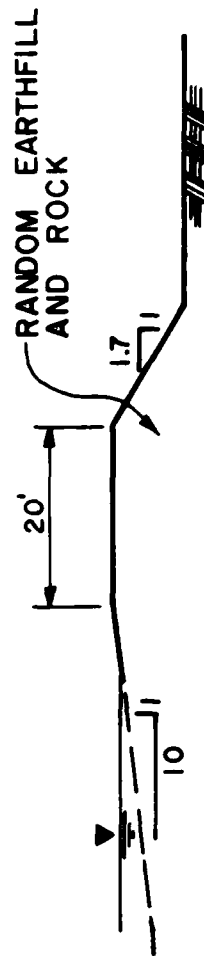
### EMBANKMENT SECTION

(1) Embankment. Visual observations of Bronson Pond Dam indicate that the dam is in fair condition. The dam is constructed of earth and field stones varying in size from a few inches up to 1 foot. It is approximately 8 feet high, has an average crest width of 20 feet, and a downstream slope of 1.7 H:1V. Since the pond is a natural lake, the upstream slope is mild at 10H:1V. Clear water is seeping through the embankment stone at approximately 4 gpm.
