PENNSYLVANIA
NDI No. PA 01069
PENN DER No. 10-26

TREESDALE FARM DAM

**PHASE I INSPECTION REPORT
NATIONAL DAM INSPECTION PROGRAM**

MARCH 1981

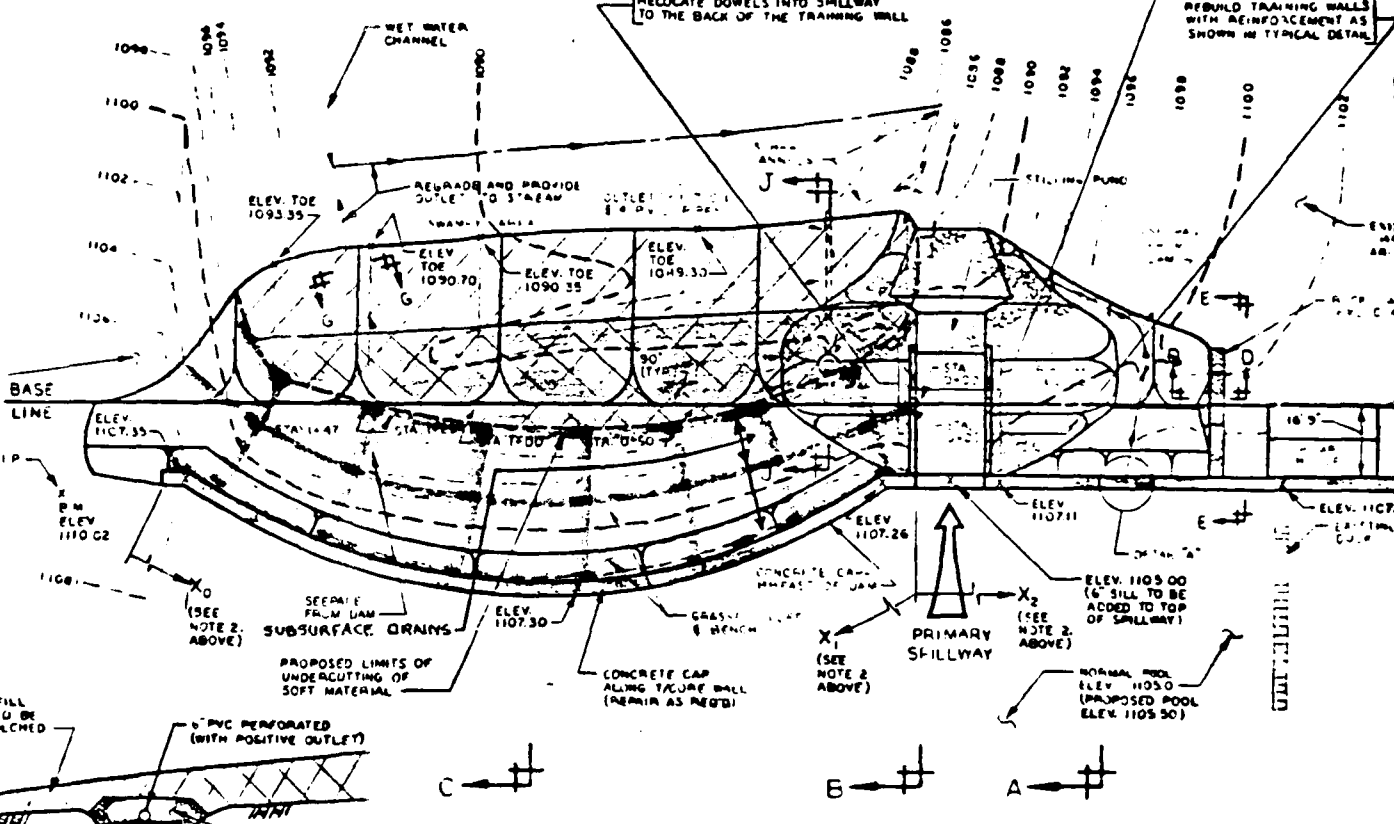
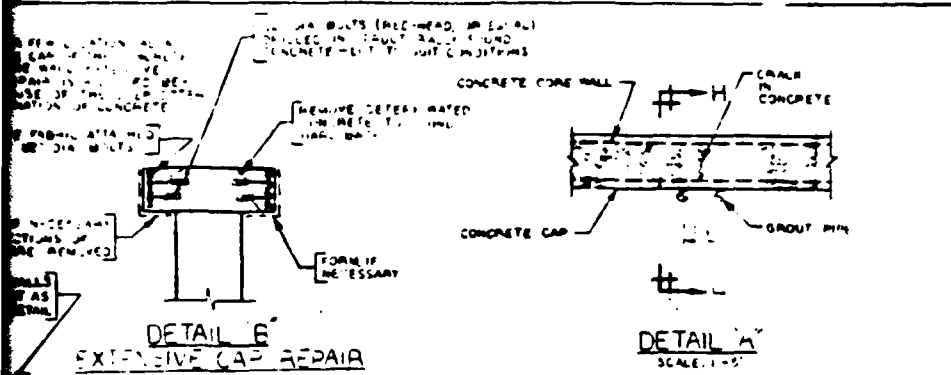
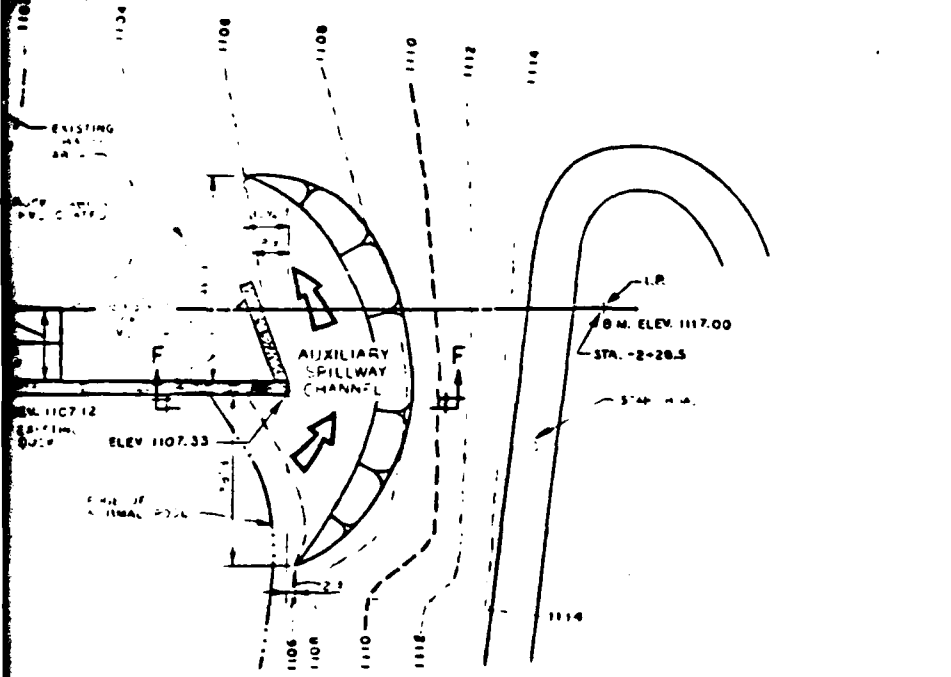
K	RONALD E KELLEY	PROPOSED EMBANKMENT REINFORCEMENT AND DETAILS	
	TREESDALE FARMS, INC. APPLE ORCHARDS MAPS PENNSYLVANIA 16046	NO	79-117-E2 C

2. FOR DESCRIPTION OF CRACKS IN CONCRETE CURB WALL AND RECOMMENDATIONS FOR SEALING, SEE CHARTS I, II, AND III.

PLAN-PROPOSED EMBANKMENT REINFORCEMENT
