LAKE ONDAWA DAM

NDI ID NO. PA-517

6 National Dam Inspection Report
LAKE ONDAWA DAM

PHASE I REPORT
NATIONAL DAM INSPECTION REPORT

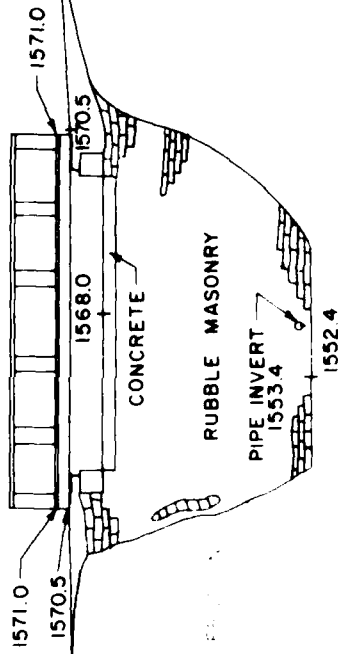
A-13

PROFILE
LOOKING UPSTREAM
SCALE: 1"=13'

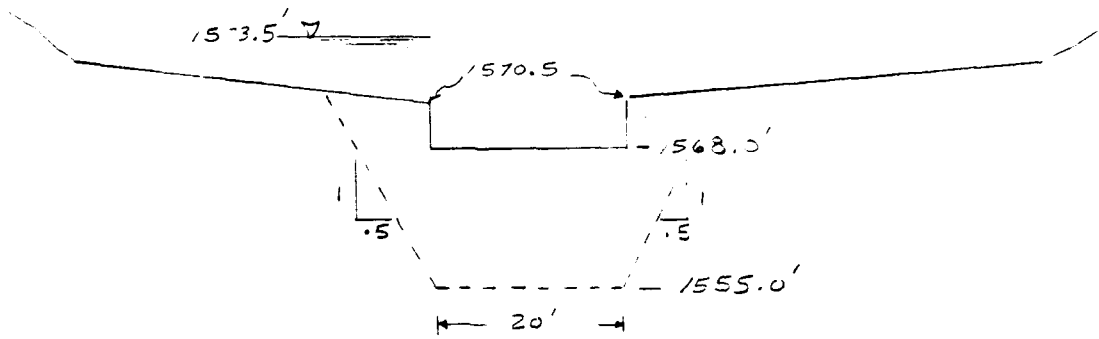
- BRWID = 20'
 - Z = 0.5
 - ELBM = 1555.0
 - TFAIL = 2 HRS
 - WSEL = 1568.0
 - FAILEL = 1573.5
- 0.5 PMF UTILIZED FOR BREACH ANALYSIS.

NOTE: BRWID & ELBM SELECTED BASED ON DATA CONTAINED IN DER. FILES (INSPECTION REPORT, DATED 7-5-29) WHICH DESCRIBED EXISTING BREACH CREATED BY THE OWNER IN AN ATTEMPT TO DRAIN THE RESERVOIR.
