INDIAN LAKE DAM

(NDI I.D. PA-0057

PHASE I INSPECTION REPORT

⑪ 19 Mar 81

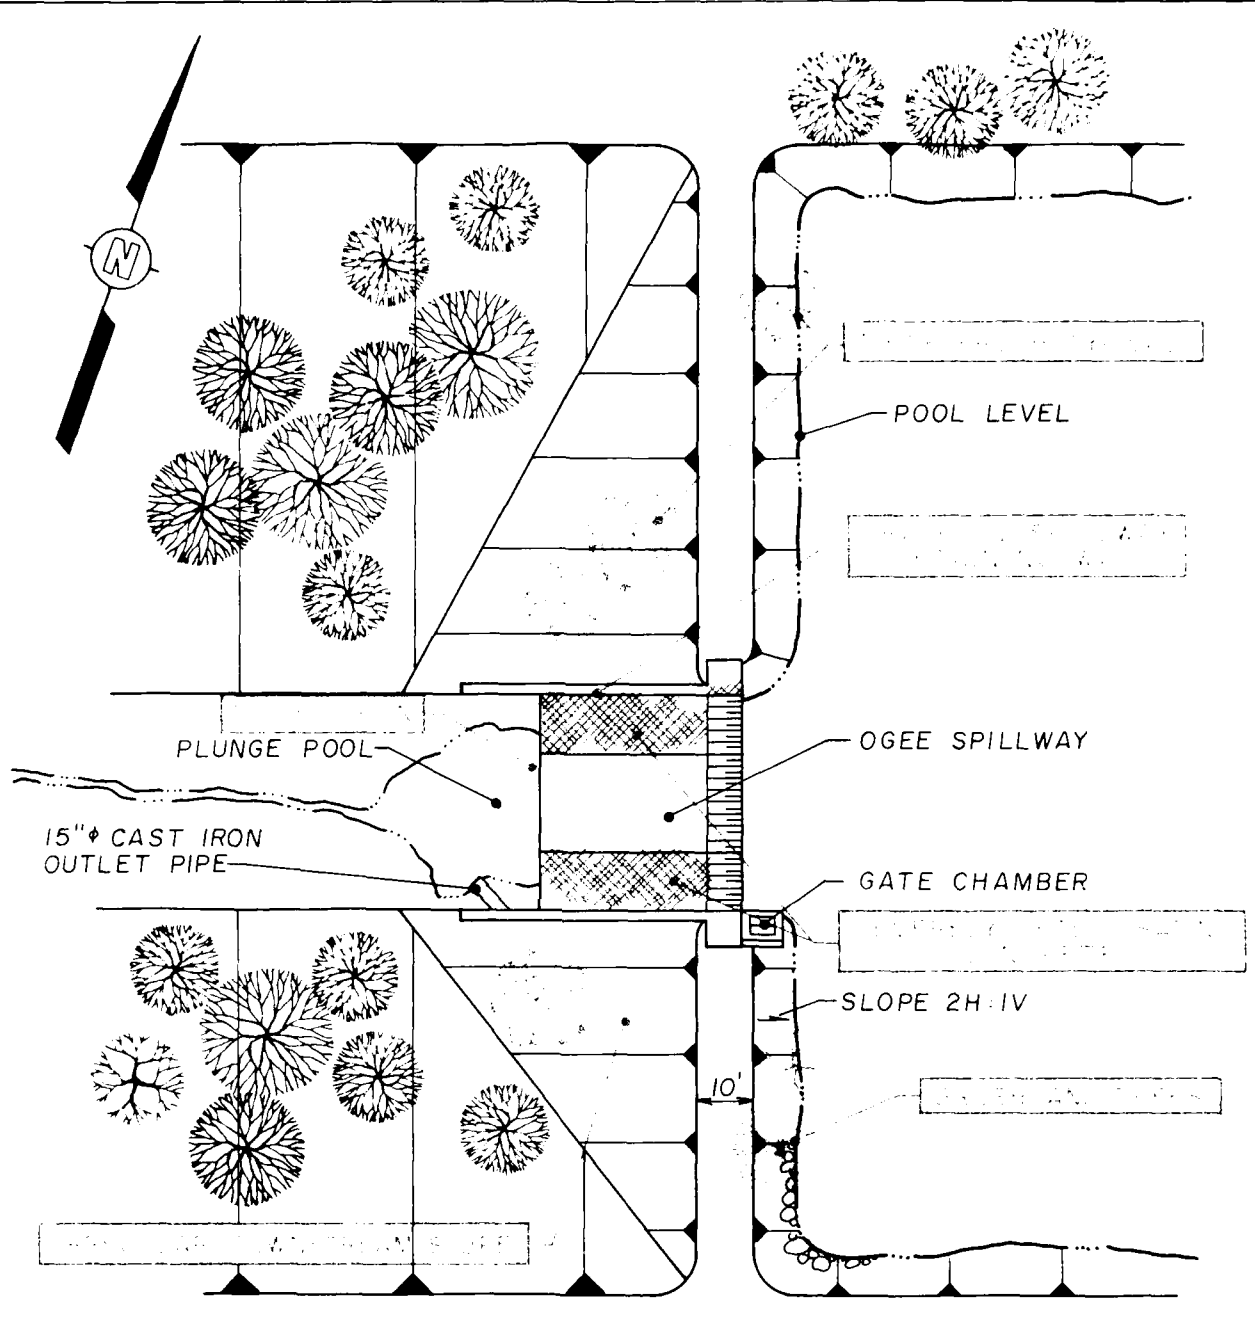
The top of the dam was surveyed relative to the spillway crest elevation and was found to have some vertical irregularities (see Plate 5). While the design freeboard for the dam was four feet, the field survey indicated a freeboard of 4.2 feet between the low spot on the left embankment and the spillway crest.

POOL LEVEL AT DATE OF INSPECTION:
 AT LOW FLOW SPILLWAY CREST
