D'APPOLONIA CONSULTING ENGINEERS INC PITTSBURGH PA  
NATIONAL DAM INSPECTION PROGRAM. COOKS POND DAM (NDI I.O. PA-00--ETC(U)  
1981

PHASE I REPORT  
NATIONAL DAM INSPECTION PROGRAM

NAME OF DAM: Cooks Pond Dam  
STATE LOCATED: Pennsylvania  
COUNTY LOCATED: Bradford  
STREAM: North Branch of Beaver Creek  
SIZE CLASSIFICATION: Small  
HAZARD CLASSIFICATION: High  
OWNER: Mr. E. W. Manchester  
DATE OF INSPECTION: November 15, 1980 and February 4, 1981

COOKS POND DAM  
NDI I.D. PA-0041  
DER I.D. 008-035  
NOVEMBER 15, 1980

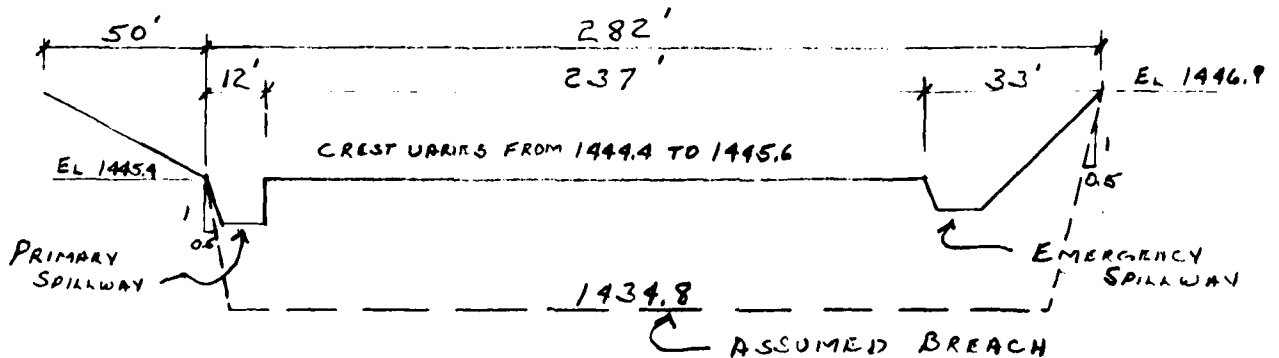
THE DAM BREACH ASSUMED IS:

of life or damage downstream from the dam over that which would exist just before overtopping failure. For the breach analysis, the duration to failure was taken as 0.75 hour and it was assumed that the breaching would initiate when the dam is overtopped by six inches, and the entire embankment would be removed within the failure duration.

BREACH DATA: LENGTH = 282'  
DEPTH = 1434.8  
SIDE SLOPES = 0.5:1.0 (H:V) (MASONARY)  
TIME = 0.75 HOURS

BREACH WILL BE ASSUMED TO OCCUR AT AN  
OVERTOPPING DEPTH OF 0.5 FEET
