SHARPE'S POND DAM

(NDI I.D. PA-0888

PHASE I INSPECTION REPORT

NATIONAL DAM INSPECTION PROGRAM

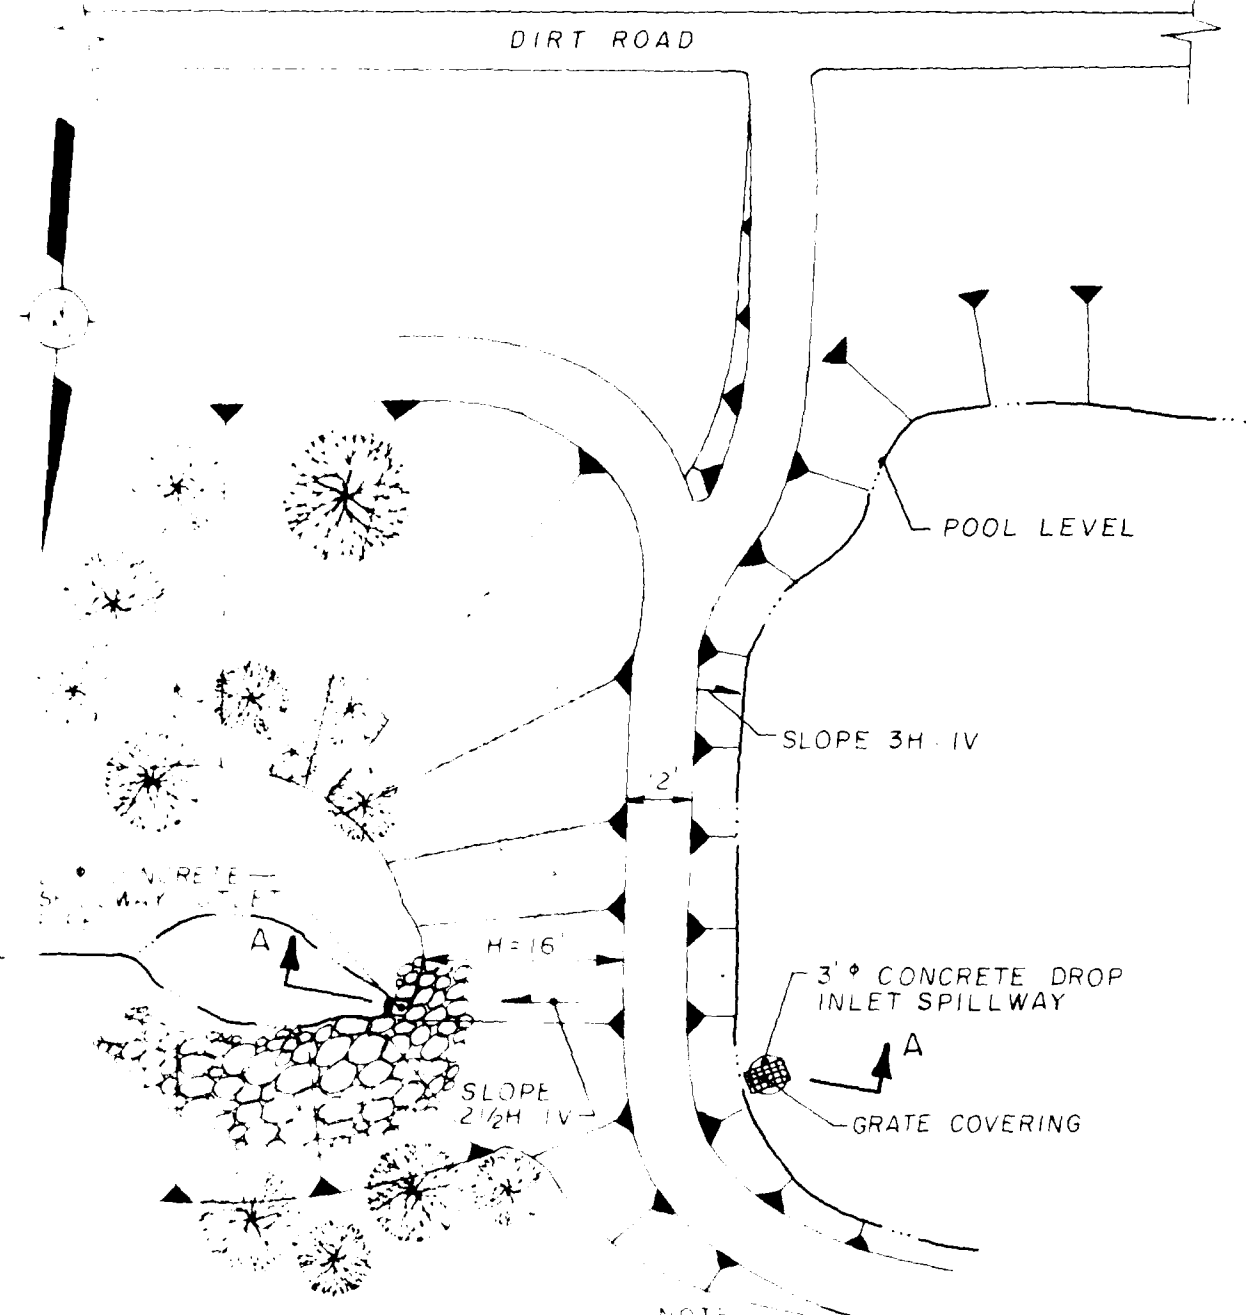
PLATE 2

The specific observations are illustrated in Plate 2.

NOTE
POOL LEVEL AT DATE OF INSPECTION:
2" BELOW DROP INLET SPILLWAY
