ECHO LAKE DAM

PHASE I INSPECTION REPORT.

6 NATIONAL DAM INSPECTION PROGRAM.
Echo Lake Dam (NDI Number PA-00957, DER
Number 48-3)

PHASE I INSPECTION PROGRAM
NATIONAL DAM INSPECTION PROGRAM

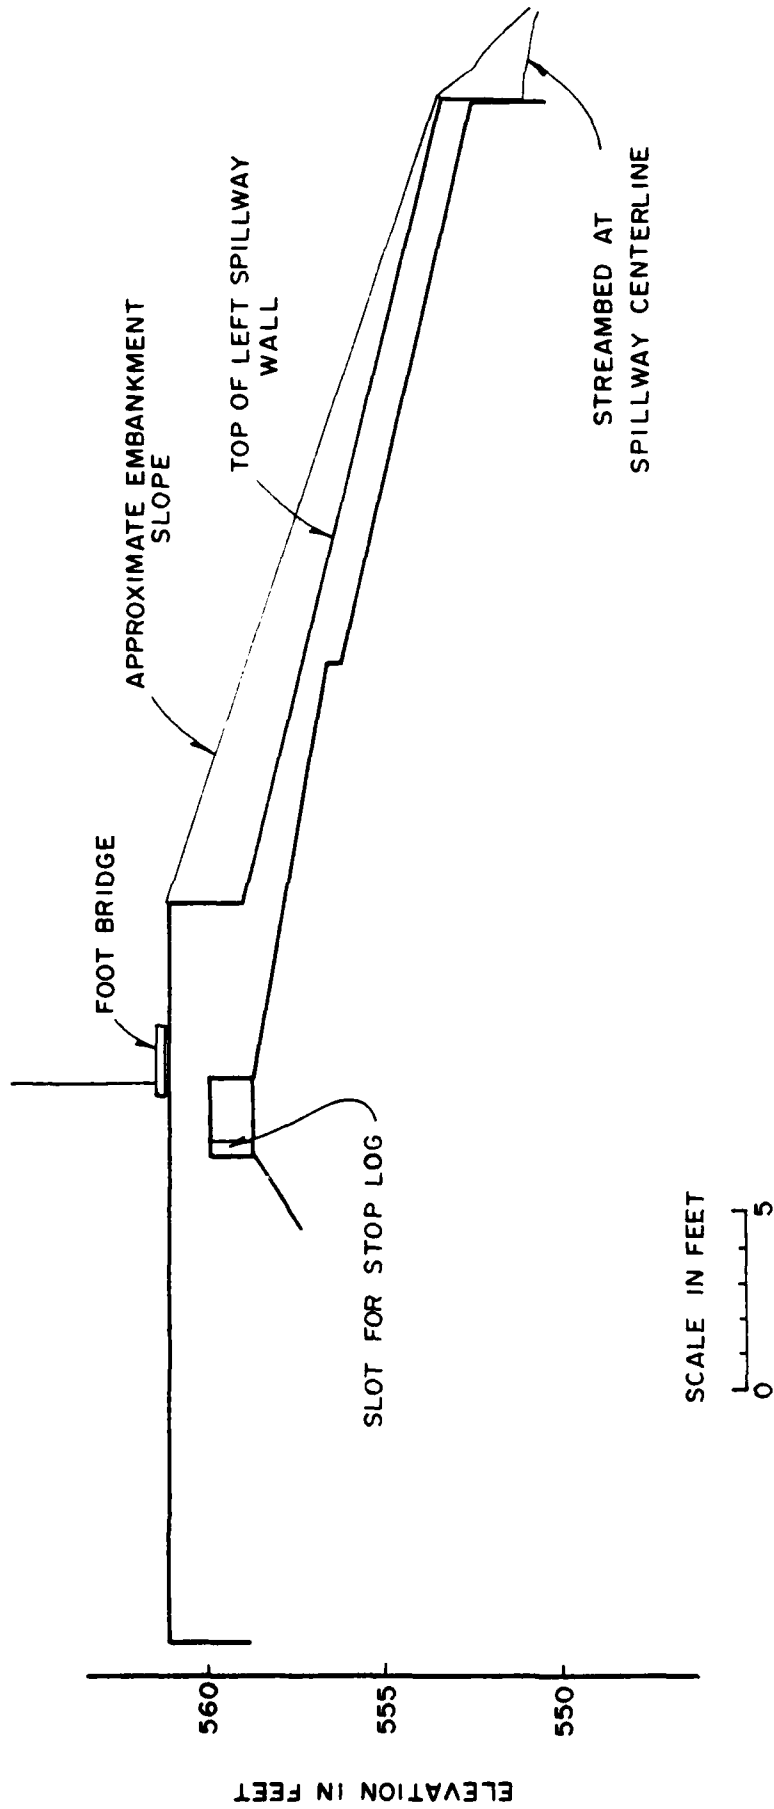
SECTION THROUGH SPILLWAY
ECHO LAKE DAM
PLATE 3

1. Spillway. The spillway is a concrete structure 49.4 feet wide. The upstream slope is concrete and underwater. The downstream slope is concrete over rock fill. A concrete weir 18.5 inches wide and 16 inches high controls spillway discharge, Plate 3, Appendix E. The weir crest ranges in elevation from 560 to 559.8 and appears to be in good condition. Flow through a notch approximately 30 inches wide by 14 inches deep is controlled by a wooden stop log. A foot bridge across the spillway is about 18.5 inches above the weir crest. The original concrete upstream spillway walls were extended as diving board platforms and the phases of construction can be seen. The spillway walls are cracked. Only the anchor bolts remain. The largest crack in the right spillway wall is approximately one-inch wide, Photograph 5. The downstream spillway walls also showed occasional cracks. The downstream slab of the spillway has a five-inch step at about its mid-height. There are several cracks noted in the spillway slab and pieces of concrete have apparently been broken off at the lower end of the slab. Cobbles and boulders underlie the spillway slab, Photograph 7. The spillway discharges directly into the downstream channel. No evidence of channel erosion or undermining of the spillway resulting from spillway discharge was noted.
