FULLER'S LAKE DAM

NDI No. PA 00073
PennDER No. 58-121
Dam Owner: Frederick Hoal

PHASE I INSPECTION REPORT NATIONAL DAM INSPECTION PROGRAM

Fuller's Lake Dam, Susquehanna County, Pennsylvania
NDI No. PA 00073, PennDER No. 58-121
Salt Lick Creek
Inspected 27 October 1980

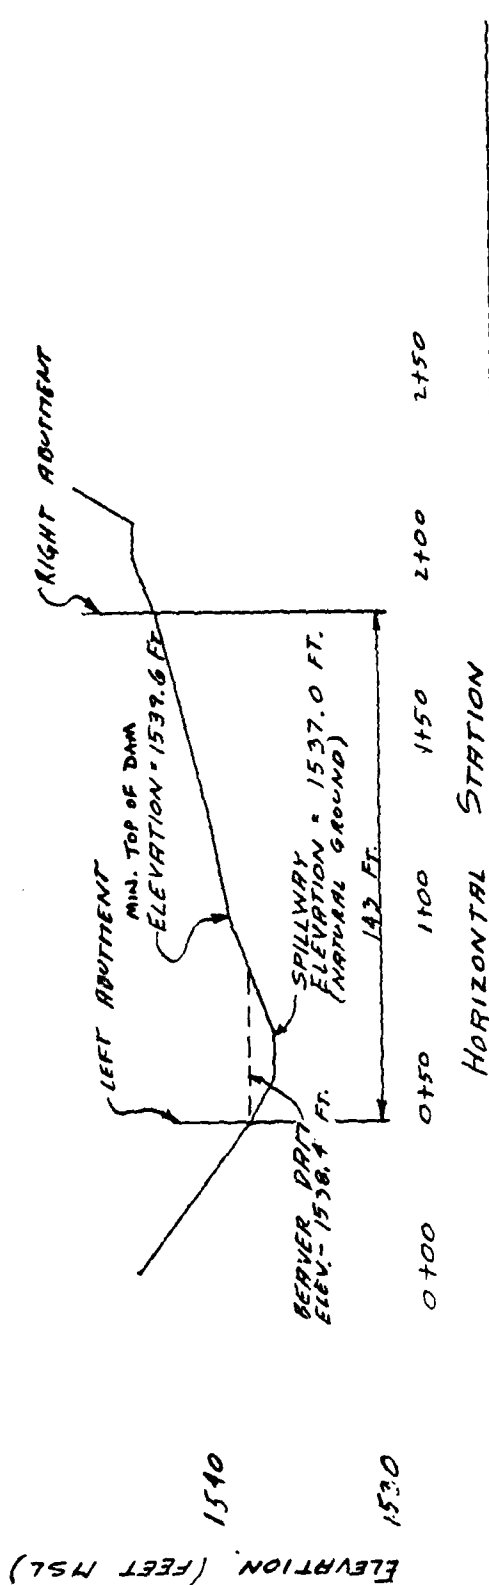
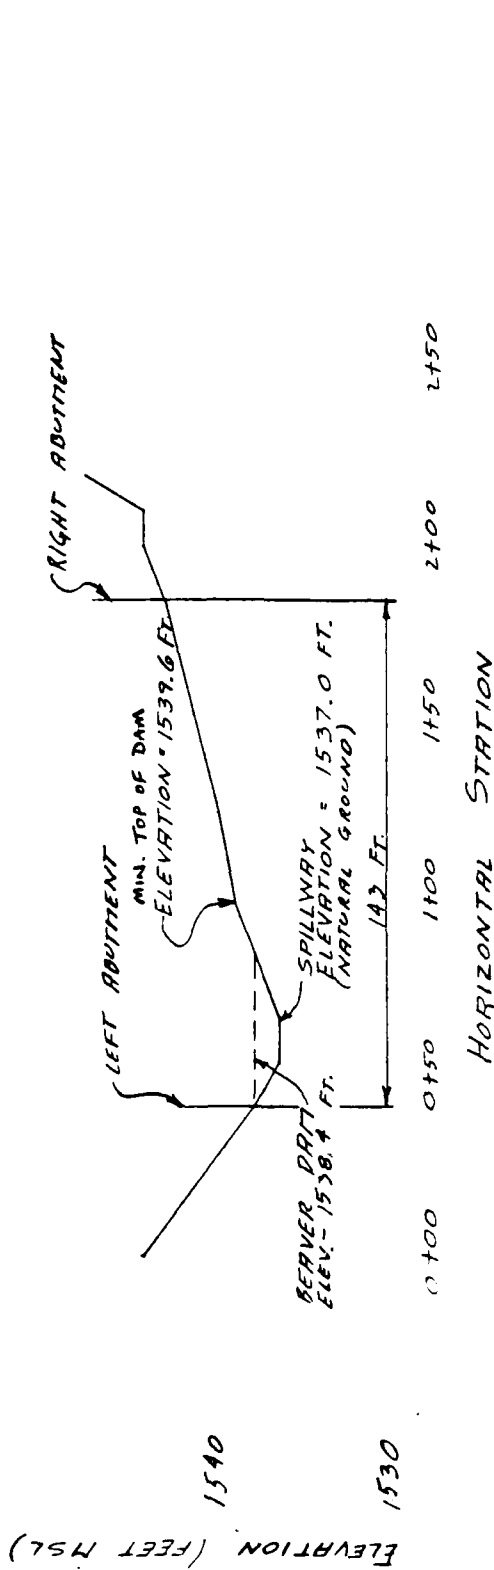
TOP OF DAM PROFILE (LOOKING DOWNSTREAM):

LENGTH OF DAM = 143 FEET

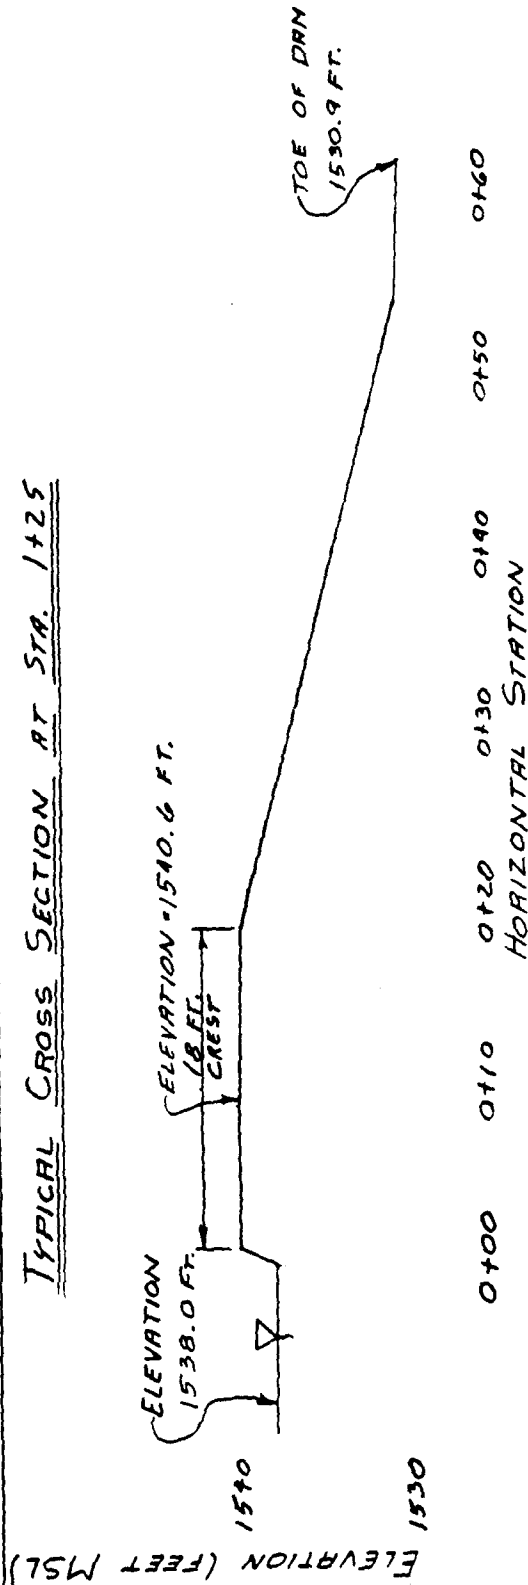
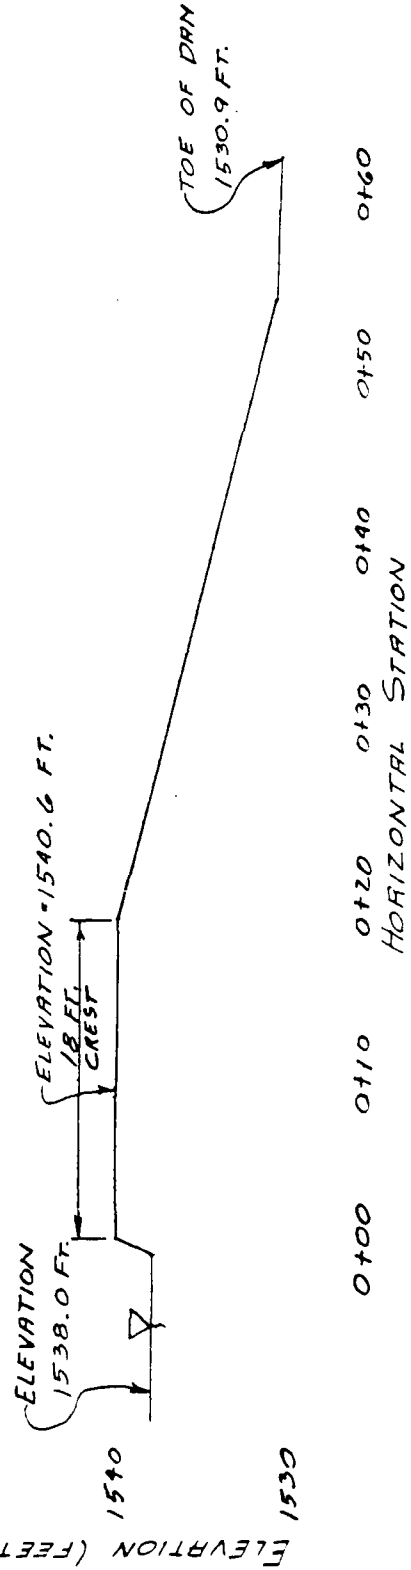
TYPICAL CROSS SECTION AT STA. 1+25

- b. Dam - Clear seepage was observed exiting the downstream slope at a rate of approximately 7.5 g.p.m. The vegetation and the erosion channel away from the seep indicated that the seepage has been occurring for a long period of time. The seep is located 8 feet vertically below the crest of the dam, at station 1+40 (see Field Sketch in Appendix A).

- a. Visual Observations - A clear seep (estimated flow rate 7.5 g.p.m.) was found on the right downstream face of the embankment. The owner reported that an old flume was located in the dam near this location. This old wooden flume may have decayed, leaving a potential seepage zone through the dam. It is recommended that the seepage be monitored at regular intervals and the quantity and turbidity of the seepage recorded. If an increase in either of these two items is occurring, then corrective measures are necessary.

- c. Operating Records - No operating records are available.
- d. Post-Construction Changes - The improper back-filling of the old wooden flume may be contributing to the seepage which was observed during the visual inspection.
