LAKE KIMBERLY DAM

NDI NO. PA-00949

PHASE I INSPECTION REPORT

NATIONAL DAM INSPECTION PROGRAM

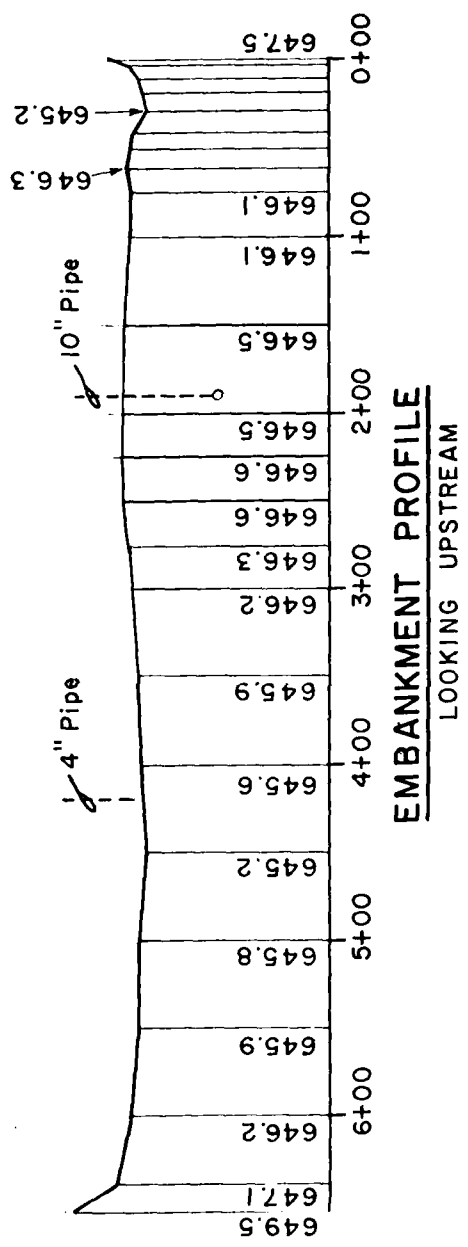
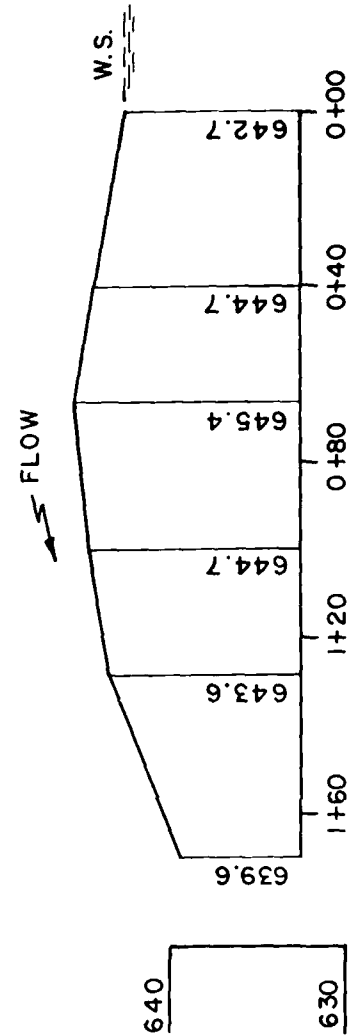
LAKE KIMBERLY DAM
 PA.-00949
 INSPECTION SURVEY
 PLATE A-I

Records of operation are not maintained by the owner. Within one or two weeks after construction was completed, a slough occurred on the downstream slope in the area indicated on Plate A-I. This condition has not been improved nor repaired.

The downstream slope, near the left and right abutments, is flat and in good condition with a good grass mat protection, except where the bike trail has killed the grass. The center portion of the downstream slope is overgrown with trees, briars and brush (Photograph No. 4). In this area a 50 foot long slope failure was observed (Photographs No. 8 and 9 and Plate A-III, Appendix A). The owner stated that this slough occurred one or two weeks after construction was completed. Repairs were never made. Heavy brush in this area prevented close observation. Seepage was not detected during the inspection. The pool level was several feet below normal at that time. A woodchuck hole is located in this slough area.
