WESTCOLANG LAKE DAM

NDI I.D. NO. PA-00396
PENNDER I.D. NO. 52-4

PHASE I INSPECTION REPORT
NATIONAL DAM INSPECTION PROGRAM.

14 MAR 1981

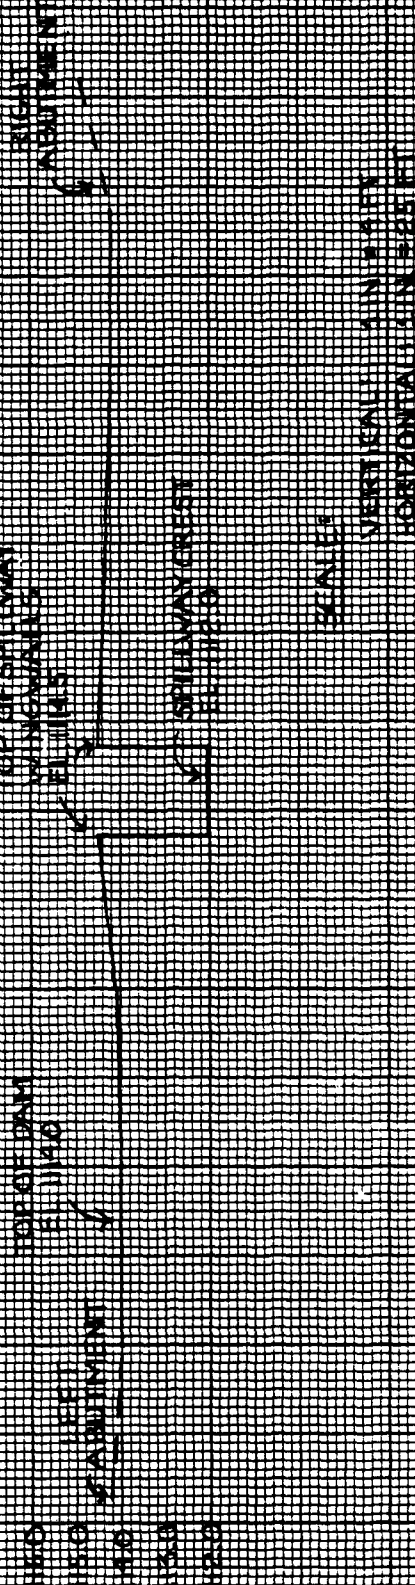
PROFILE OF CREST
FROM FIELD SURVEY

1. Embankment. Based strictly on visual observations and field measurements, general statements can be made regarding the embankment design. The dam is an eight-foot high, 160-foot long earth embankment, including spillway, constructed at the outlet to a natural lake. The crest is wide, measuring from a minimum of 48 feet along the centerline of the spillway to about 70 feet near the junction of the embankment and right abutment. Most of the crest is grass covered except for the crushed stone covered roadway which provides access between the abutments (see Photograph 1). The upstream embankment face is sloped at 2.5H:1V and protected with a riprap layer comprised of hard, durable sandstone boulders (see Photograph 11). The downstream embankment face to the left of the spillway consists of a small, vertical, masonry wall (see Photograph 12). Remnants of a similar wall are also evident to the right of the spillway; however, the downstream embankment face in this area is best described as irregular and poorly defined. No information is available relative to the internal or foundation design of this structure.

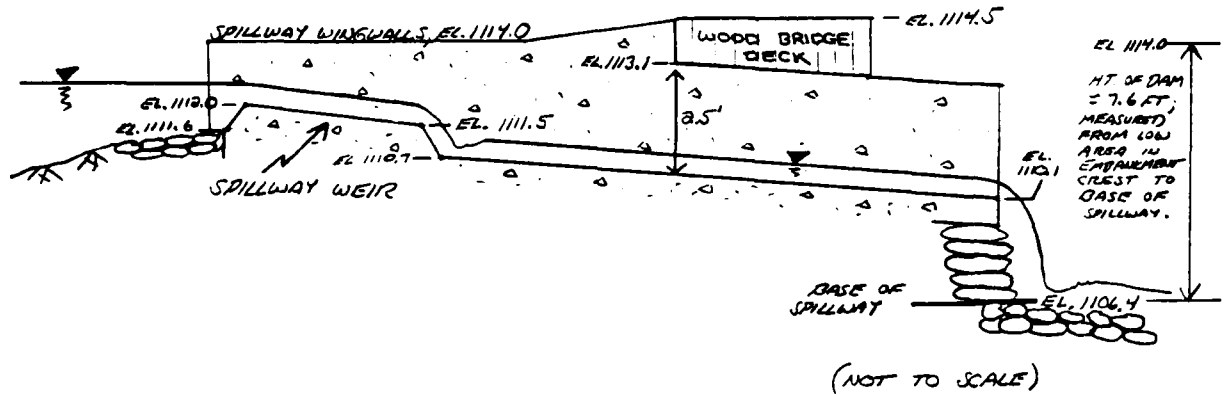
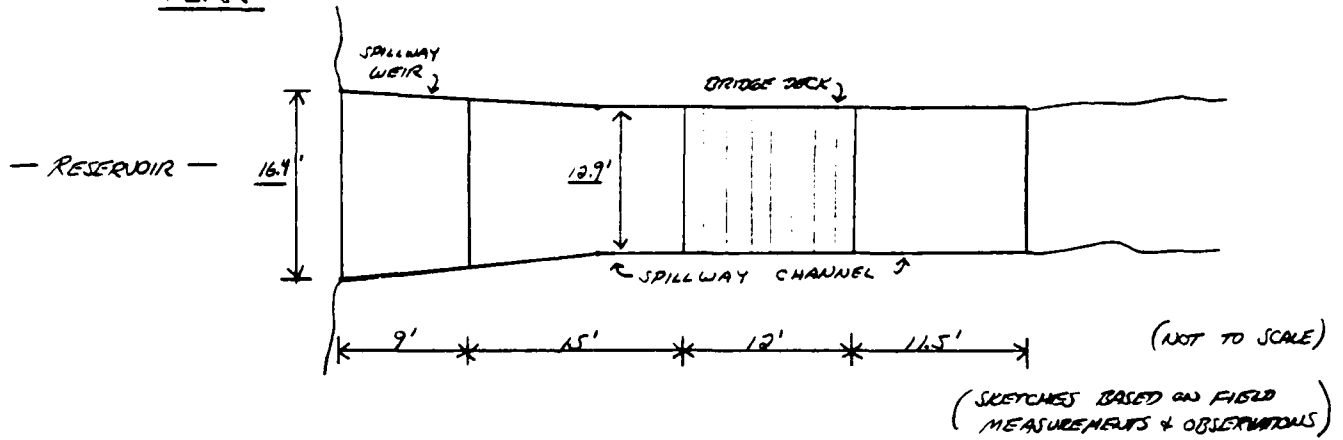
SPILLWAY CAPACITY

THE SPILLWAY CONSISTS OF AN UNCONTROLLED, RECTANGULAR-SHAPED CONCRETE AND MASONRY CHUTE CHANNEL, WITH DISCHARGES REGULATED BY A CONCRETE BROAD-CRESTED WEIR.

d. Repair the deteriorated concrete associated with the spillway channel and its sidewalls.
