**PURDY (STUMP POND) DAM**

NDI No. PA 00063

**PHASE I INSPECTION REPORT**  
**NATIONAL DAM INSPECTION PROGRAM**

February 1981

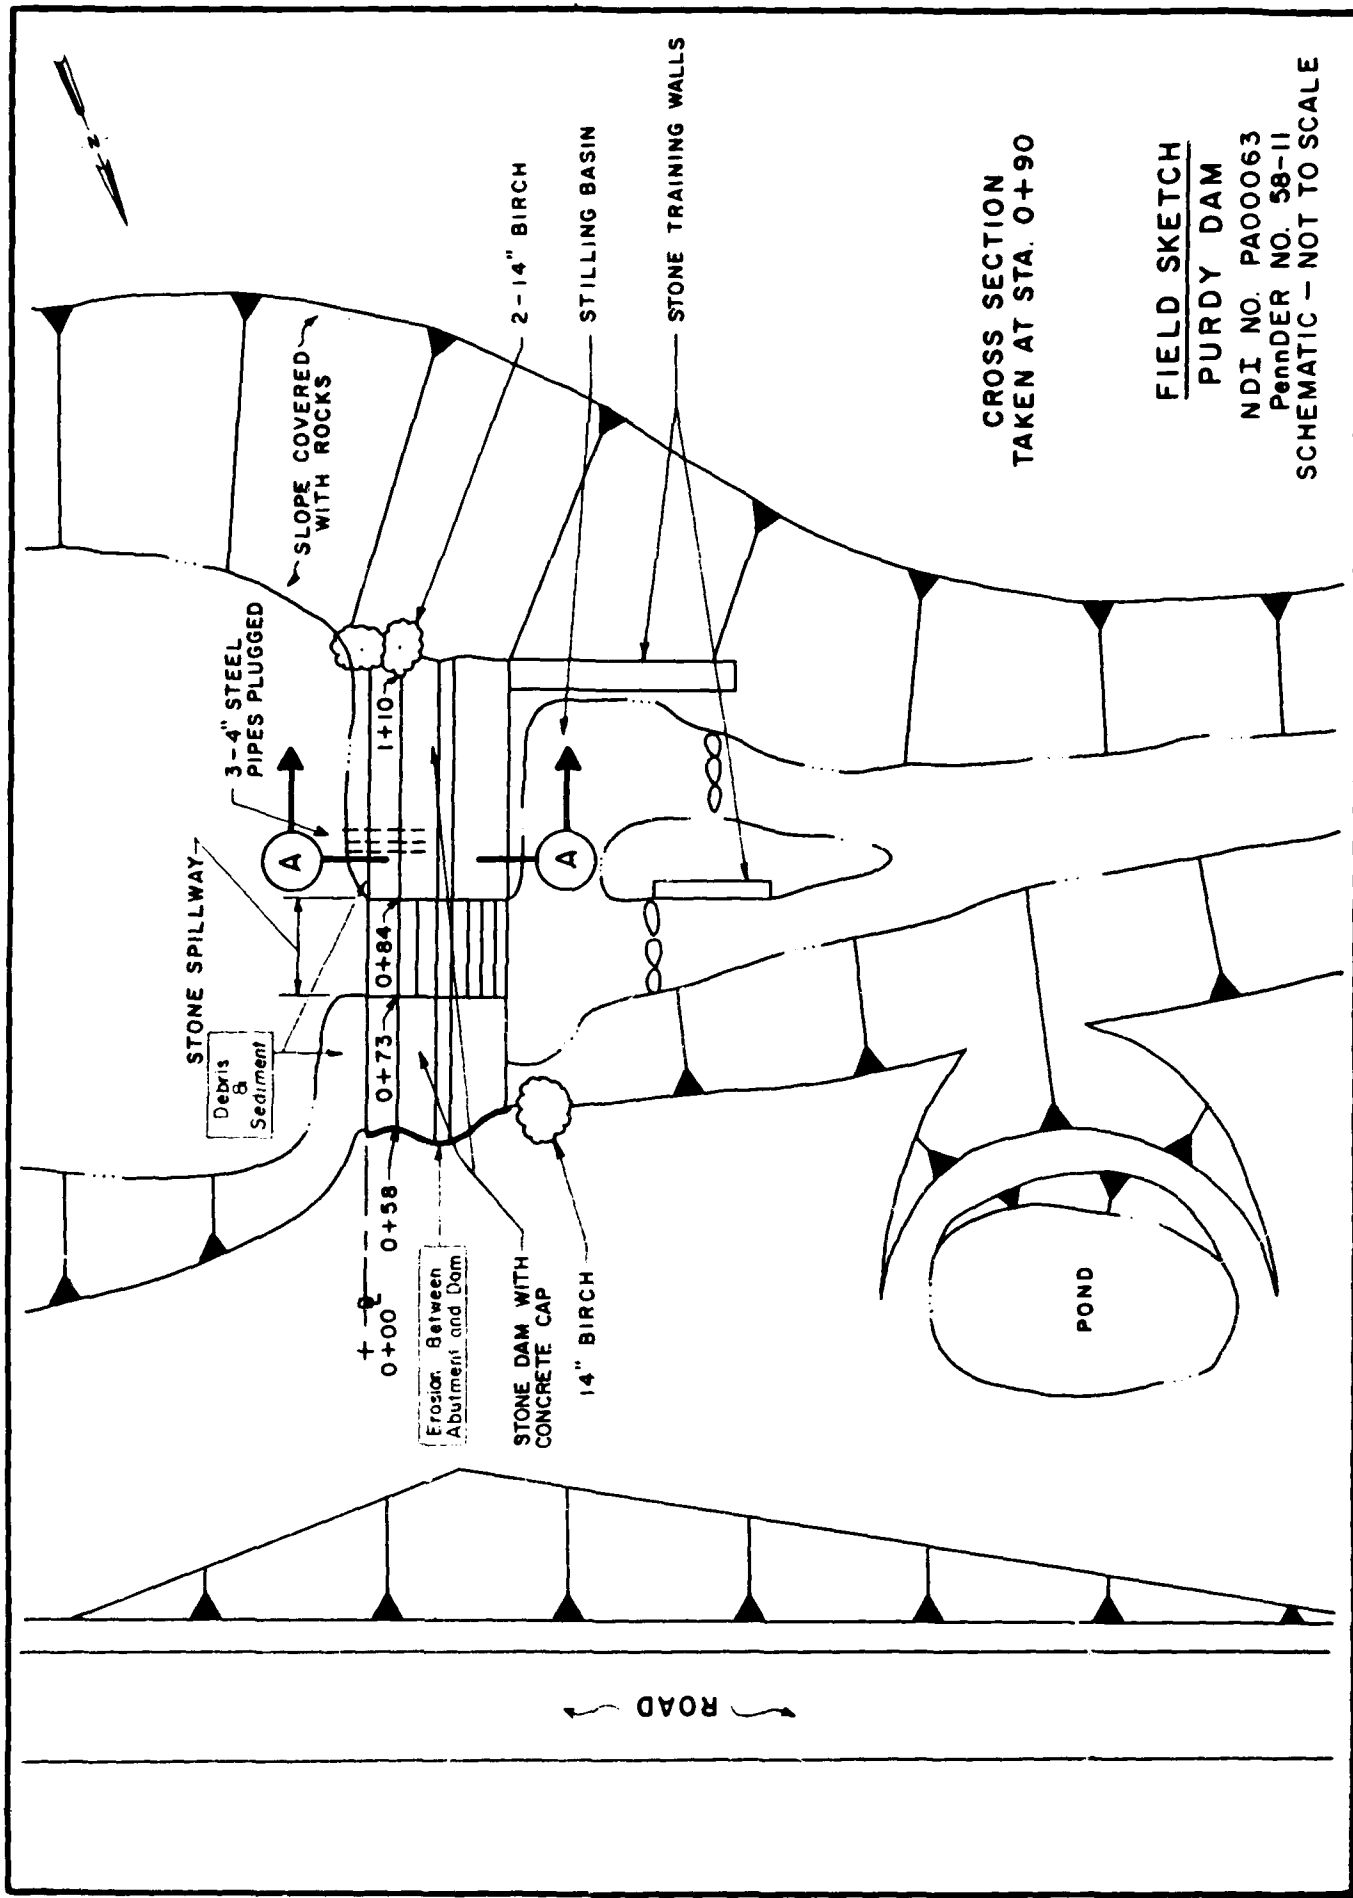
FIELD SKETCH  
 PURDY DAM  
 NDI NO. PA00063  
 PENNER NO. 58-II  
 SCHEMATIC - NOT TO SCALE

- b. Dam - An erosion gully was observed at the right downstream abutment of the dam. No other significant problems were observed.
- c. Appurtenant Structures - Some debris and sediment has accumulated in the spillway approach channel.
