NATIONAL DAM SAFETY PROGRAM. SILVER LAKE DAM (NJ00469), WALLKIL--ETC(U)

4. TITLE (and Subtitle) Phase I Inspection Report National Dam Safety Program Silver Lake Dam, NJ00469 Sussex County, N.J.	5. TYPE OF REPORT & PERIOD COVERED FINAL

SILVER LAKE DAM (NJ00469)

Name of Dam: Silver Lake Dam, I.D. NJ00469
State Located: New Jersey
County Located: Sussex
Drainage Basin: Wallkill River
Stream: Tributary to Franklin Pond Creek
Date of Inspection: December 19, 1980

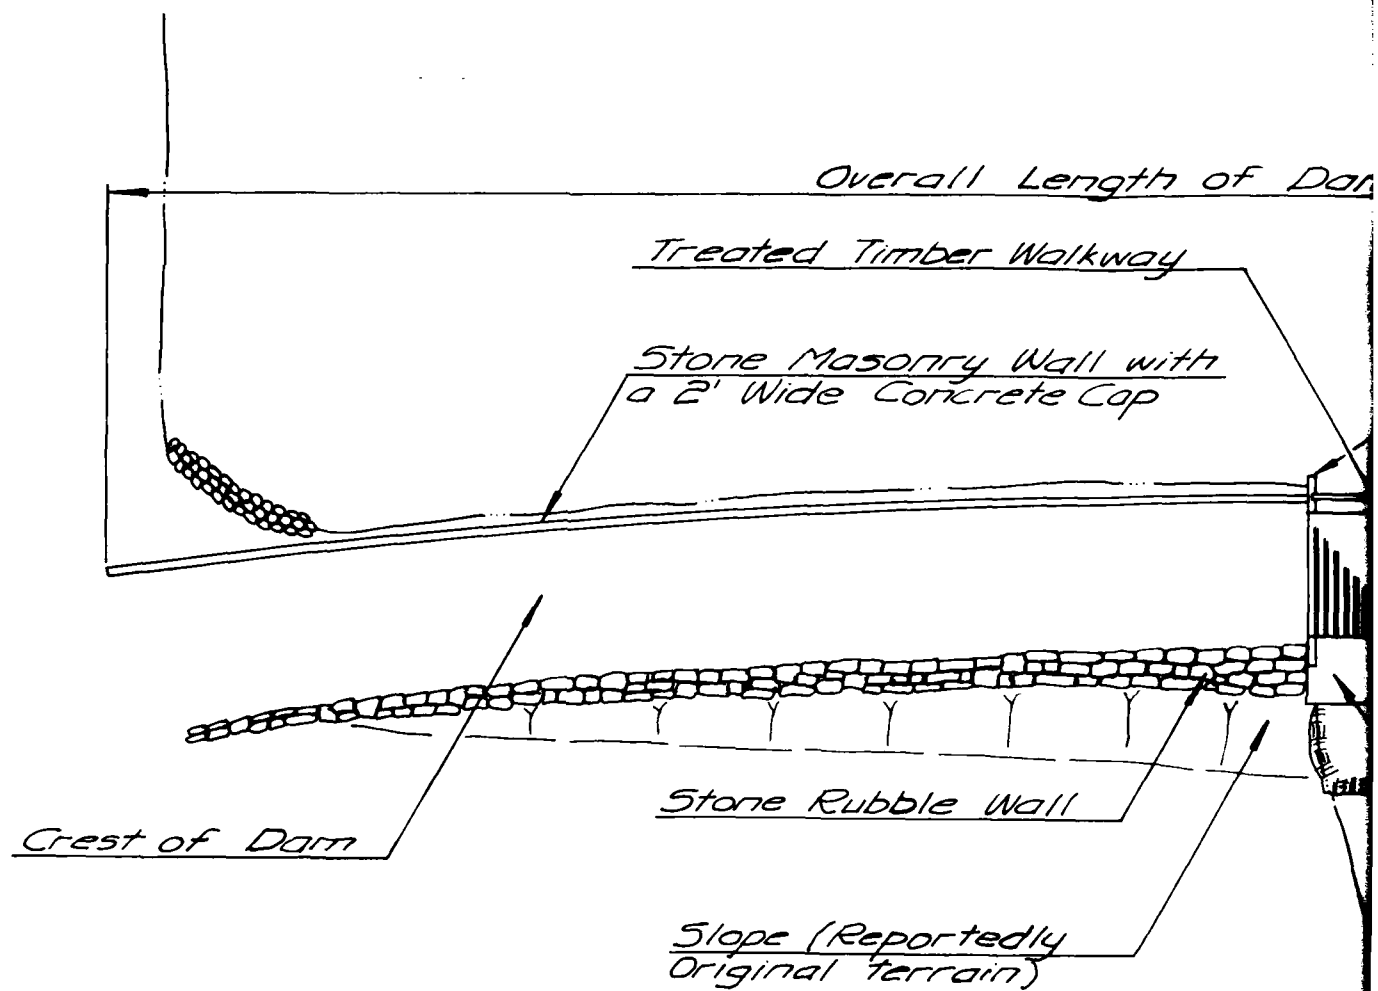
Note: Information taken from field inspection December 19, 1980.

Length of Dam = 171'
