**ICE POND DAM**

NDI ID NO. PA-00566  
DER ID NO. 40-79

**PHASE I INSPECTION REPORT  
NATIONAL DAM INSPECTION PROGRAM**

APRIL 1981

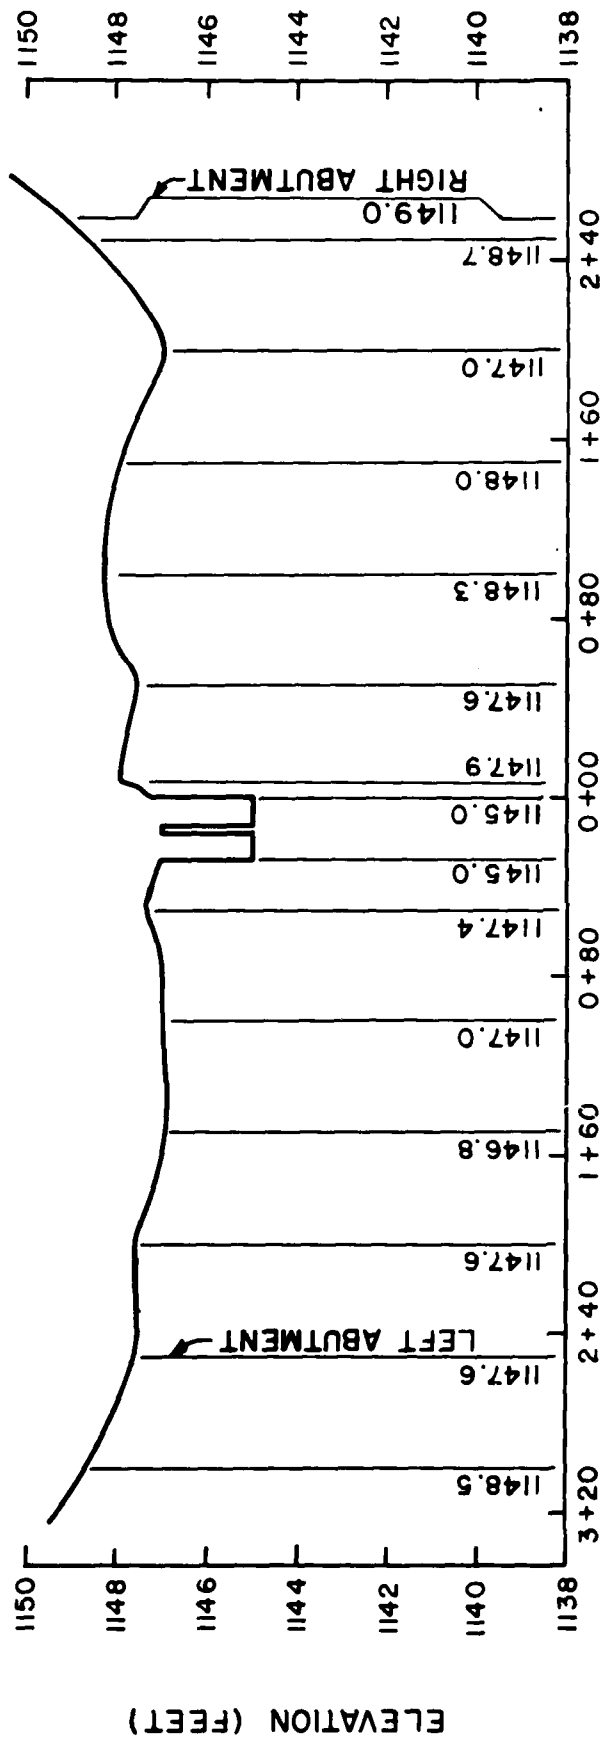
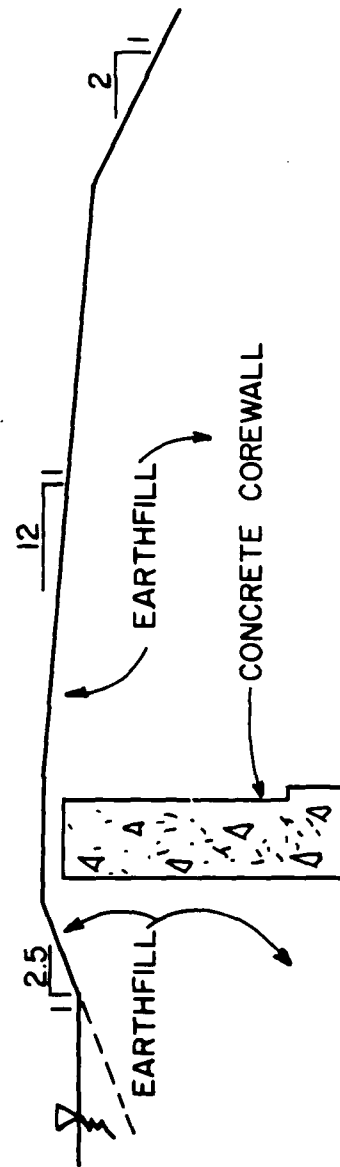
EXHIBIT A-1

**TOP OF DAM - PROFILE**  
 HORIZ: 1 IN. = 80 FT.  
 SCALE - VERT: 1 IN. = 4 FT.

NOTE: SEE APPENDIX E FOR  
 SECTION OF SPILLWAY

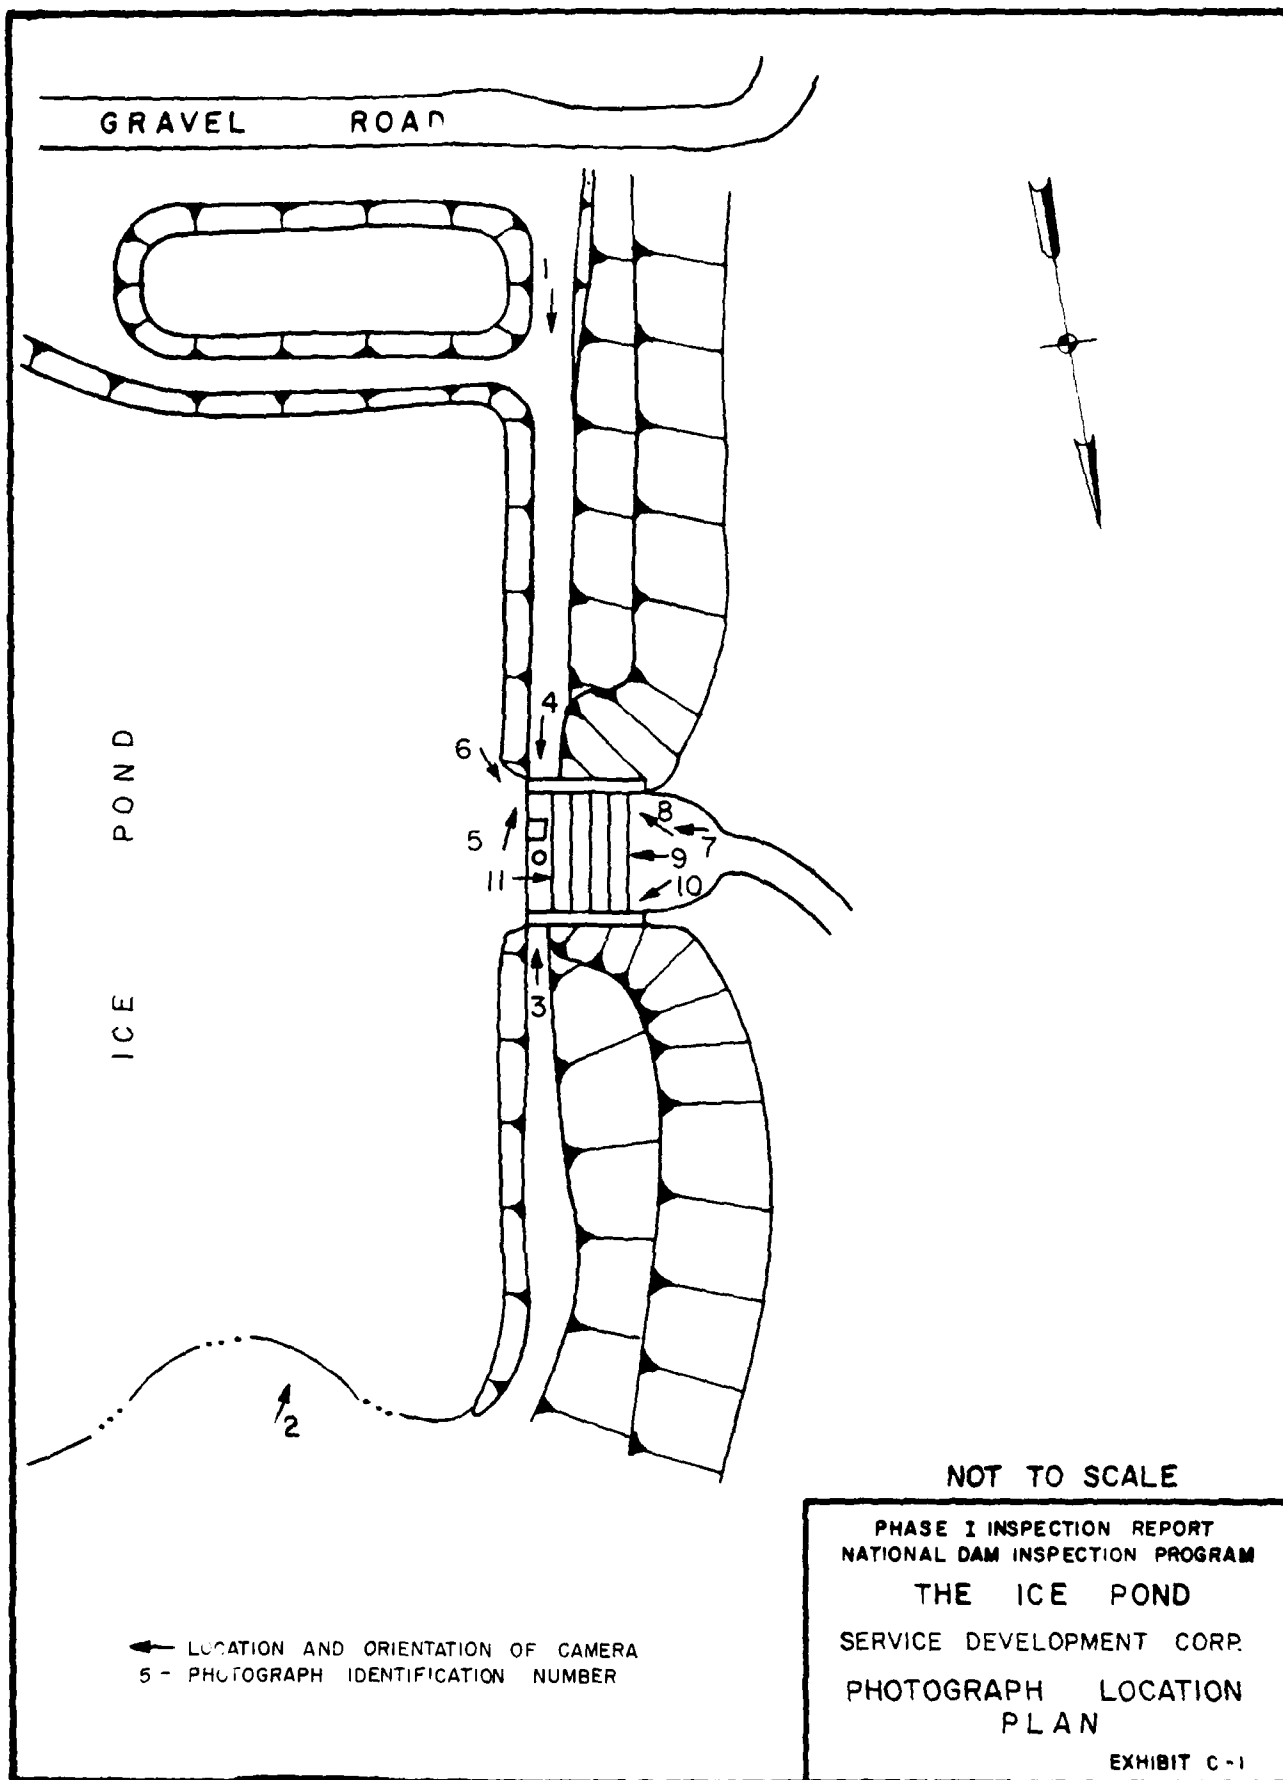
Ice Pond Dam - ND1 No. 00566

c. Appurtenant Structures. The outlet works and spillway are located in the center of the dam. The spillway crest is cracked and spalled and is undermined on the upstream side to a depth of about one foot. The downstream face of the weir and the spillway walls are severely deteriorated and spalled. Although the right wall is not as deteriorated as the left, clear water is flowing at about 8 gallons per minute from a hole near the base of the wall about eight feet below spillway crest. Siltation and debris have buried the bottom step and concrete apron of the spillway. A severely deteriorated wooden bridge which crosses the spillway crest has a 2.5 feet wide pier which is in

poor condition. It was apparent during the review inspection that the condition of the spillway had worsened considerably since the initial inspection.

f. Evaluation. Based on the above visual observations, it is apparent that no maintenance of the dam has been performed for some time. The trees and brush should be removed from the embankment. The spillway crest, discharge channel and walls should be repaired. The spillway bridge and pier should also be rehabilitated or removed since the structure could block the spillway if it collapses. The embankment and spillway appear stable since no signs of movement were noted and the core wall and downstream slope are adequate.

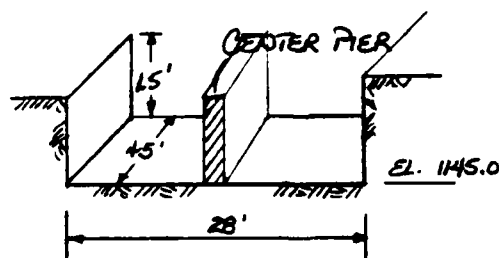
CENTER PIER IS 2.5 FEET IN WIDTH, LEAVING A FLOW AREA OF 24.5 FEET BY 1.5 FEET. BRIDGE SECTION OVER SPILLWAY NOT SHOWN.

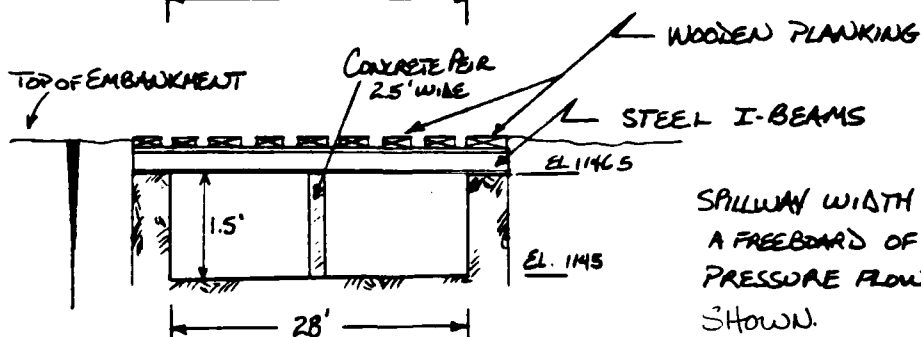
SPILLWAY WIDTH IS 25.5 FEET, WITH A FREEBOARD OF 1.5 PRIOR TO PRESSURE FLOW. BRIDGE SECTION SHOWN.
