INDIAN LAKE DAM

NDI ID NO. PA-01041

**PHASE I INSPECTION REPORT
NATIONAL DAM INSPECTION PROGRAM**

**DEPARTMENT OF THE ARMY
Baltimore District, Corps of Engineers
Baltimore, Maryland 21203**

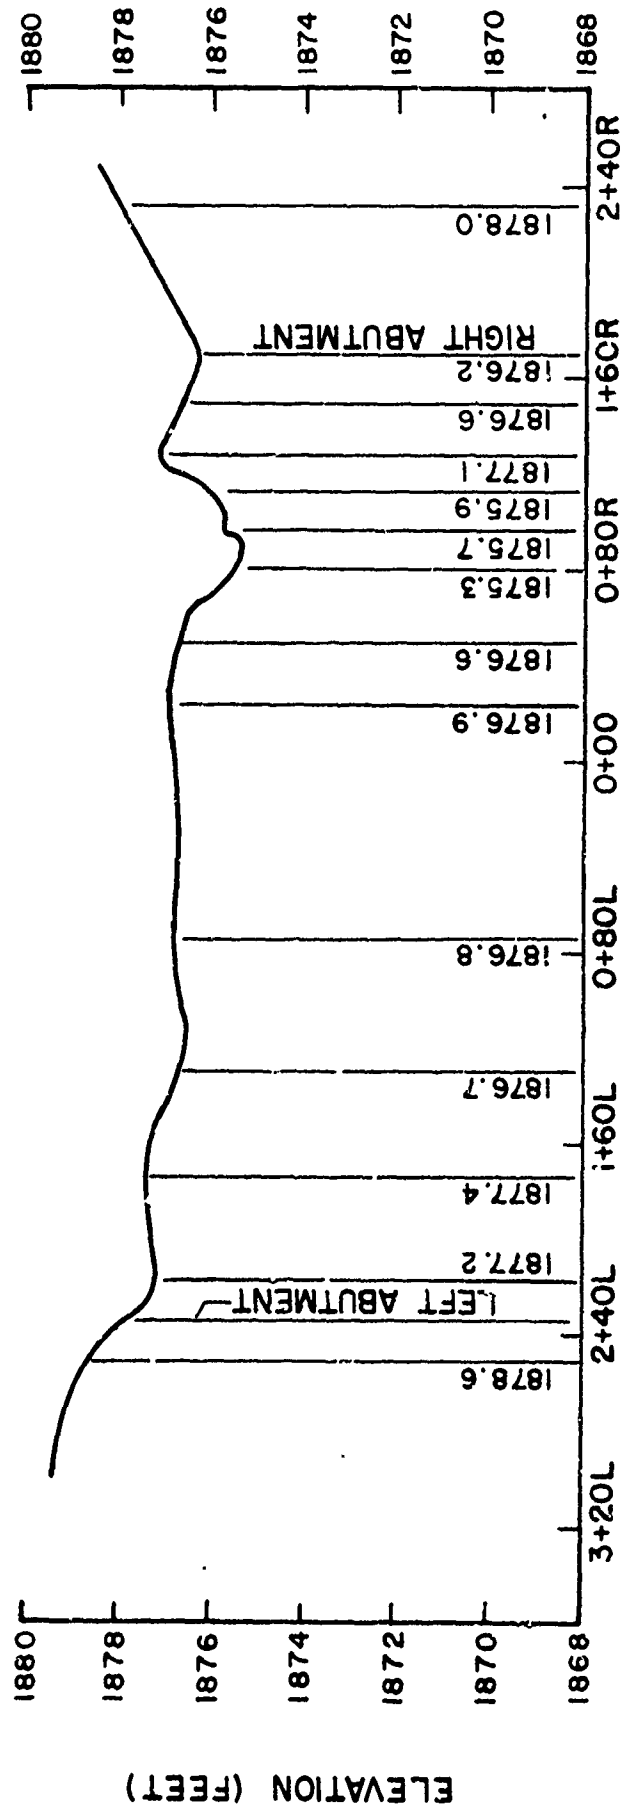
TOP OF DAM - PROFILE
 SCALE - HORIZ.: 1 IN. = 80 FT.
 SCALE - VERT.: 1 IN. = 4 FT.

On the date of the inspection, a condition was present that may prevent the facility from operating effectively during a flood event. The spillway level has been raised and the top of dam is lower than design. This significantly reduces the freeboard. See field sketch in
