BEAVER POND DAM

**NDI No. PA 00133
PennDER No. 64-19
Dam Owner: Marguerite Card**

**PHASE I INSPECTION REPORT
NATIONAL DAM INSPECTION PROGRAM**

Beaver Pond Dam, Wayne County, Pennsylvania
NDI No. PA 00133, PennDER No. 64-19
Unnamed Tributary of Shadigee Creek
Inspected 28 October 1980

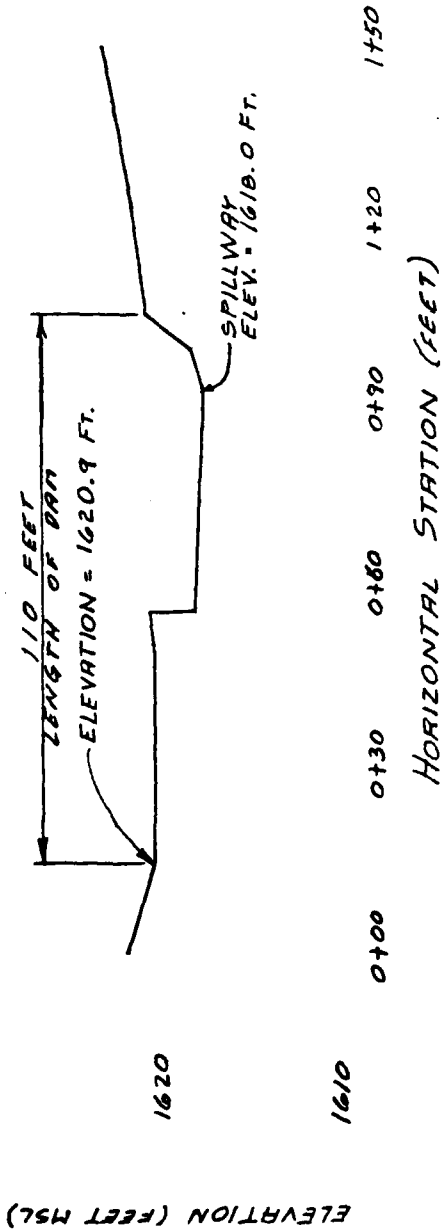
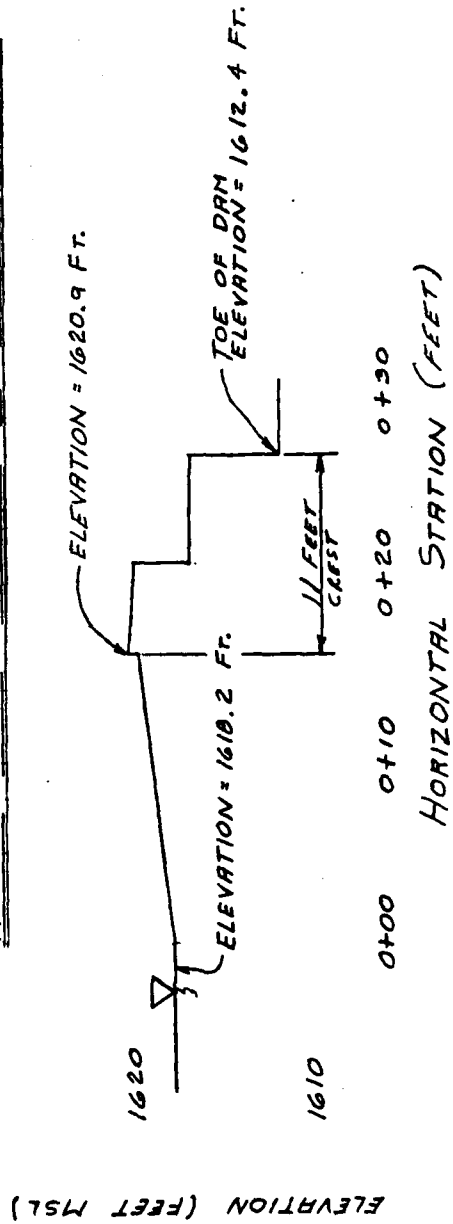
TOP OF DAM PROFILE (LOOKING DOWNSTREAM)
LENGTH OF DAM = 110 FEET

TYPICAL CROSS SECTION AT STATION 0+50

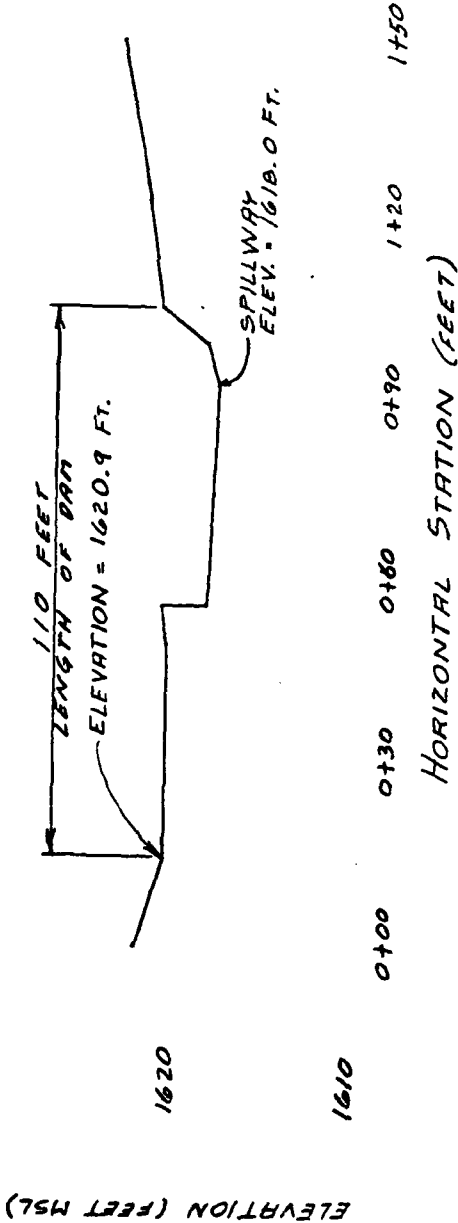
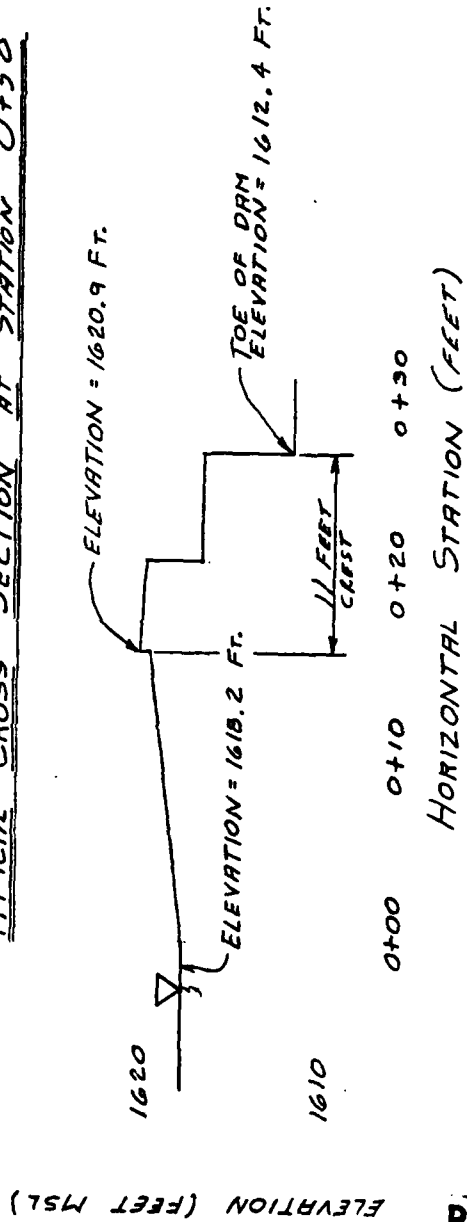
Plate 4 - Top of Dam Profile and Typical Cross-Section from
Visual Inspection

TOP OF DAM PROFILE (LOOKING DOWNSTREAM)
 LENGTH OF DAM = 110 FEET

TYPICAL CROSS SECTION AT STATION 0+50
