BRESKIN POND DAM No. 1

NDI No. PA 01141

**PHASE I INSPECTION REPORT
NATIONAL DAM INSPECTION PROGRAM**

Breskin Pond Dam No. 1, Westmoreland County, Pennsylvania
NDI No. PA 01141, PennDER No. 65-141
Unnamed Tributary to Fourmile Run
Inspected 5 December 1980

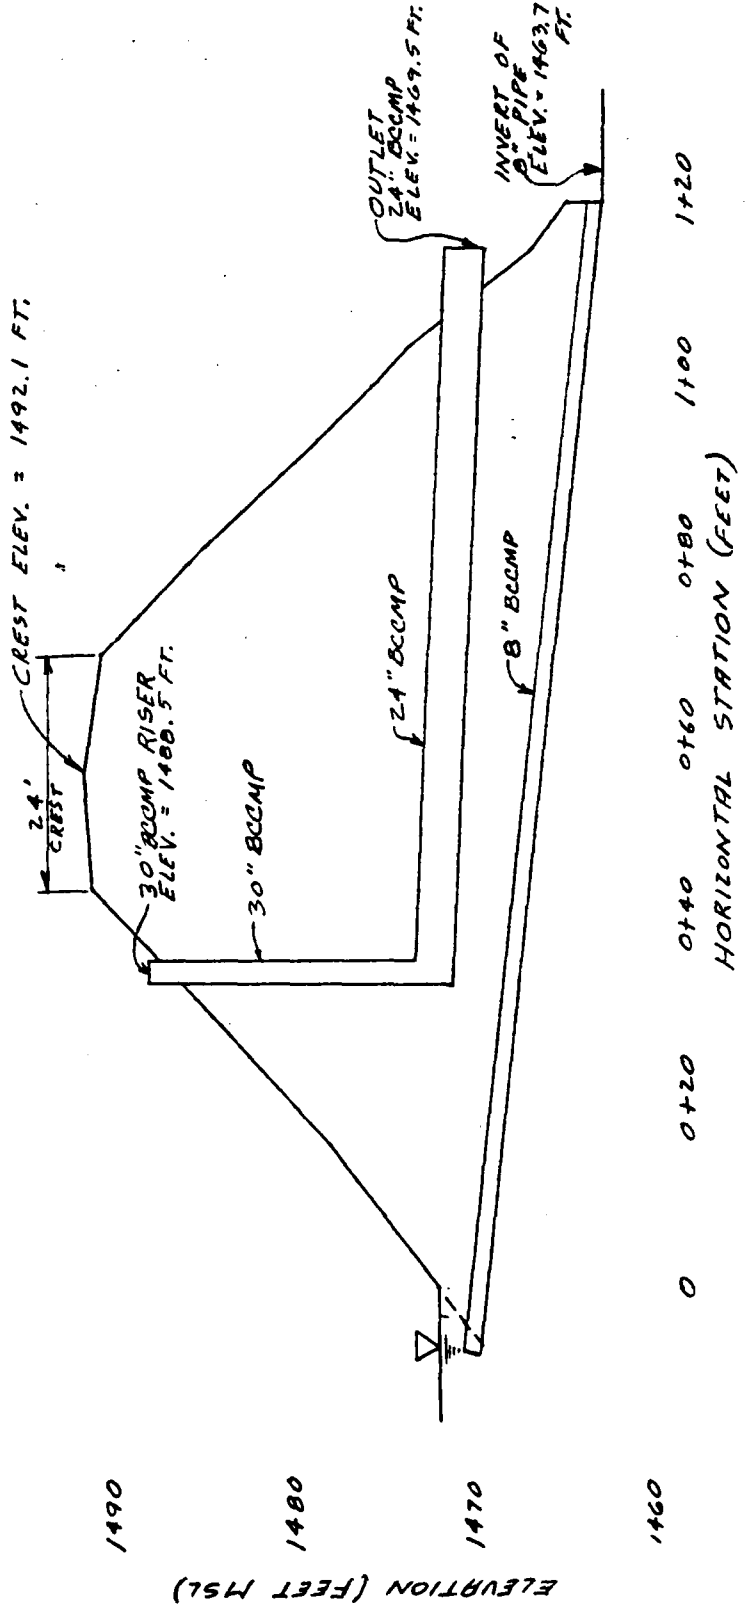
TYPICAL CROSS SECTION AT STA. 3+25

A rodent hole was observed at
approximate station 3+25, approx-
imately 7 ft. below the crest.

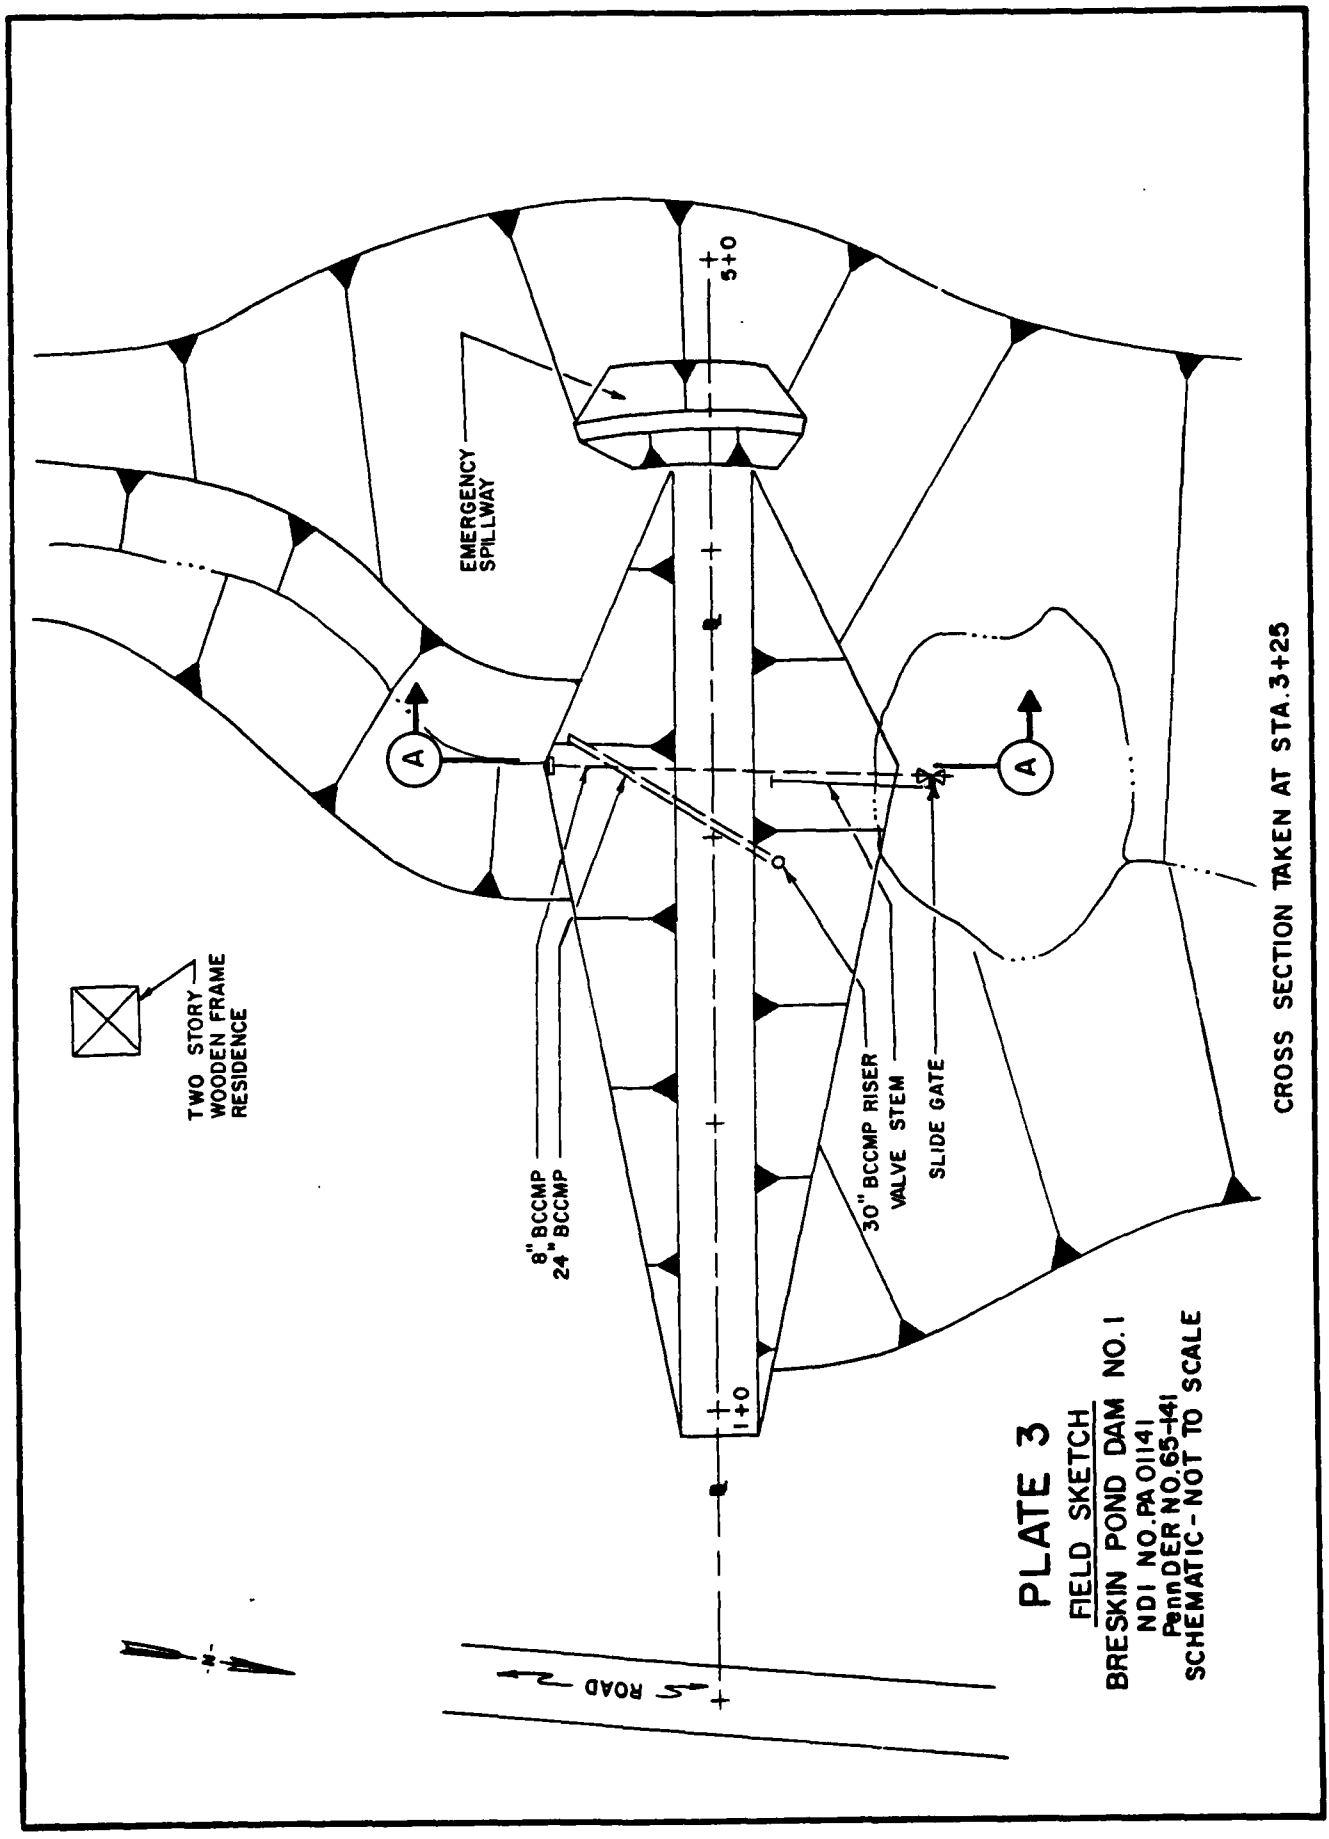
PLATE 3
 FIELD SKETCH
 BRESKIN POND DAM NO. 1
 NDI NO. PA 01141
 Penn DER NO. 65-141
 SCHEMATIC - NOT TO SCALE

None observed. The owner reports that the reservoir will not hold water. He reported that a rise of 3 to 4 in. occurs in his springhouse downstream when the lake is full. No outlet for seepage from the reservoir was observed in the immediate area of the dam during the inspection.
