MINE No. 60 - POND 5

PHASE I INSPECTION REPORT
NATIONAL DAM INSPECTION PROGRAM

MINE NO. 60-POND 5
WASHINGTON COUNTY, COMMONWEALTH OF PENNSYLVANIA
NDI NO. PA 01144
PennDER NO. 63-88

PHASE I INSPECTION REPORT
NATIONAL DAM INSPECTION PROGRAM
MINE NO. 60-POND 5
NATIONAL I. D. NO. PA 01144
PennDER No. 63-88

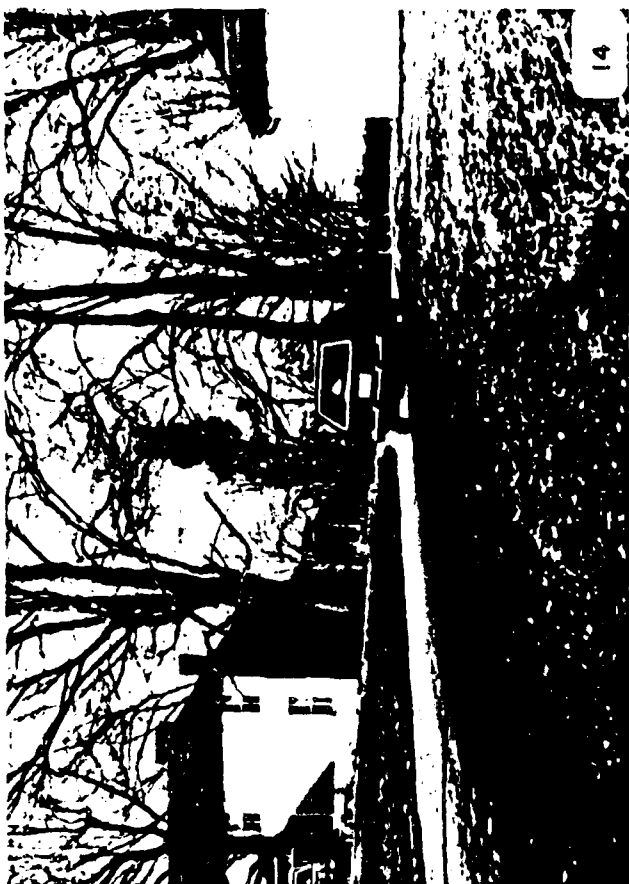
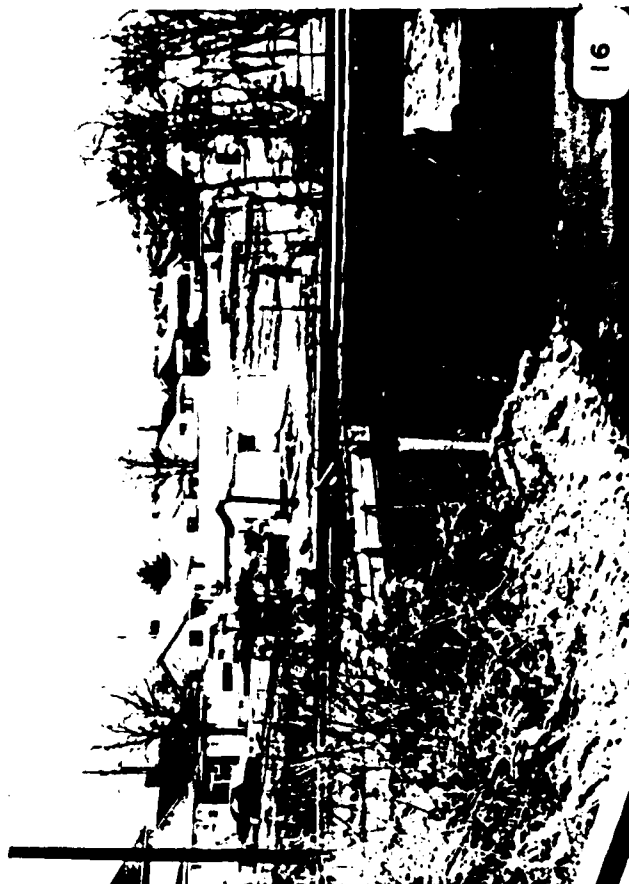
- Photo 1 Pond Overview taken from embankment crest.
- Photo 2 Embankment Crest showing slurry inflow pipe.
- Photo 3 Upstream Slope.
- Photo 4 Downstream Slope.
- Photo 5 Downstream Slope and Toe Area. Upper seepage zone is located in the groin area, to the right of the tree in the left center portion of the photo.
- Photo 6 Close Up of Seepage Zone in the Left Groin. Note fine coal refuse ("blackwater") staining.
- Photo 7 Toe of Embankment and Straw Bales.
- Photo 8 Swampy Area Downstream of Toe.
- Photo 9 Upstream End of Pond.
- Photo 10 Outlet Works Pump.
- Photo 11 Principal (and Emergency) Spillway Entrance and silt fence.
- Photo 12 Spillway Discharge Channel.
- Photo 13 Slurry Pipeline Discharge Point.
- Photo 14 Downstream Hazard.
- Photo 15 Downstream Hazard.
- Photo 16 Downstream Hazards.
