NDI NO. PA-00948
DER NO. 50-061

PHASE I INSPECTION REPORT.

National Dam Inspection Program.
Negley Dam (NDI Number PA-00948,
DER Number 50-061), Susquehanna River
Basin, Perry County, Pennsylvania.
Phase I Inspection Report,

Name of Dam: NEGLEY DAM
State & State No.: PENNSYLVANIA, 50-61
County: PERRY
Stream: TRIBUTARY TO LITTLE JUNIATA CREEK
Date of Inspection: NOVEMBER 4, 1980

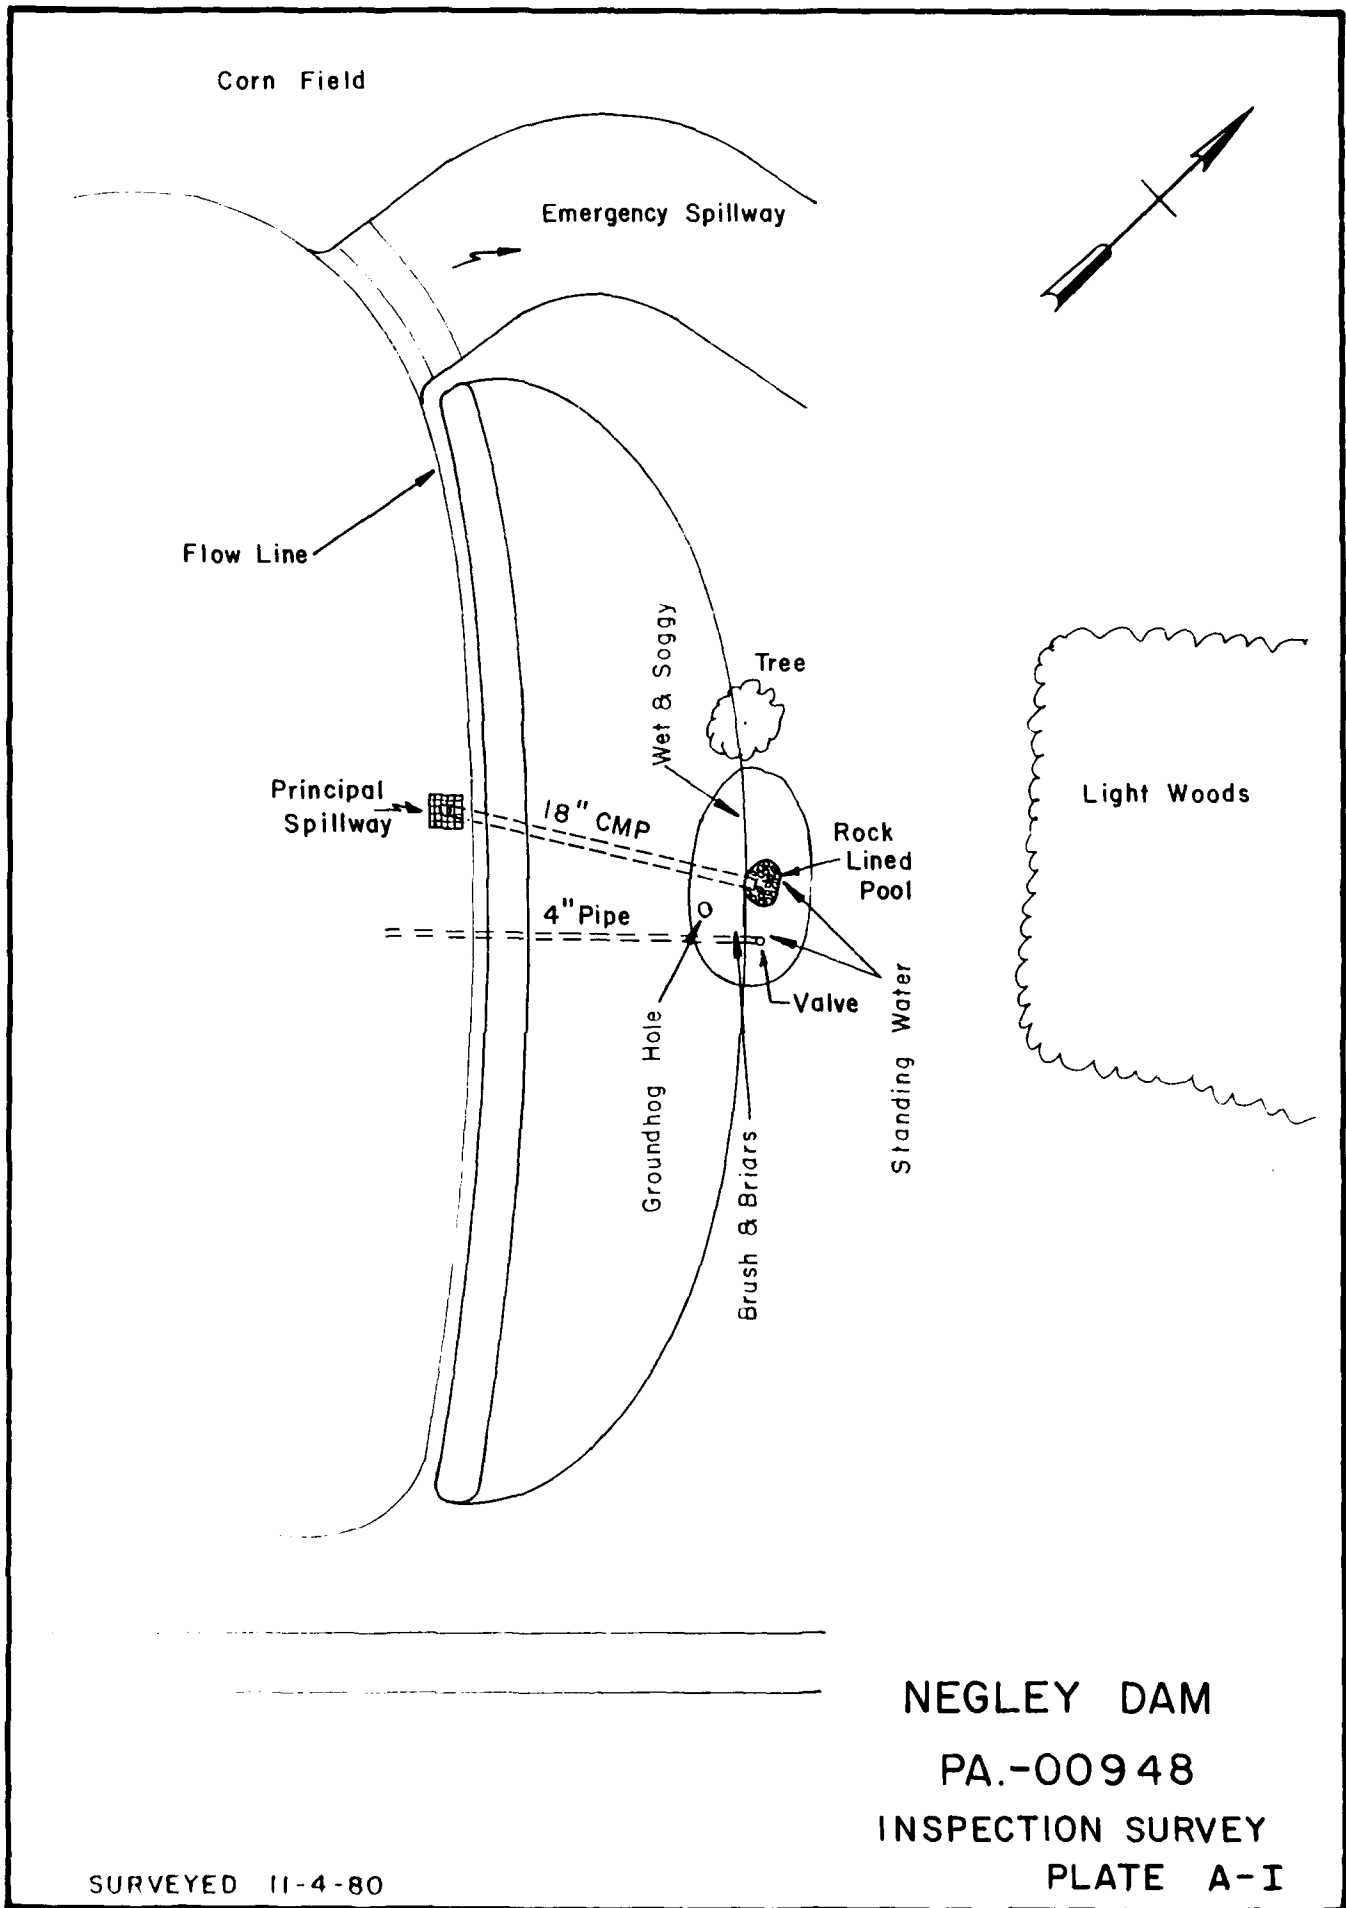
PLATE A-I

OBSERVATIONS AND REMARKS
<u>INSTRUMENTATION</u>	
Monumentation	None.
Observation Wells	None.
Weirs	None.
Piezometers	None.
Staff Gauge	None.
Other	None.
<u>RESERVOIR</u>	
Slopes	Cultivated fields.
Sedimentation	None reported.
Watershed Description	Cultivated fields and woodlands.
<u>DOWNSTREAM CHANNEL</u>	
Condition	Small creek through lightly wooded area.
Slopes	Moderate 5-10° in the floodplain.
Approximate Population	3
No. Homes	One house and warehouse.

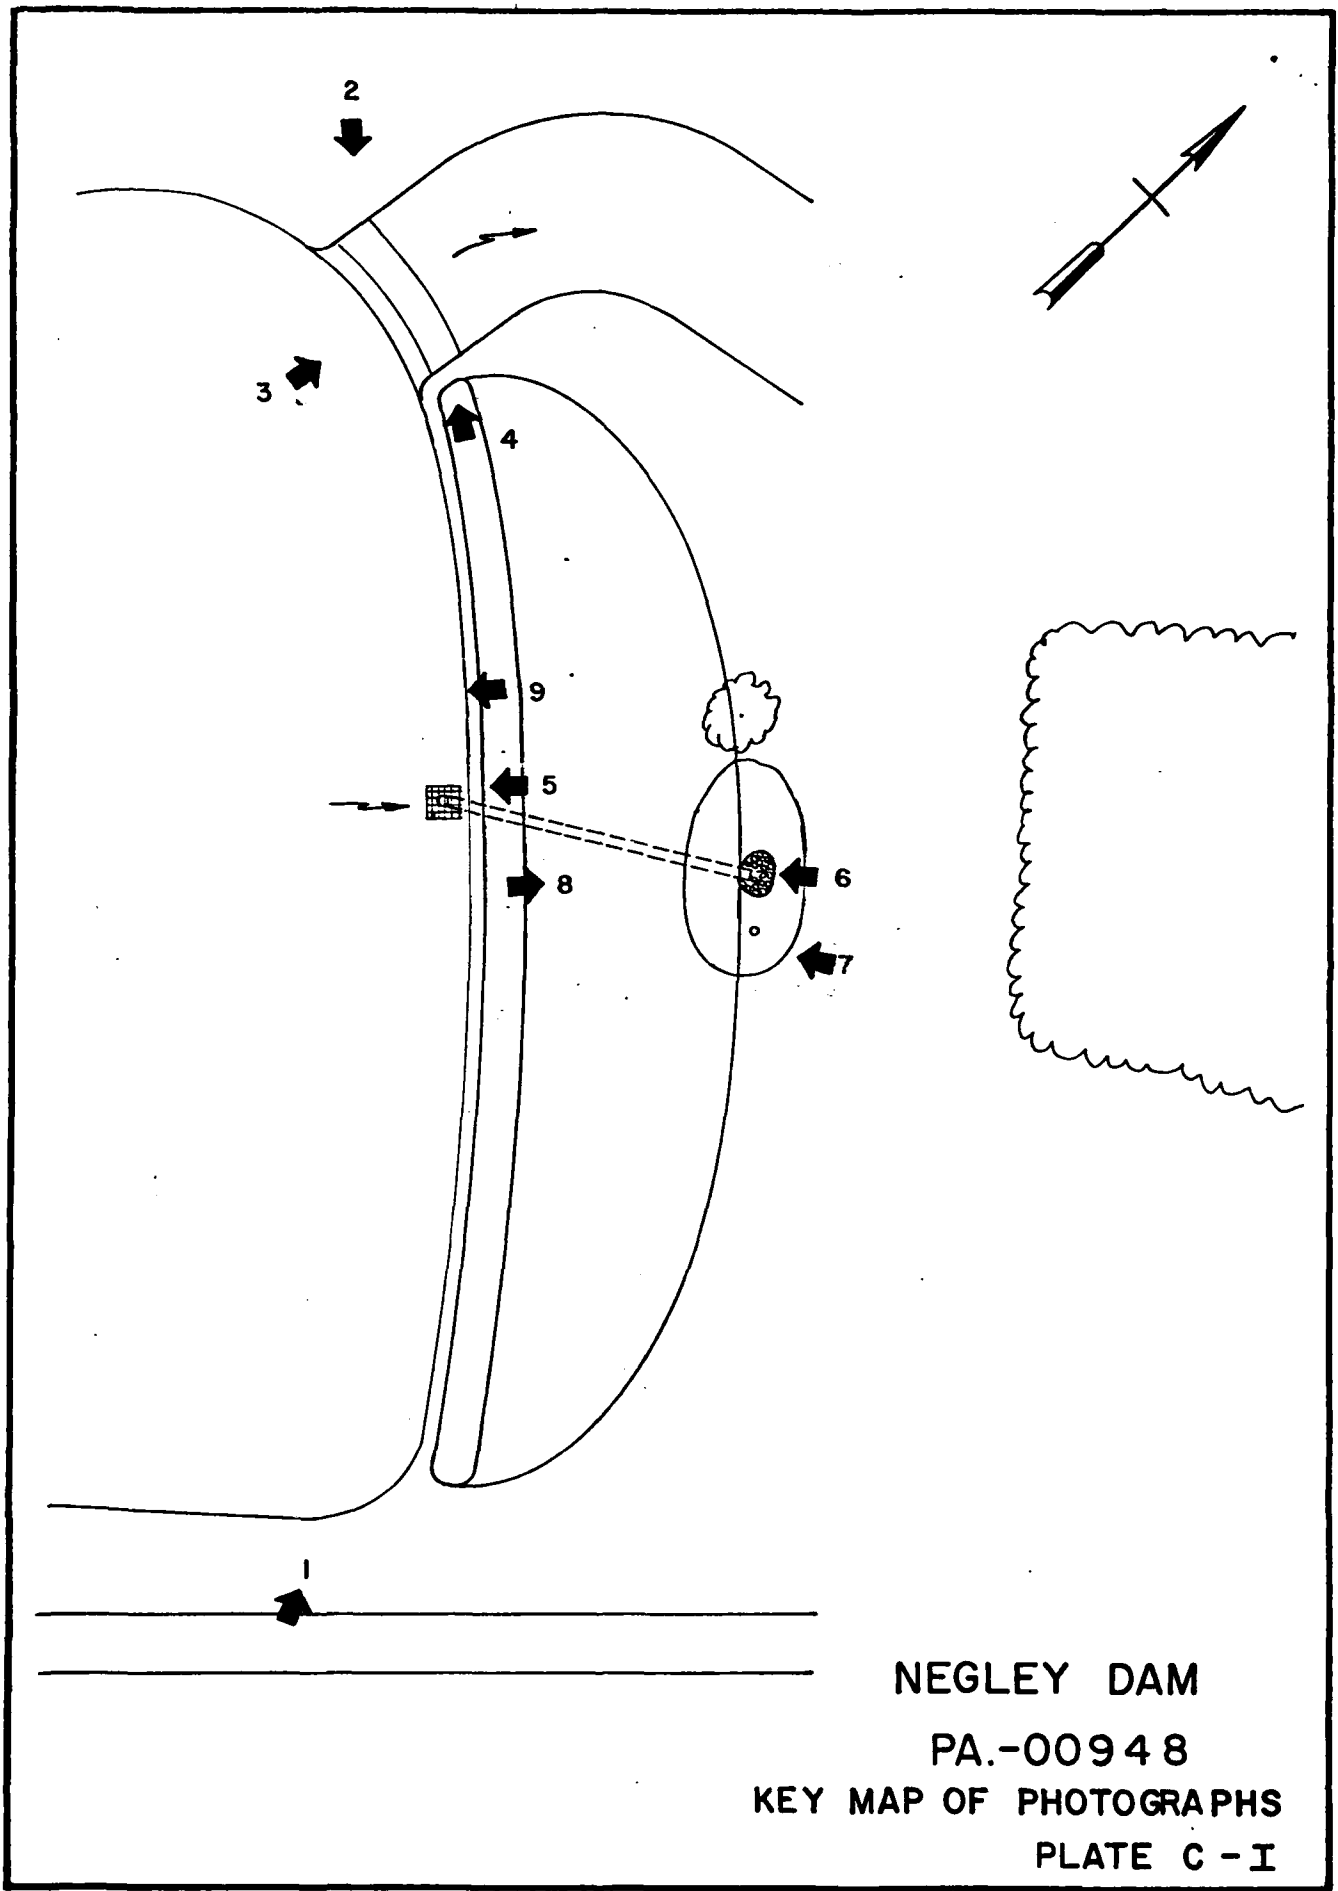
A house and a warehouse/manufacturing plant are located immediately below the dam (Photograph No. 2). There is a potential hazard for loss of a few lives downstream if the dam failed. The hazard category for Negley Dam is considered to be "Significant."
