FAWN LAKE DAM

(NDI I.D. NO. PA-00822
PENNDER I.D. NO. 52-182)

PHASE I INSPECTION REPORT
NATIONAL DAM INSPECTION PROGRAM

JUNE 1981

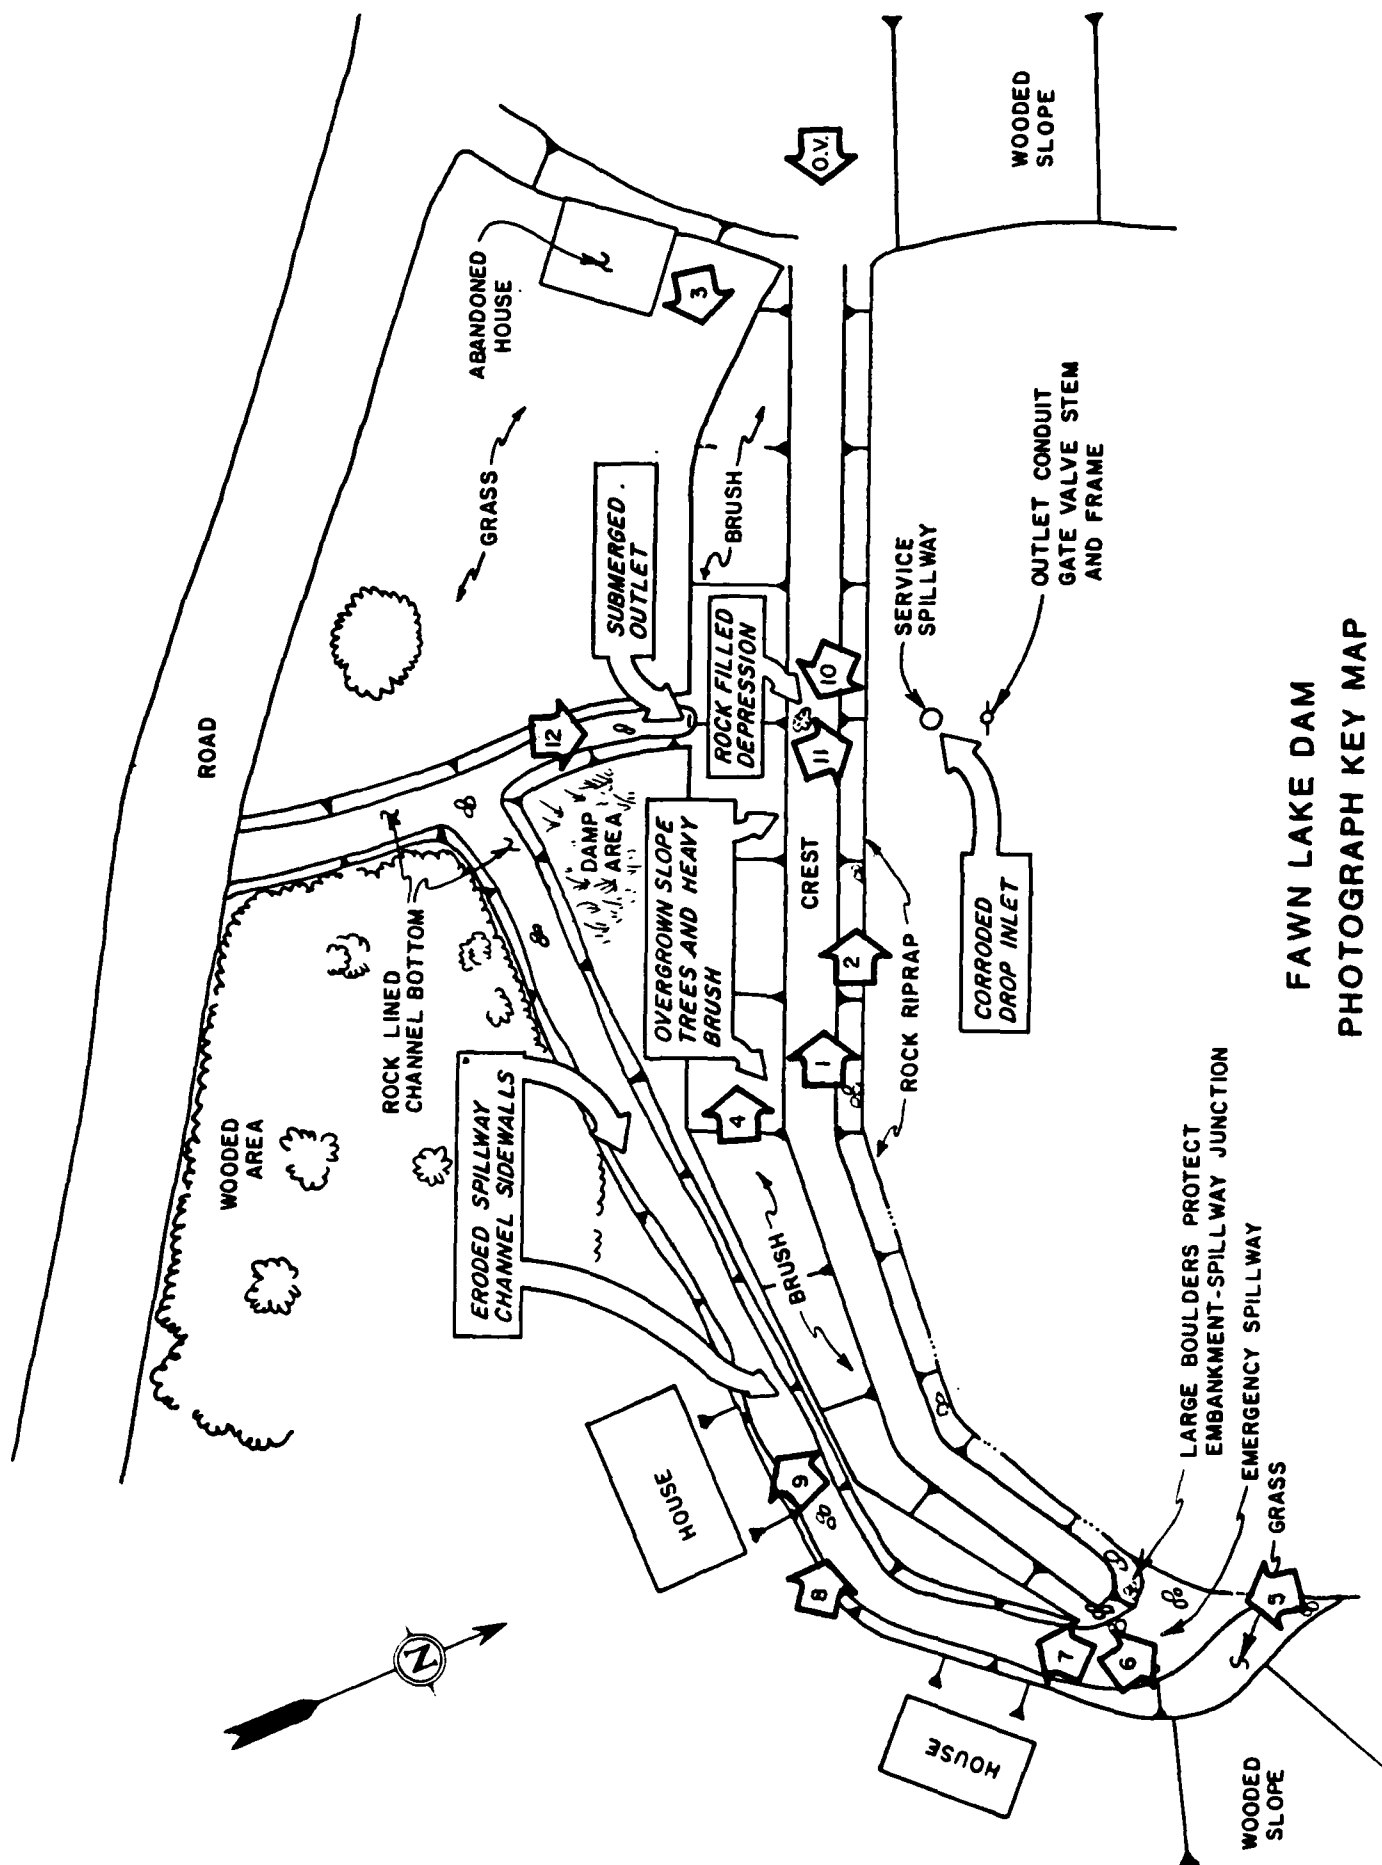
PHOTOGRAPH 1 View of the embankment crest looking toward the right abutment.

PHOTOGRAPH 2 View of the upstream embankment face looking toward the right abutment and the service spillway drop inlet.

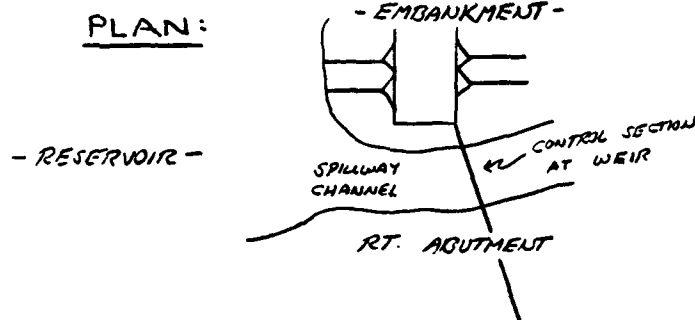
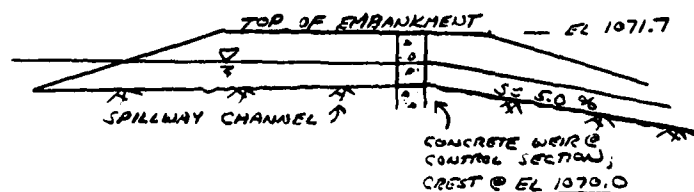
THE SPILLWAY CONSISTS OF AN UNCONTROLLED, ROUGHLY TRAPEZOIDAL CHANNEL CUT IN SOIL AND ROCK AT THE RIGHT ABUTMENT. THE CONTROL SECTION IS LOCATED AT THE CONCRETE WEIR SHOWN BELOW:

THE WEIR IS TRAPEZOIDAL IN CROSS-SECTION, WITH AVERAGE SIDE-SLOPES $\approx 1.5H:1V$, BOTTOM WIDTH ≈ 30 FT, AND FREETBOARD OF APPROXIMATELY 1.7 FT TO TOP OF DAM. SINCE THE MAXIMUM SPILLWAY DISCHARGE CAPACITY (AT TOP OF DAM) IS SMALL IN COMPARISON TO THE EXPECTED PMF-MAGNITUDE OUTFLOWS, THE WEIR SECTION WILL BE APPROXIMATED AS RECTANGULAR, 35 FT LONG.

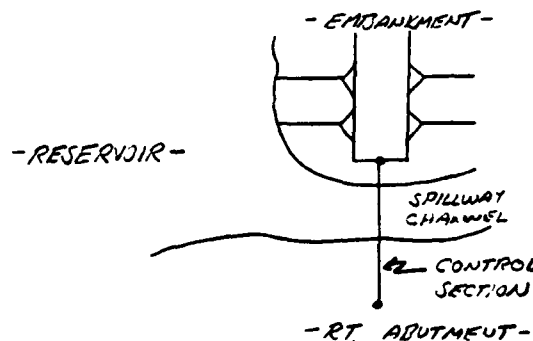
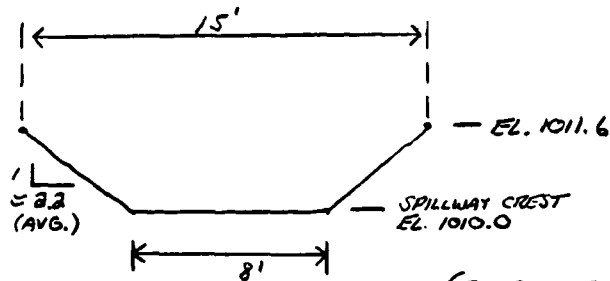
THE SPILLWAY CONSISTS OF AN UNCONTROLLED, ROUGHLY TRAPEZOIDAL CHANNEL CUT IN SOIL AND ROCK AT THE RIGHT ABUTMENT. THE CONTROL SECTION IS LOCATED NEAR THE RESERVOIR OUTLET, AS SHOWN BELOW.
