BEAVER LAKE LODGE DAM

NDI I.D. NO. PA-00300  
PENNDER I.D. NO. 52-93

PHASE I INSPECTION REPORT  
NATIONAL DAM INSPECTION PROGRAM

JUNE 1981

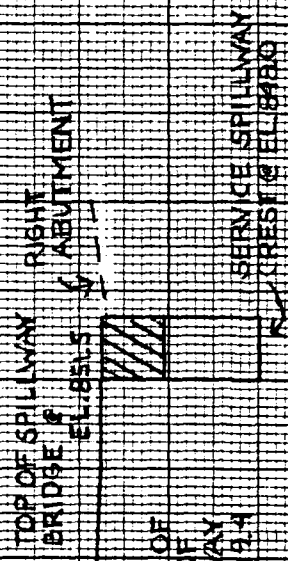
PROFILE OF DAM CREST  
FROM FIELD SURVEY

LEFT ABUTMENT  
EMERGENCY SPILLWAY CREST @ EL 8487  
MINIMUM ELEVATION OF TOP OF DAM  
EMERGENCY SPILLWAY SIDEWALK  
SERVICE SPILLWAY CREST @ EL 8480  
TOP OF SPILLWAY BRIDGE @ EL 8515  
RIGHT ABUTMENT

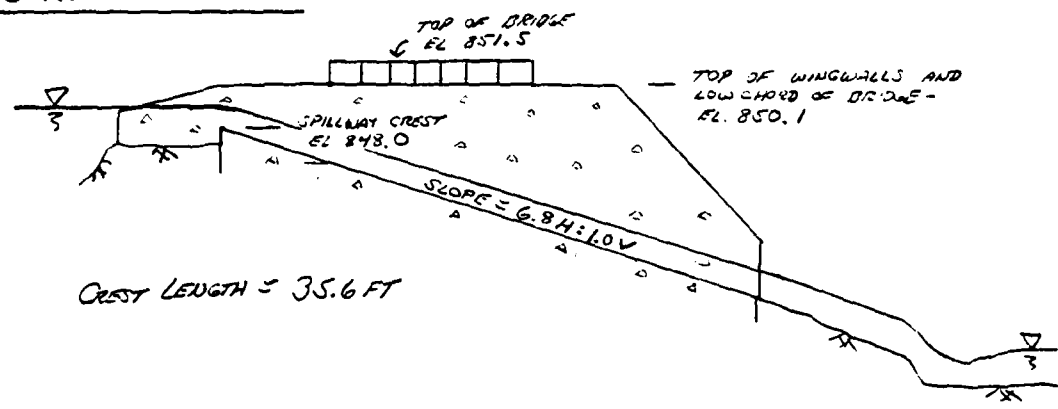
### 1.) SERVICE SPILLWAY

IN COMPARING THE 100-YR FLOOD PEAK (3340 CFS) WITH THE TOTAL SPILLWAY CAPACITY AT THE TOP OF THE DAM (240 CFS) IT IS SEEN THE DAM WILL BE OVERTOPPED BY THE 100-YEAR FLOOD. IF THE EMBANKMENT CREST WERE REGRADED TO THE ELEVATION OF THE TOP OF THE SPILLWAY BRIDGE (EL 851.5), THE MAXIMUM SPILLWAY CAPACITY WOULD BE ABOUT 1230 CFS, AND THE DAM WOULD STILL BE SUBJECT TO OVERTOPPING UNDER THE 100-YEAR EVENT. IT WAS ASSUMED HERE THAT THERE WOULD BE NO SIGNIFICANT ATTENUATION OF THE 100-YEAR FLOOD, IN SPITE OF THE FACT THAT THERE ARE UPSTREAM DAMS AND NATURAL LAKES. THIS ASSUMPTION WAS BASED ON THE FACT THAT THERE WAS LITTLE OR NO ATTENUATION OF FLOOD PEAKS AT THE UPSTREAM CRESCENT LAKE DAM (SEE NOTE 2). SINCE CAMP NEVINUS DAM (FIG. 2) AND BEAVER LAKE LODGE DAM ARE APPROXIMATELY IN THE SAME SIZE RANGE AS CRESCENT LAKE DAM, IT CAN BE ASSUMED THAT THERE WOULD BE NO SIGNIFICANT ATTENUATION OF THE FLOOD PEAKS AT THESE FACILITIES. ALSO, ALTHOUGH GOLD KEY LAKE AND LOG TAVERN POND (FIG. 2) ARE NATURAL LAKES WITH LARGE STORAGE CAPACITIES, THESE FACILITIES ARE LOCATED IN THE UPPEMOST REACHES OF THE WATERSHED, AND THUS WILL HAVE LITTLE EFFECT ON THE PEAK FLOWS ENTERING BEAVER LAKE. FINALLY, POCOMO WOODLAND LAKE DAM (NDI No. PA-00443, DER No. 52-179), FOR WHICH A PHASE I INSPECTION REPORT IS CURRENTLY BEING PREPARED, HAS A RELATIVELY SMALL DRAINAGE AREA (0.3 SQUARE MILES; SEE FIG. 2), AND THIS WILL HAVE LITTLE EFFECT ON BEAVER LAKE INFLOWS. THEREFORE, IT IS CONCLUDED THAT BEAVER LAKE LODGE DAM WILL BE OVERTOPPED UNDER THE 100-YEAR EVENT.

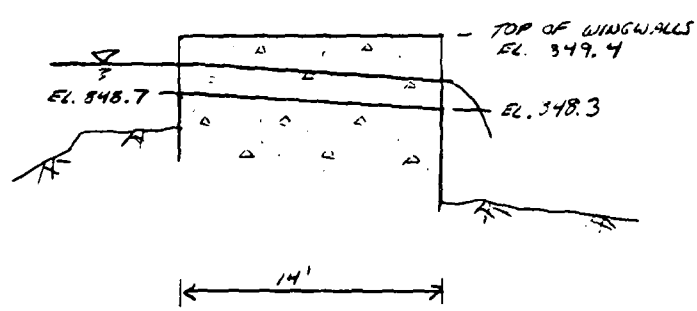
### 2.) EMERGENCY SPILLWAY

EFFECTIVE CREST LENGTH = 38 FT
