WHITNEY LAKE DAM

NDI ID NO PA-00142
DER ID NO 64-133

PHASE I INSPECTION REPORT

NATIONAL DAM INSPECTION PROGRAM

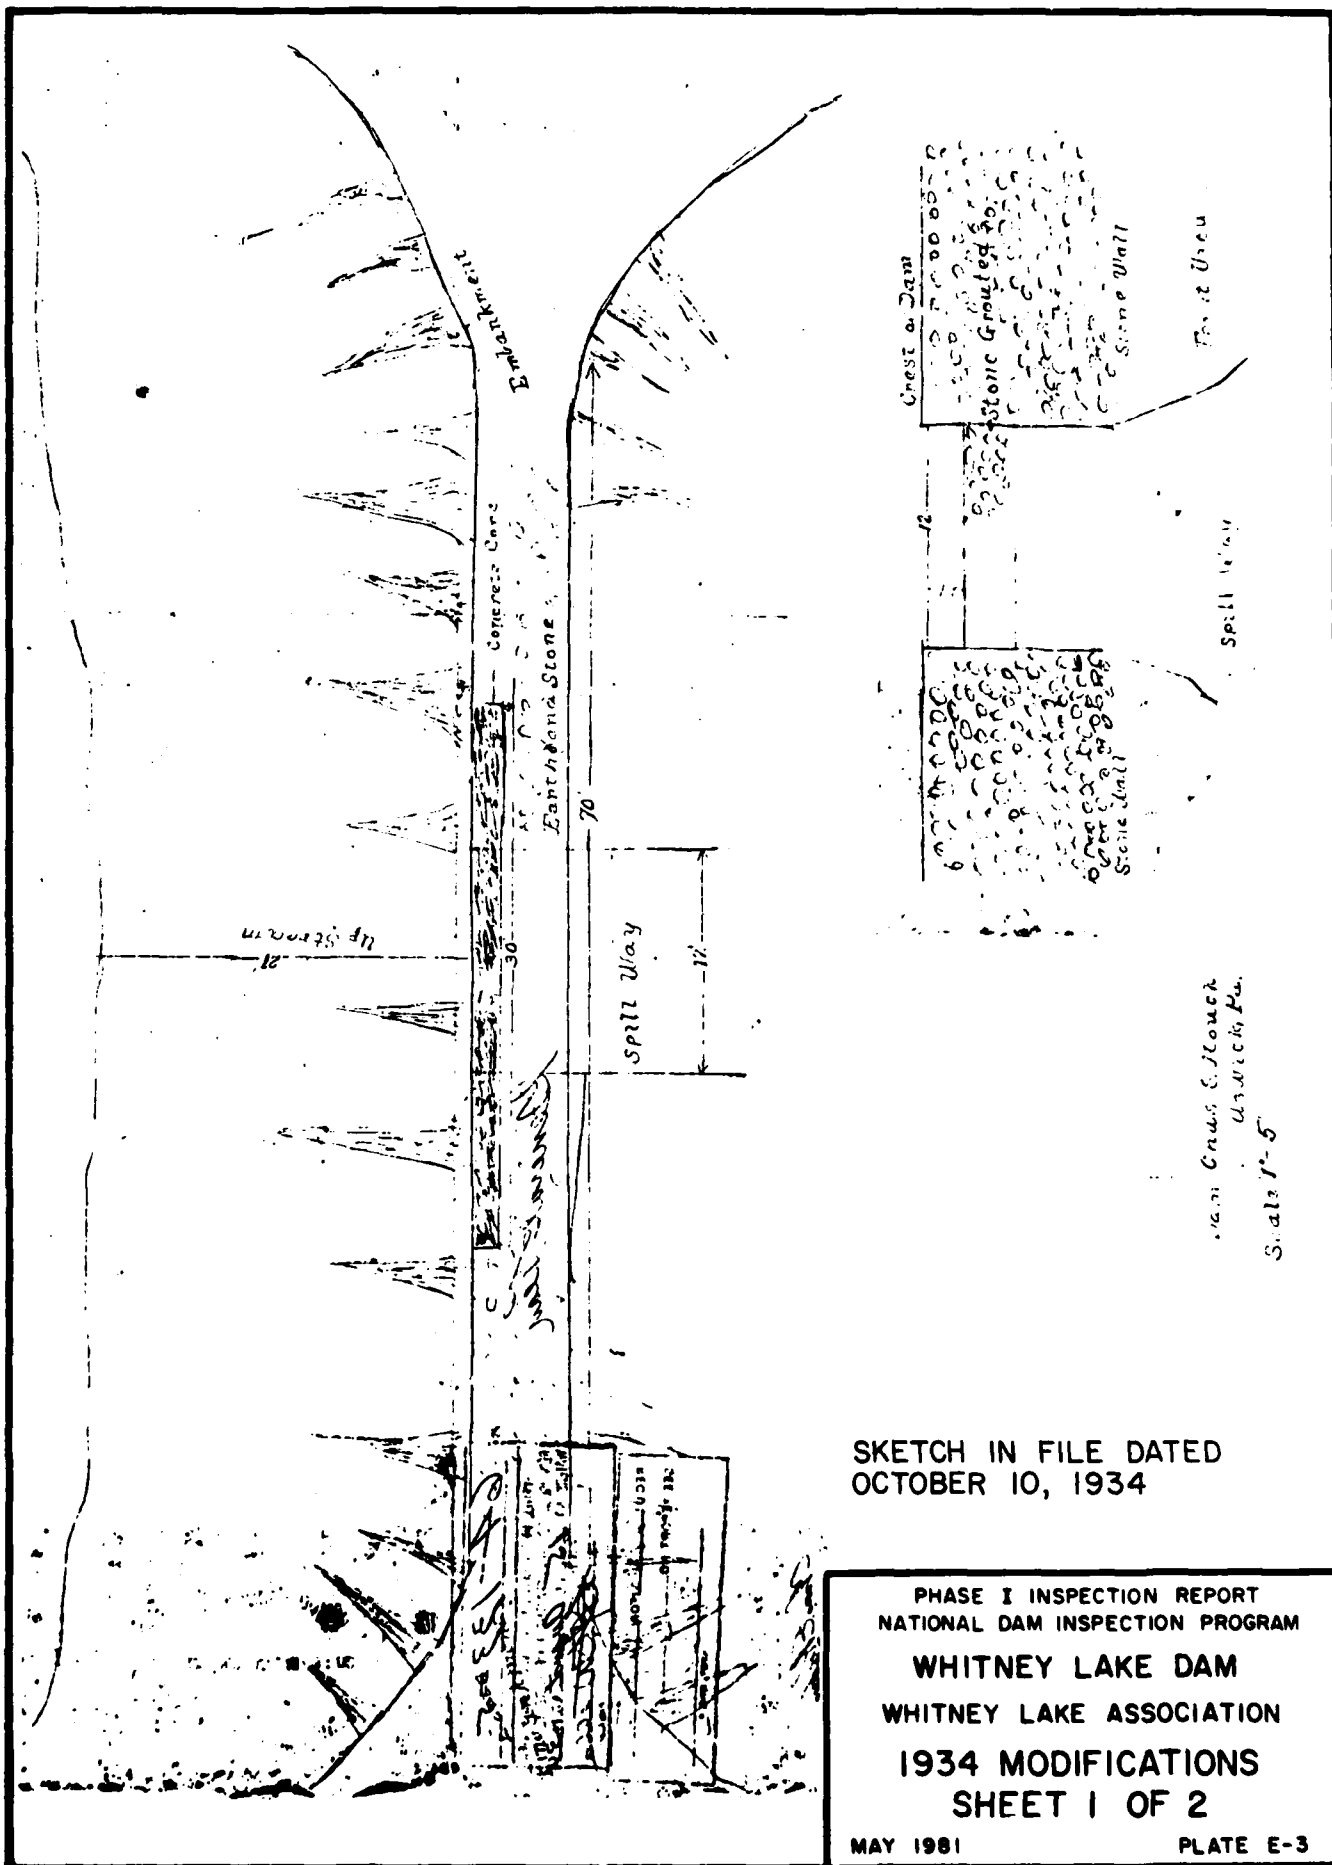
PHASE I INSPECTION REPORT
NATIONAL DAM INSPECTION PROGRAM
WHITNEY LAKE DAM
WHITNEY LAKE ASSOCIATION
1934 MODIFICATIONS
SHEET 1 OF 2
MAY 1981 PLATE E-3

SKETCH IN FILE DATED
OCTOBER 10, 1934

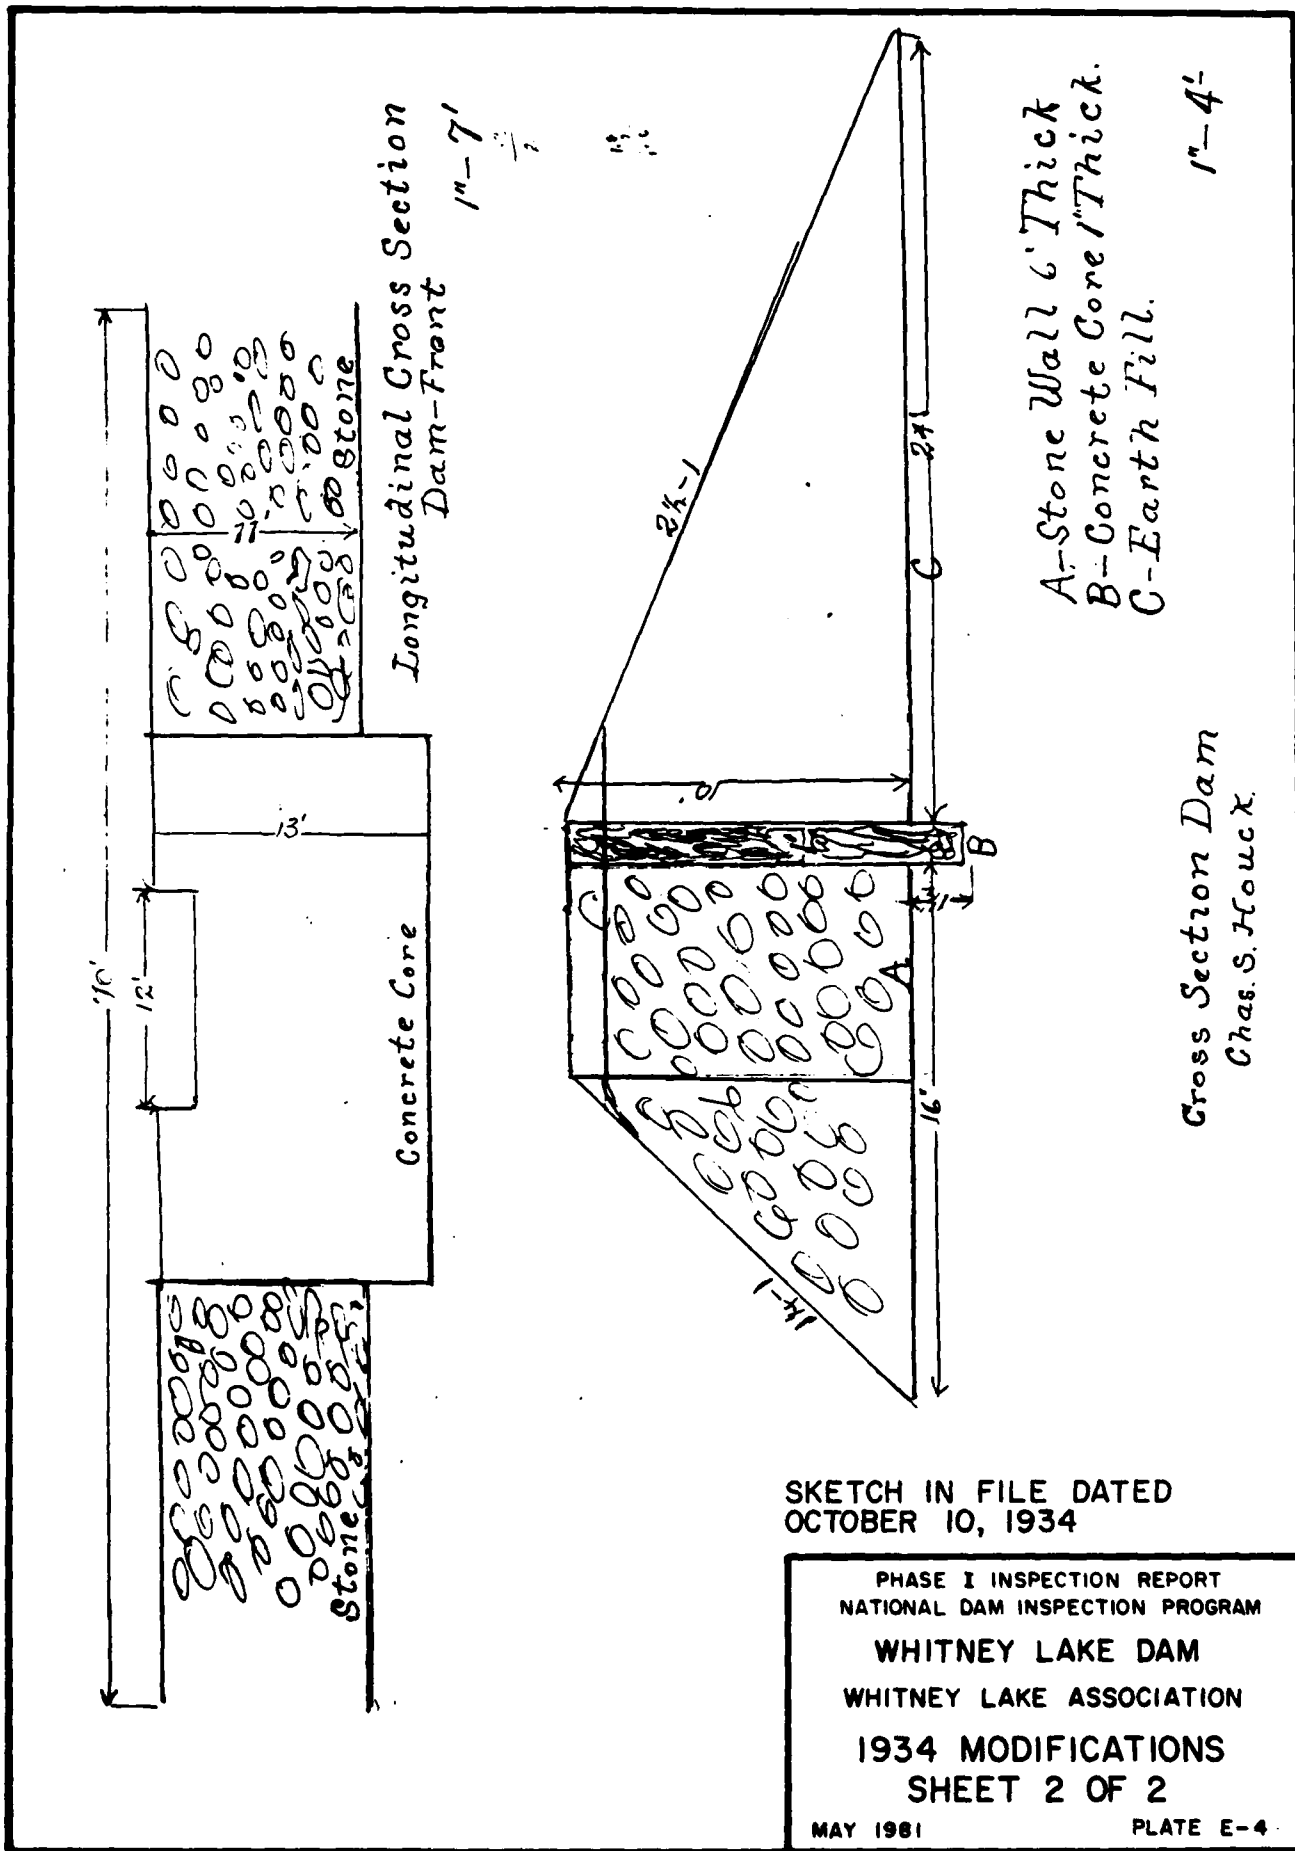
PHASE I INSPECTION REPORT
NATIONAL DAM INSPECTION PROGRAM
WHITNEY LAKE DAM
WHITNEY LAKE ASSOCIATION
1934 MODIFICATIONS
SHEET 2 OF 2
MAY 1981 PLATE E-4

SKETCH IN FILE DATED
OCTOBER 10, 1934
