National Dam Inspection Program.
Duck Harbor Pond Dam (NDI ID Number
PA-00144, DER ID Number 64-54), Dela-
ware River Basin, Little Equinunk Creek,
Wayne County, Pennsylvania. Phase I
Inspection Report.

DUCK HARBOR POND DAM

NDI ID No. PA-00144

PHASE I INSPECTION REPORT
NATIONAL DAM INSPECTION PROGRAM

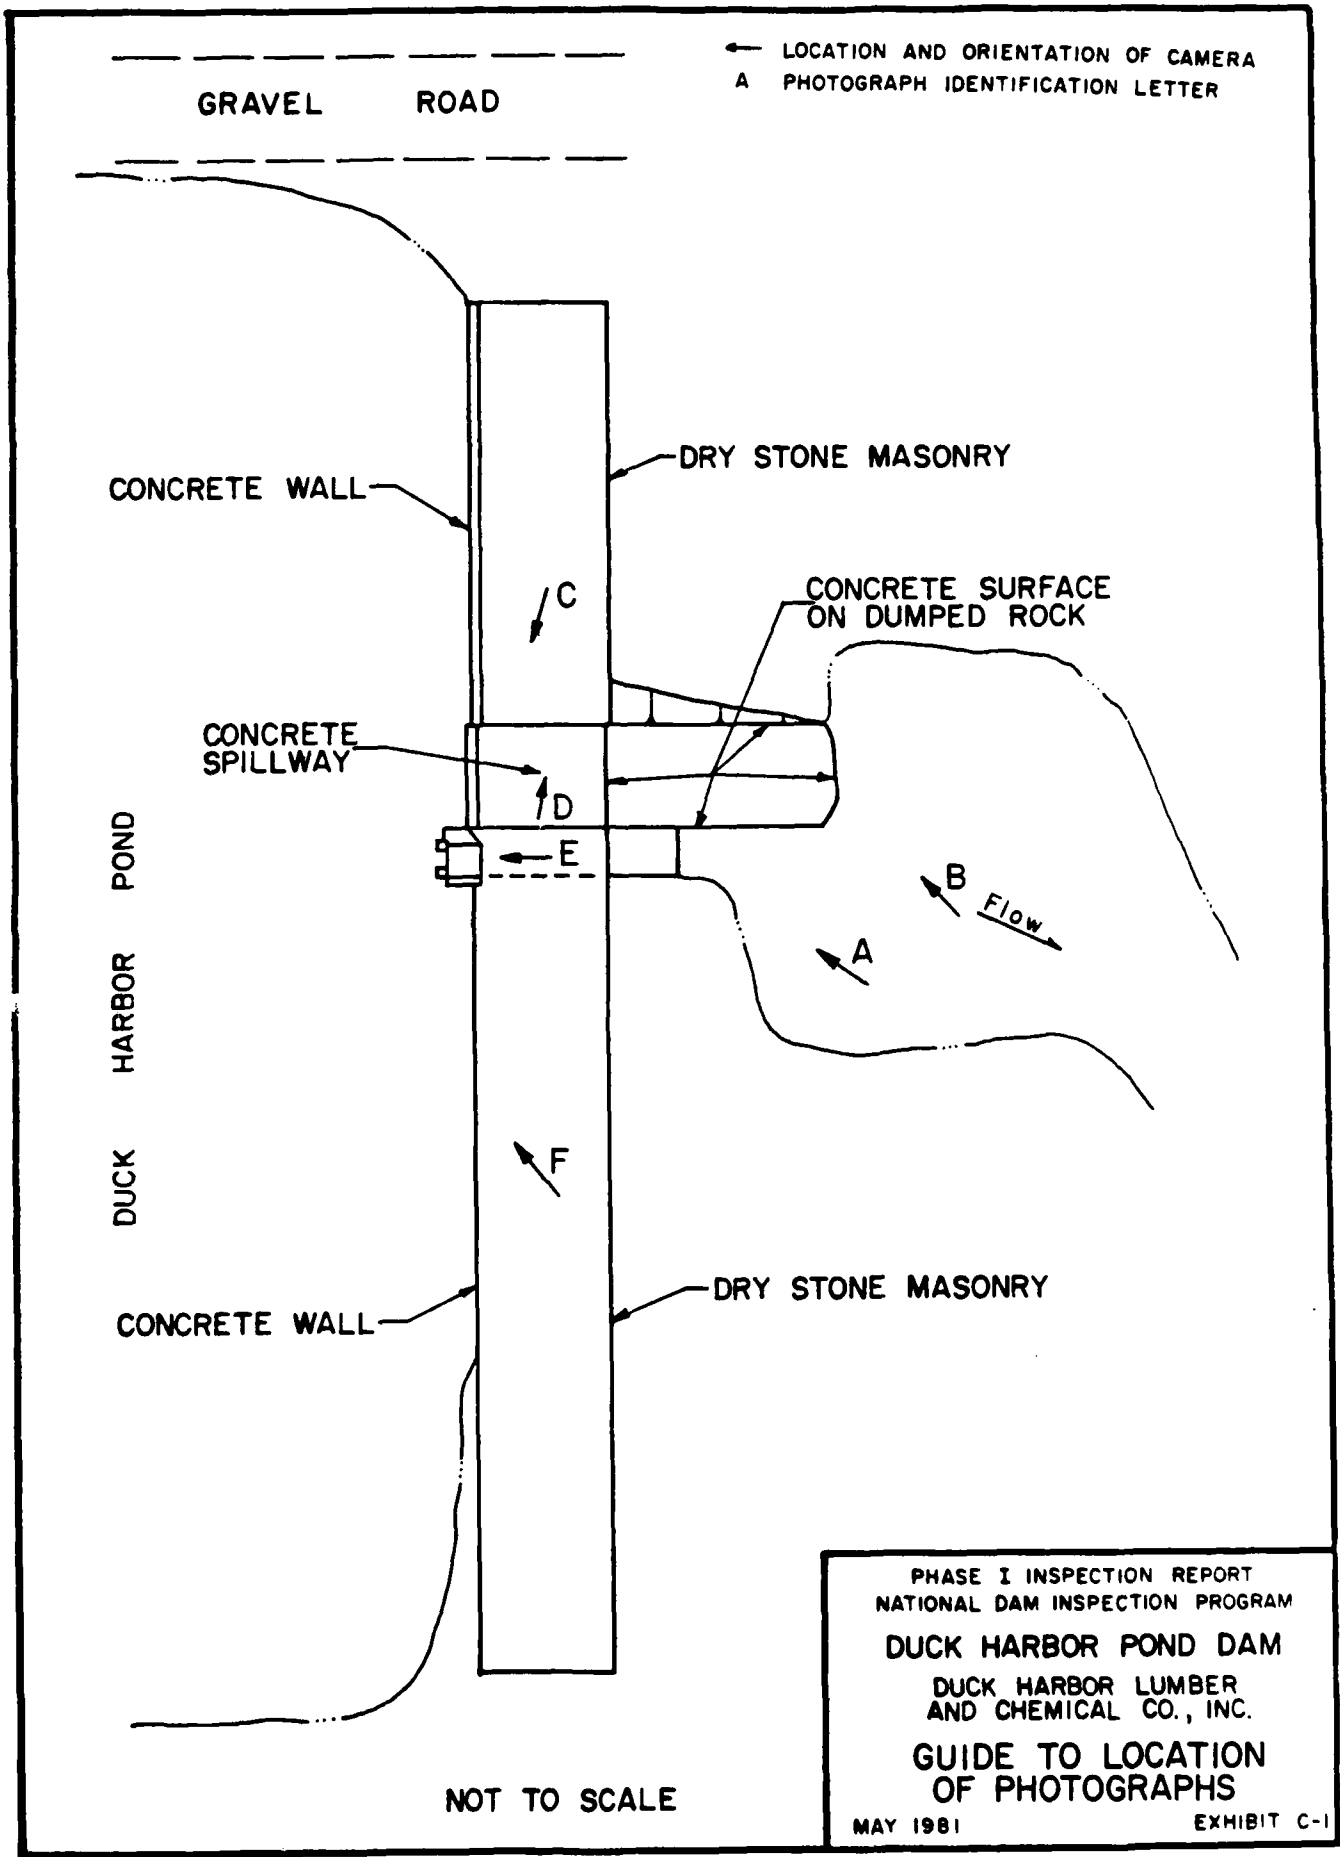
b. Dry Stone Masonry Structure. This structure is in good condition. To the right of the spillway along the downstream edge, a few stones have been displaced. The top of the dam is covered with a thin layer of soil. At one area, this soil has washed through the dry masonry, leaving a depression on the top (Photograph F). Mature trees are growing along the downstream toe of the dry masonry. Clear seepage, estimated at 60 gpm, was flowing from beneath the stones to the left of the spillway ramp (Photograph B).

F. Depression in Top
