WILDWOOD LAKE DAM

NDI ID NO. PA-00157

PHASE I INSPECTION REPORT

NATIONAL DAM INSPECTION PROGRAM

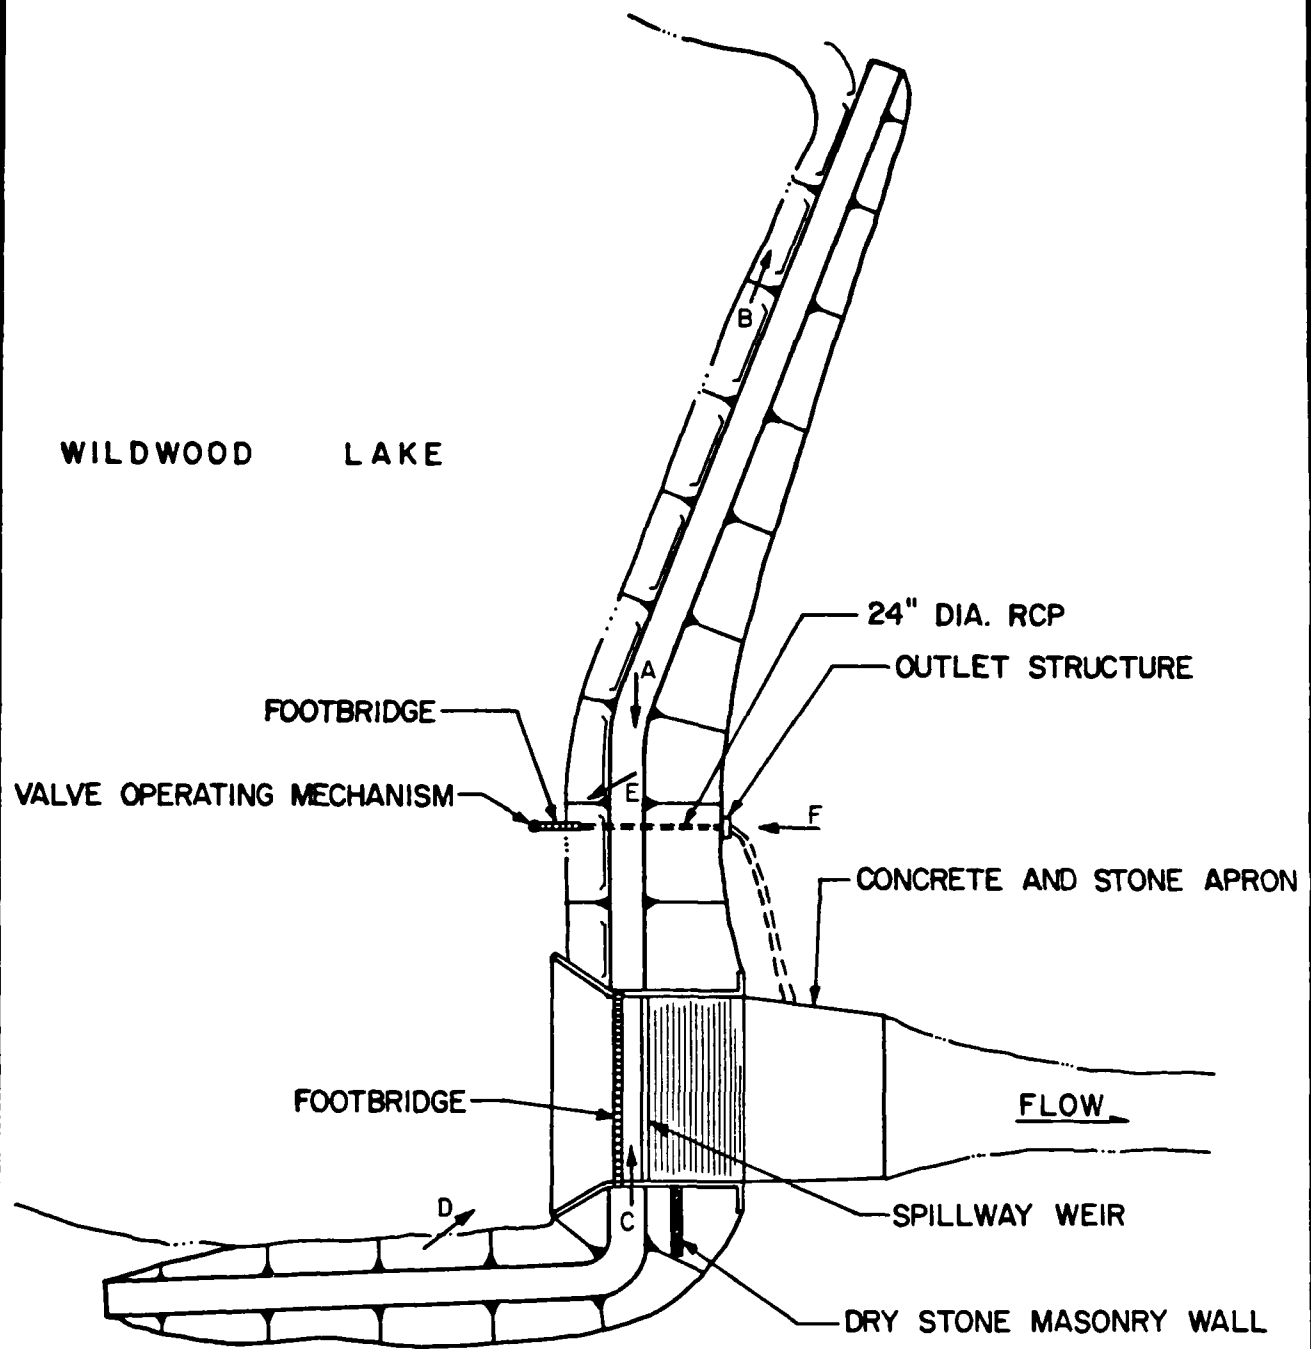
a. General. The overall appearance of the dam is fair. Some deficiencies were observed as noted below. A sketch of the dam with the locations of deficiencies is presented on Exhibit B-1 in Appendix B. Survey information acquired for this Report is summarized in Appendix B. Datum used for the survey was the spillway crest level, Elevation 1358.0. On the day of the inspection, the pool was at the spillway crest level.
