STONE LAKE DAM

(NDI.D. PA-0055,  
DER ID. 058-129), Susquehanna

~~OWNER: SUSQUEHANNA RIVER BASIN~~  
River Basin, Stonestreet Creek, Susquehanna County,  
Pennsylvania. PHASE I INSPECTION REPORT,

NATIONAL DAM INSPECTION PROGRAM

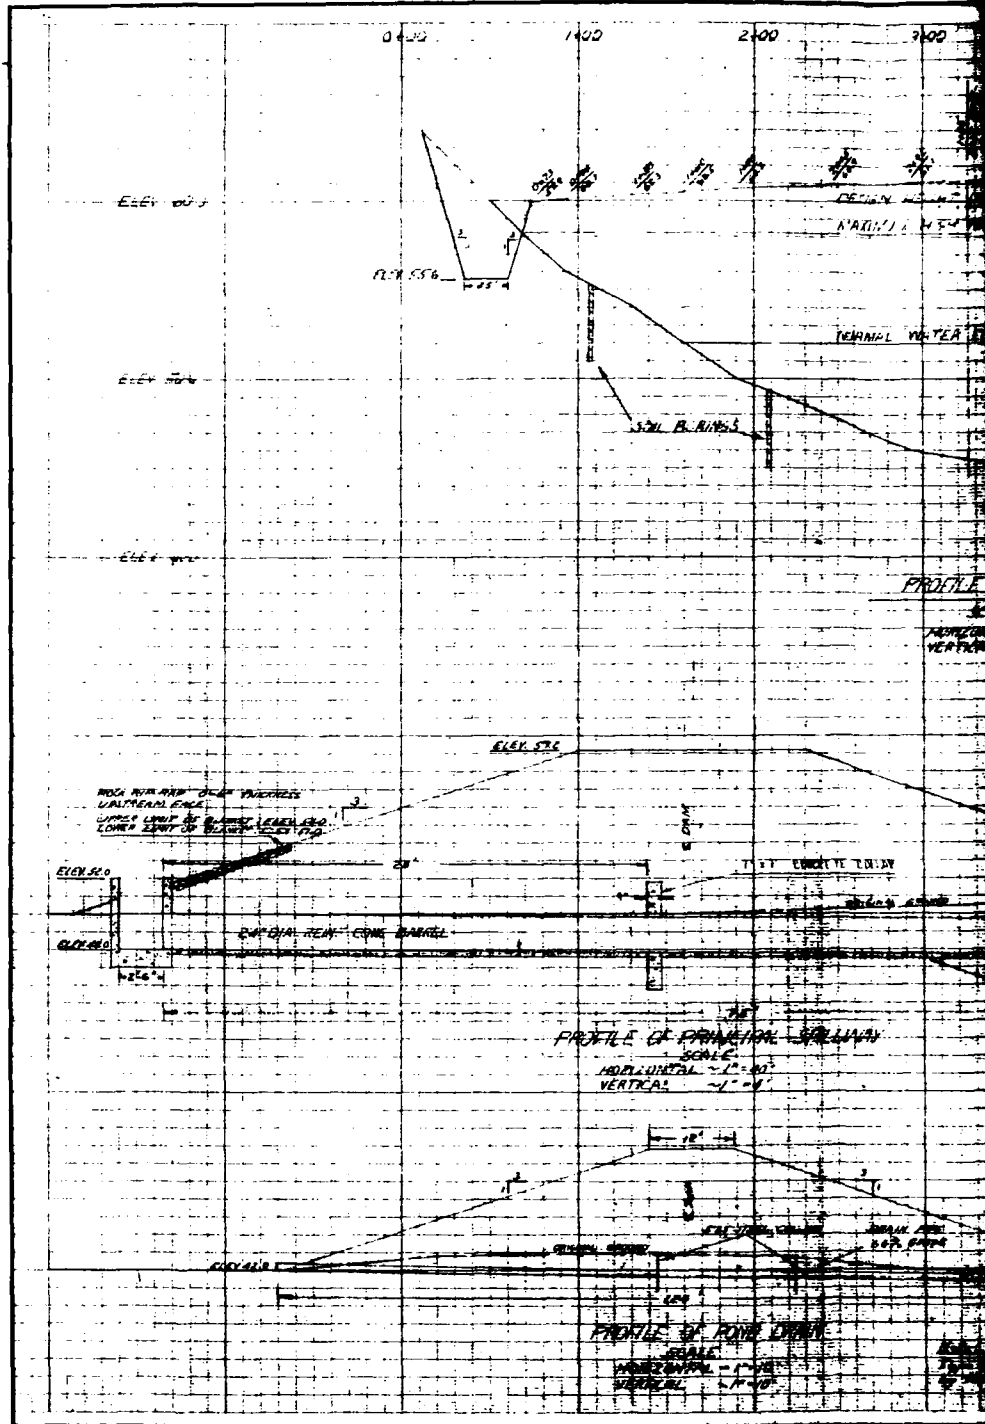
DRAWN BY  
 4-27-81  
 CHECKED BY  
 4-27-81  
 APPROVED BY  
 4-27-81  
 DRAWING NUMBER 80-556-B18

The dam crest was surveyed relative to the primary spillway crest elevation and was found to have some vertical irregularities. Although the design freeboard for the dam is 7.2 feet, the field survey indicated freeboards ranging from 6.3 feet to 7.2 feet. The lowest area occurred in a section adjacent to the left emergency spillway. The dam crest profile, according to field measurements, is illustrated in Plate 5.
