MINKLER LAKE DAM

NDI I.D. PA-0052

PHASE I INSPECTION REPORT  
NATIONAL DAM INSPECTION PROGRAM

NAME OF DAM: Minkler Lake Dam  
 STATE LOCATED: Pennsylvania  
 COUNTY LOCATED: Susquehanna  
 STREAM: Apalachin Creek  
 SIZE CLASSIFICATION: Small  
 HAZARD CLASSIFICATION: Significant  
 OWNER: Mr. Mario Roma and Mr. Asa B. Chilson  
 DATE OF INSPECTION: March 24, 1981 and April 30, 1981

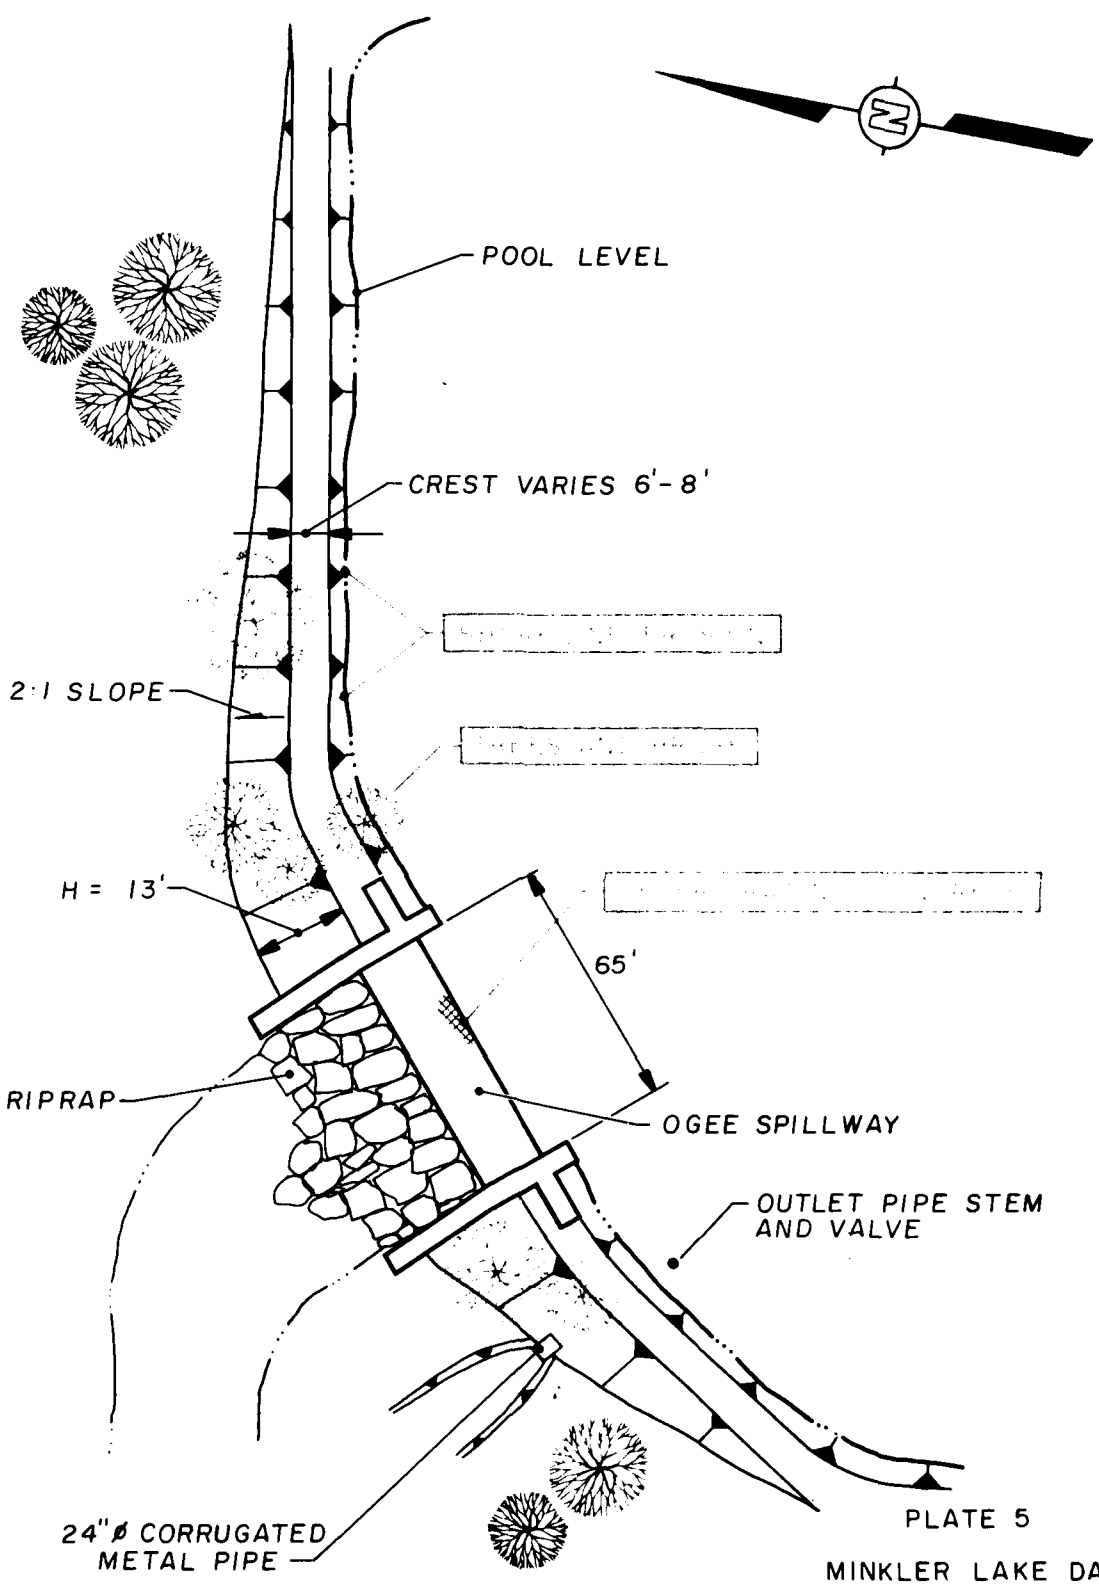
PLATE 5  
 MINKLER LAKE DAM  
 GENERAL PLAN  
 FIELD INSPECTION NOTES  
 FIELD INSPECTION DATE: MAR. 24, 1981

The specific observations are illustrated in Plate 5.

In general, the condition of the embankment is considered to be poor. The upstream area, crest and downstream face are covered with brush and large trees. The upstream face lacks erosion protection and significant shoreline erosion exists at various locations. At some sections the upstream slope is essentially vertical.

c. Appurtenant Structures. The appurtenant structures were examined for deterioration or other signs of distress and obstructions that would limit flow. In general, the structures were found to be in fair condition. While the concrete surfaces on the spillway wing walls have deteriorated, the concrete in the overflow is in fair condition. The outlet pipe gate hoist structure has collapsed and is not functional.
