SUSQUEHANNA RIVER BASIN
UPPER MT. HOLLY DAM
EATON - DIKEMAN OF KNOWLTON BROS.

NDI NO. PA-00583
DER NO. 21-001

CUMBERLAND COUNTY, PENNSYLVANIA
PHASE I INSPECTION REPORT
NATIONAL DAM INSPECTION PROGRAM

JUNE 1981

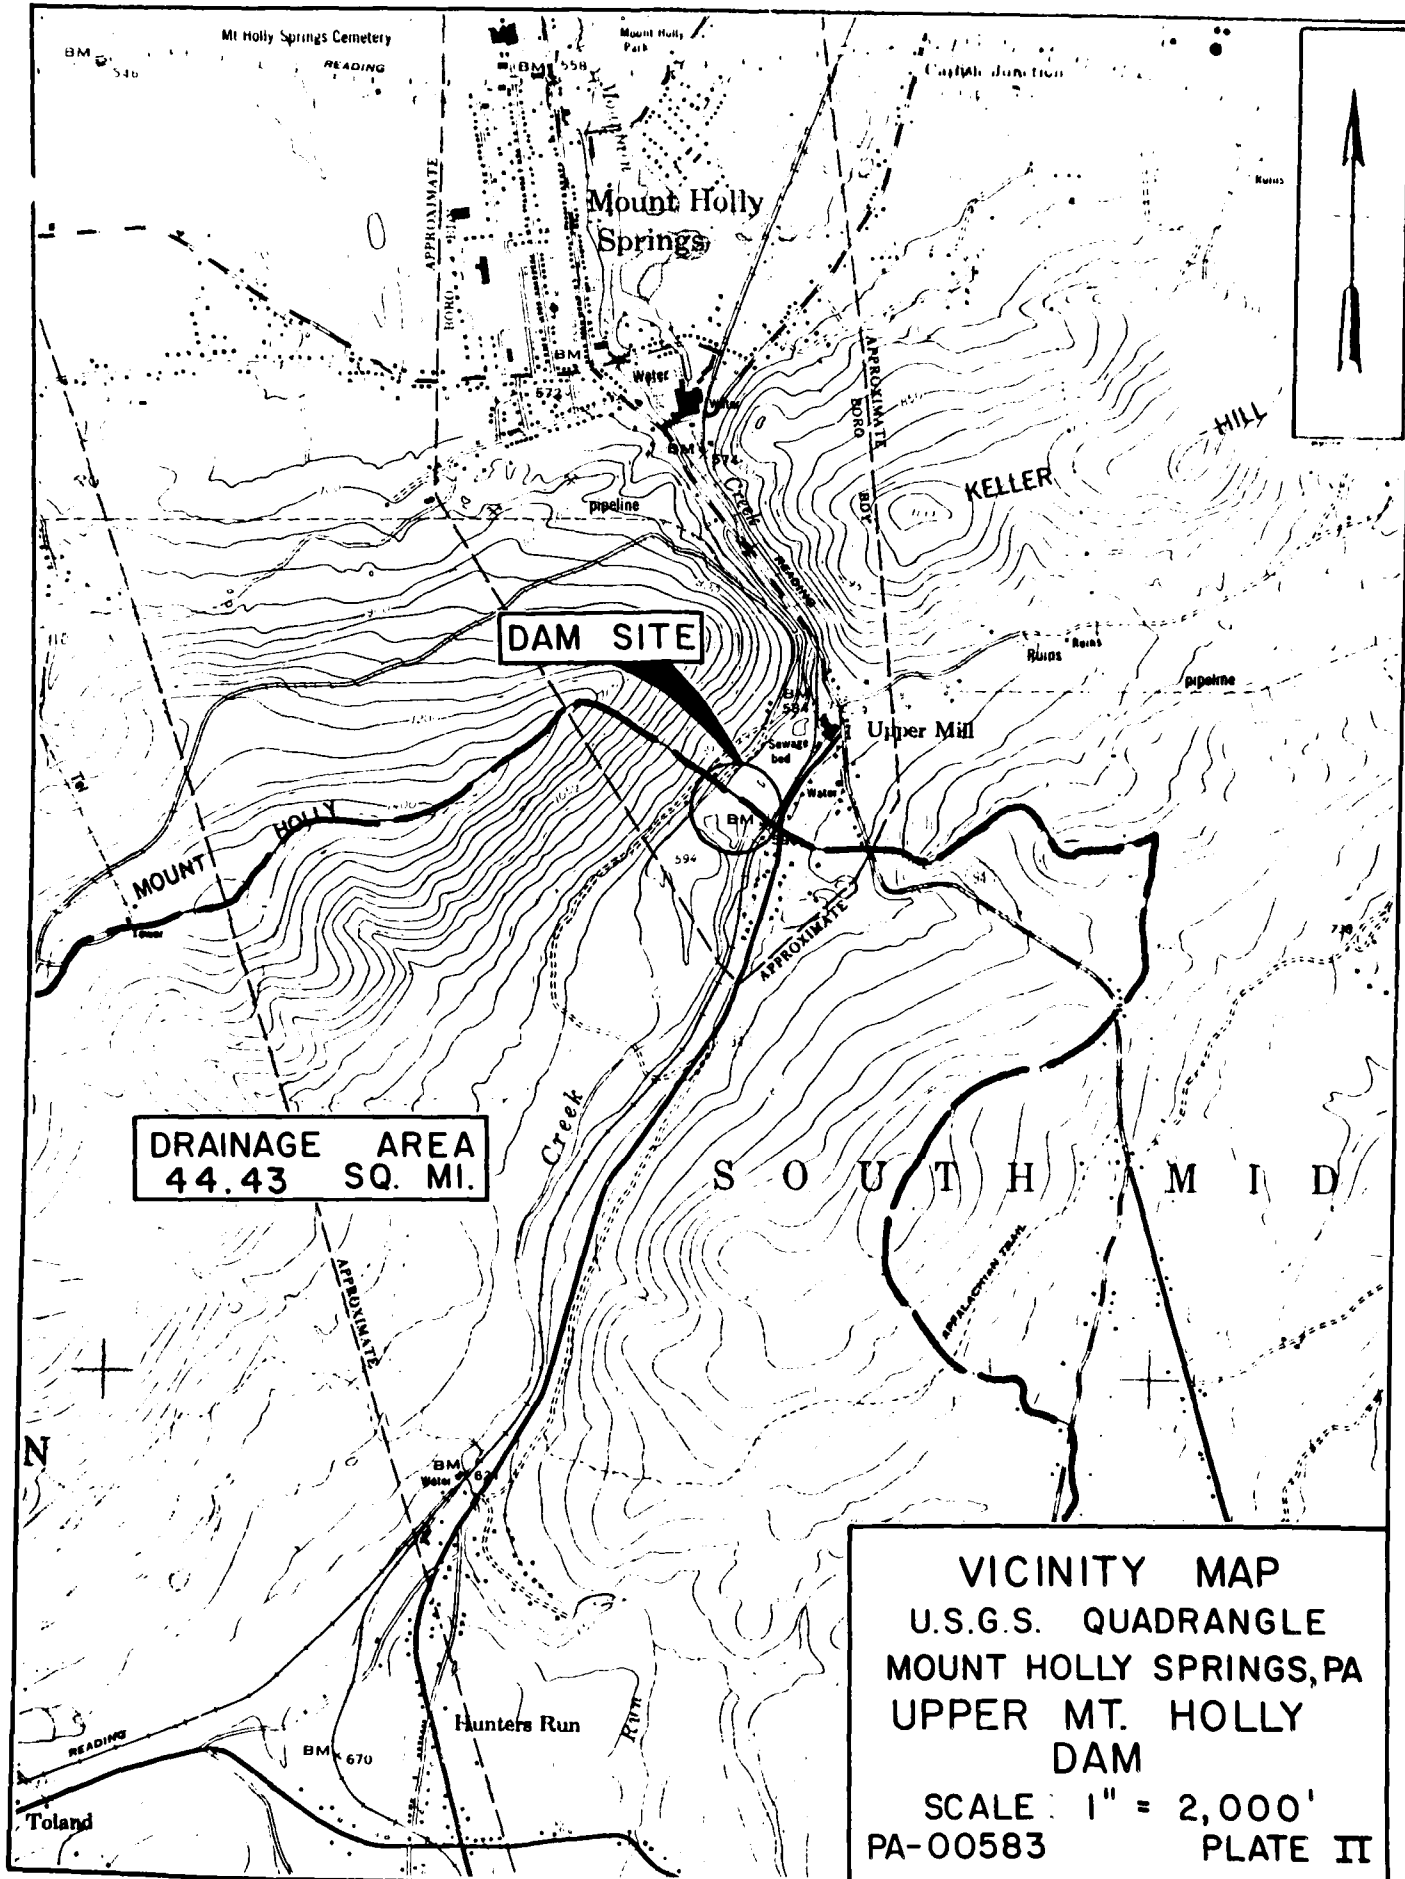
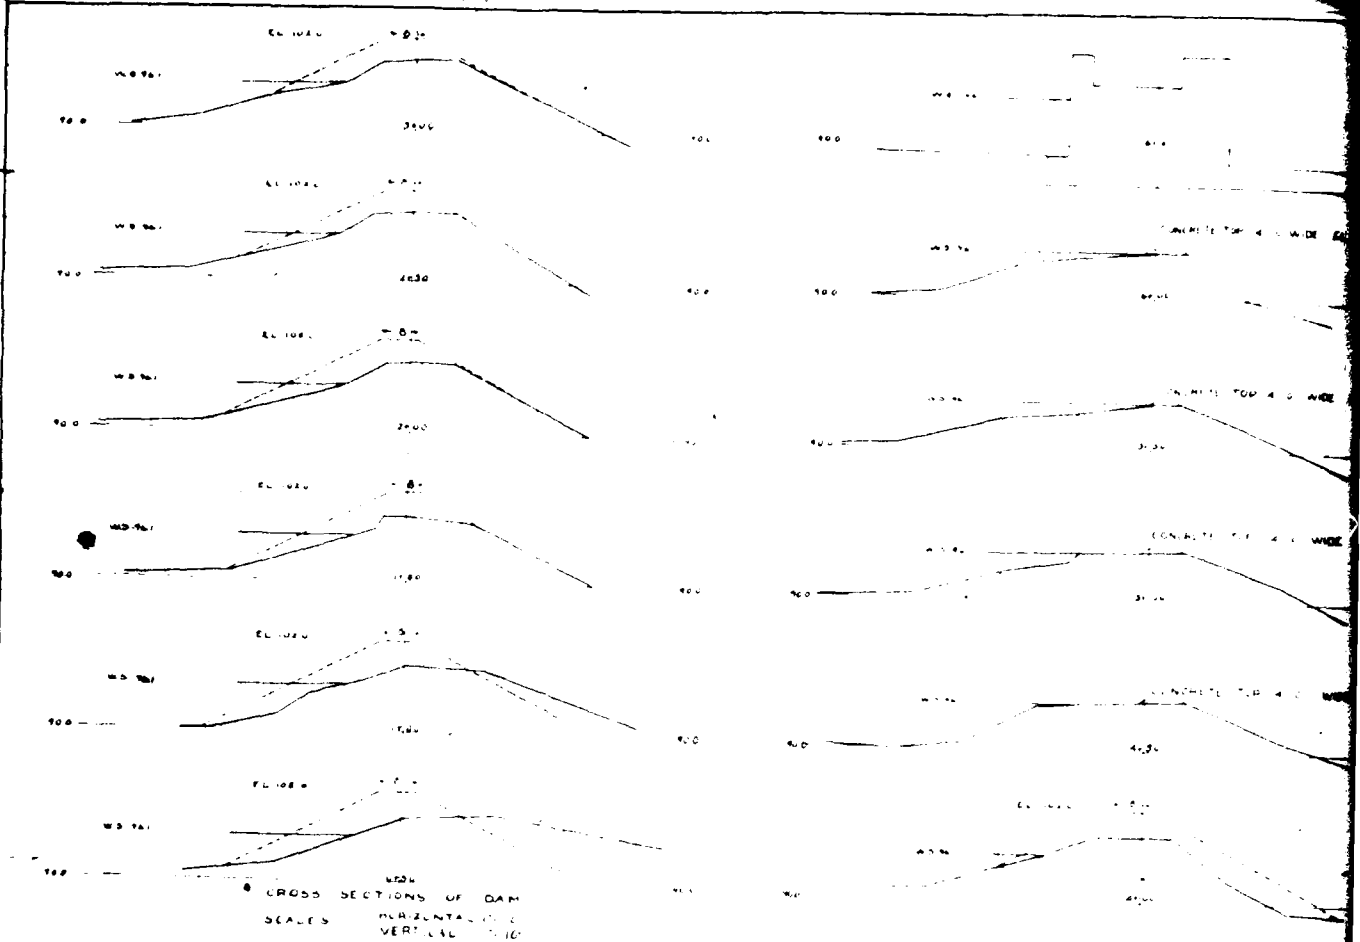
PLAN AND DETAILS OF PROPOSED
 TO THE "UPPER DAM"
 MOUNT HOLLY SPRINGS,
 SCALES AS NOTED C.A. CARLISLE
 SEPTEMBER 1922

PennDER requested plans, which were submitted in 1922 (Plate III, Appendix E). After approval, all repairs were made. The repairs included the removal of brush and trees, the raising of the embankment to elevation 100.0, and the leveling of the spillway crest with three inches of concrete to elevation 96.7. The embankment was not raised to elevation 102.0, as shown on Plate III, Appendix E.
