COLEMAN DAM

NDI ID NO. PA-00191
DER ID NO. 35-94

PHASE I INSPECTION REPORT
NATIONAL DAM INSPECTION PROGRAM

MAY 1981

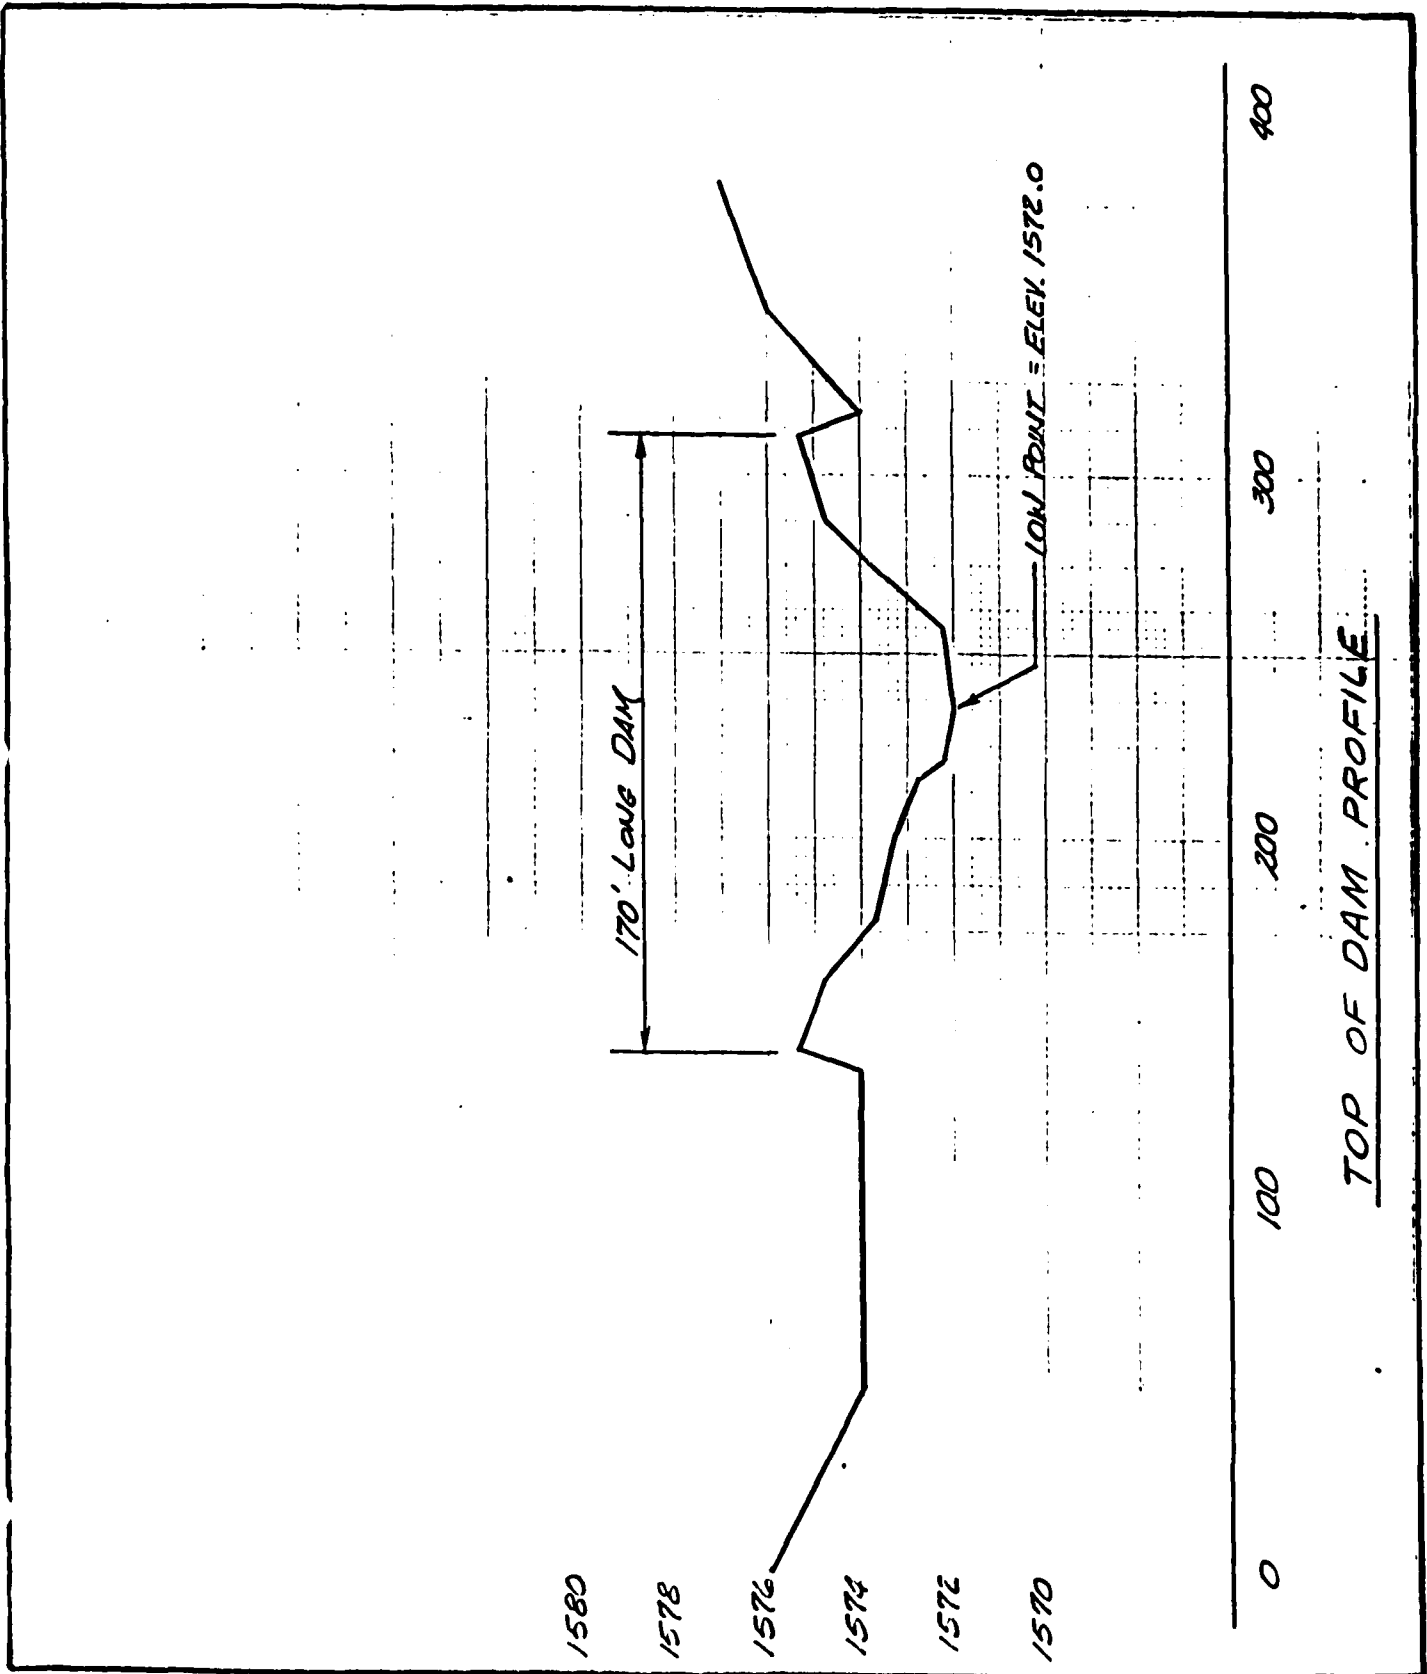
COLEMAN DAM
GENERAL PLAN - FIELD INSPECTION NOTES

a. General. The overall appearance of the dam is very poor. Location of observed deficiencies are shown on the General Plan presented in Exhibit A-1, Appendix A. The profile and typical sections of the dam are presented in Exhibits A-2 and A-3 and are based on field survey made on the day of the inspection. The survey datum for this inspection is elevation 1572 feet above mean sea level for the normal water surface of the Lake (see Exhibit E-1). On the inspection date (3/02/81), the lake level was approximately at elevation 1572, which is also the low point near the middle of the dam crest (see Exhibit A-2). Deficiencies observed during the field inspection are described below, and are illustrated in Exhibit A-1, Appendix A. Visible features are depicted in photographs, presented in Appendix C.
