**LAKE SAINTE LOUISE DAM
ST. CHARLES COUNTY, MISSOURI
MO 10490**

PHASE 1 INSPECTION REPORT NATIONAL DAM SAFETY PROGRAM

**PREPARED BY: U. S. ARMY ENGINEER DISTRICT, ST. LOUIS
FOR: STATE OF MISSOURI**

SEPTEMBER 1978

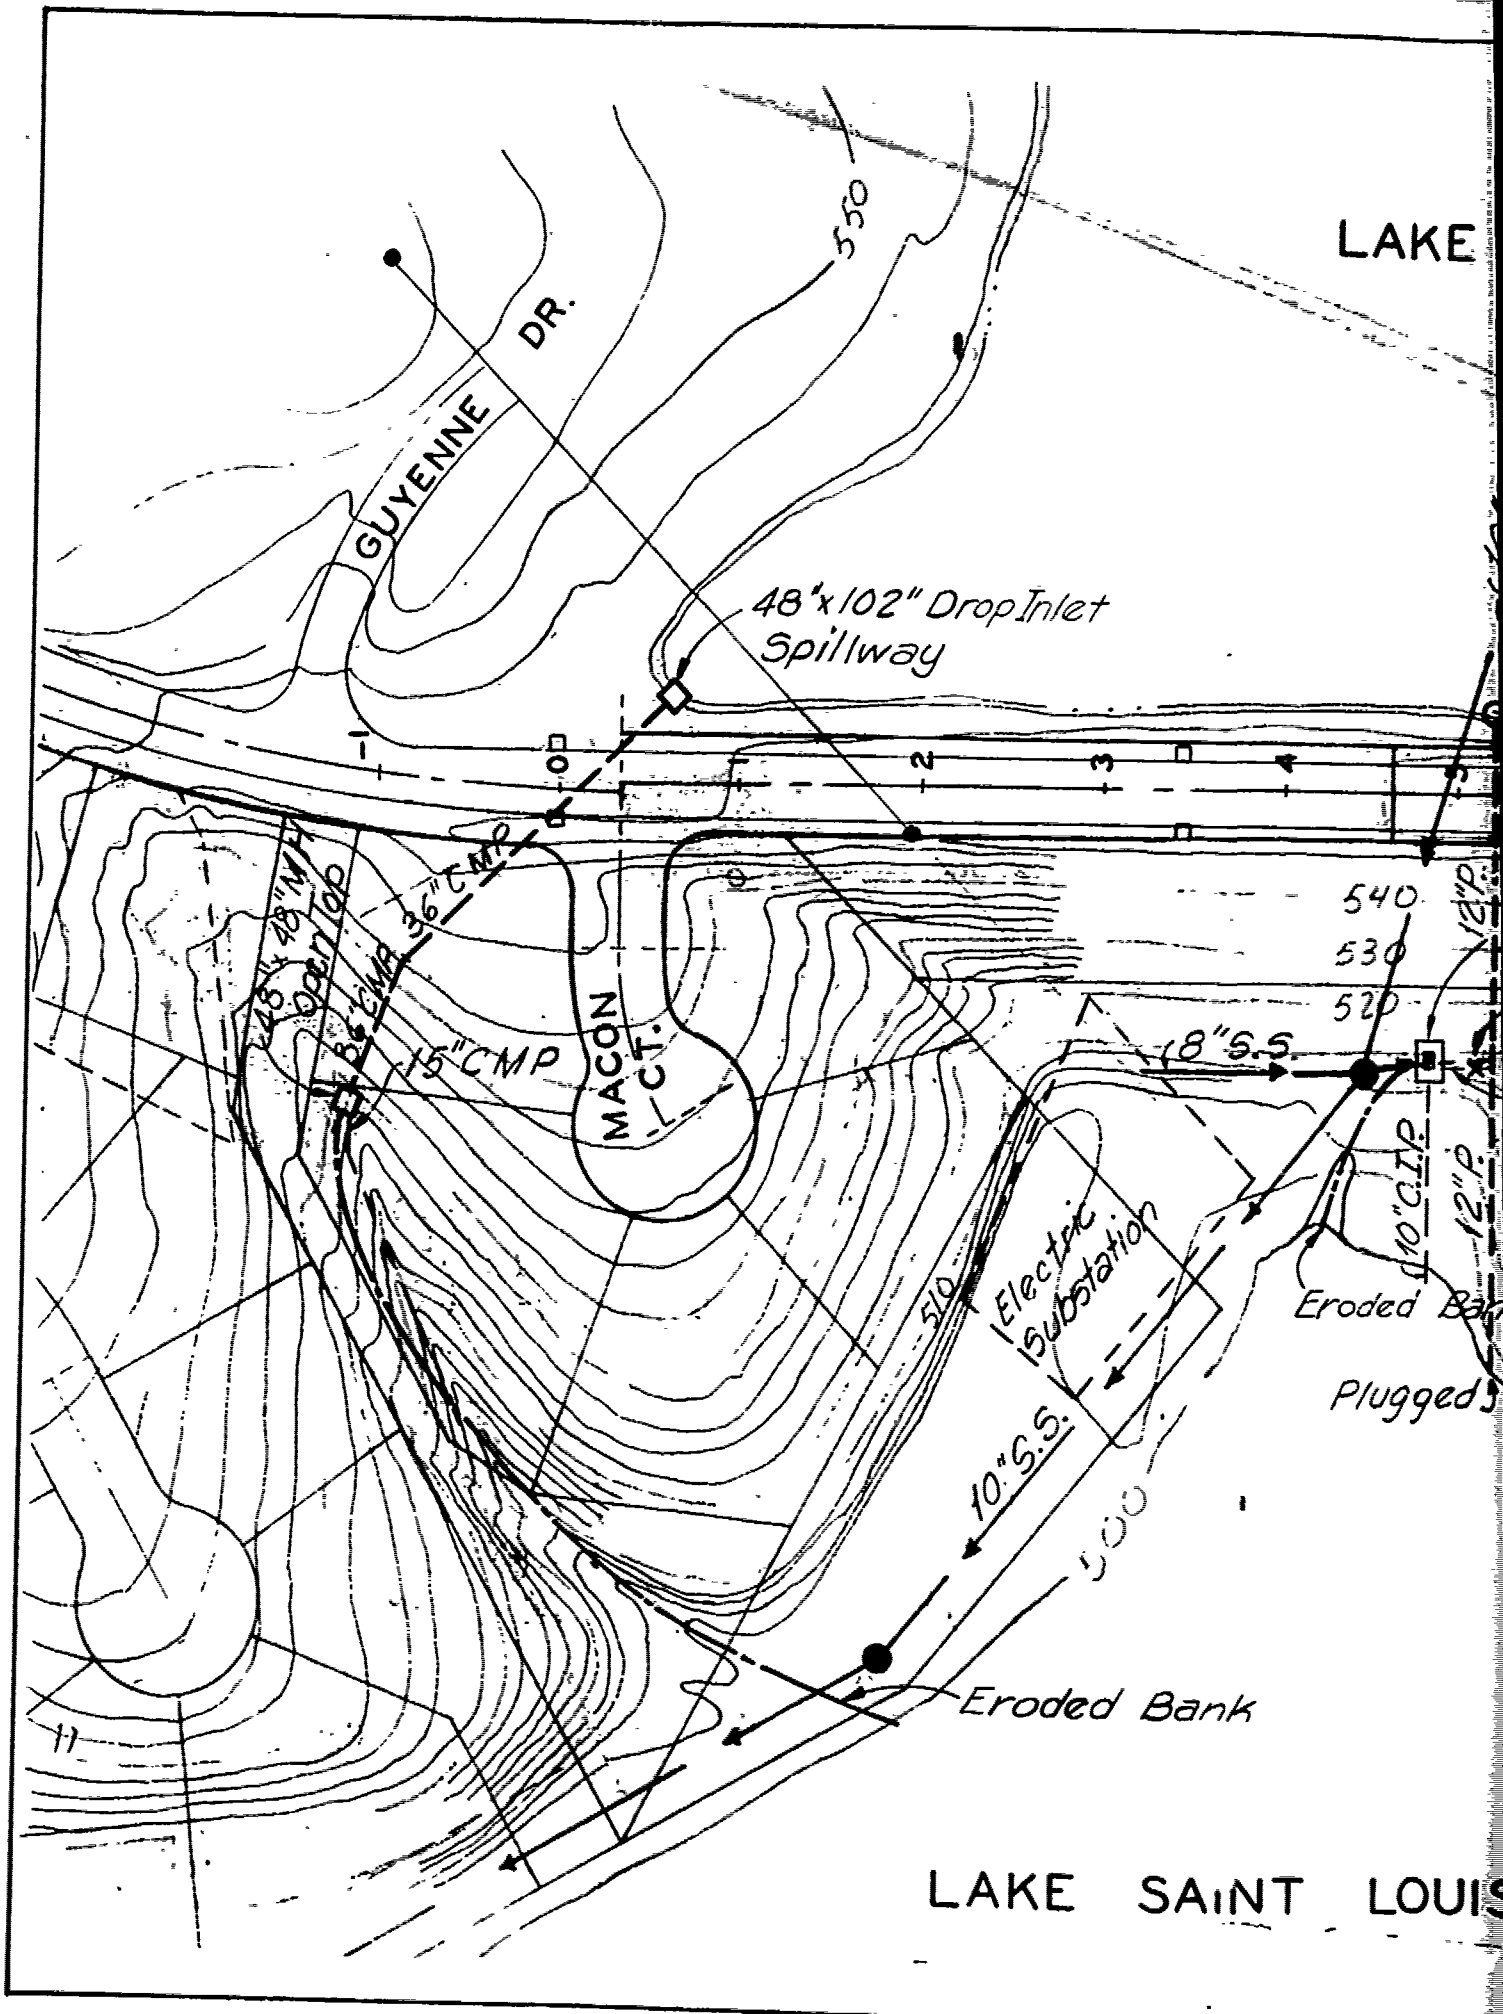
PLATE 2

A facility for installation of a pump (see Photo 8) has been constructed on the area near the center of the dam immediately adjacent to the downstream toe of slope. This pump is used to replenish Lake Sainte Louise by pumping water from Lake Saint Louis. The 12-inch outlet pipe for the 42-inch diameter drop inlet spillway at this location has been modified to function as a pump discharge line. A 10-inch cast-iron pipe that serves as the discharge line for the pump is connected to the 12-inch spillway outlet pipe. At the connection to the 12-inch pipe, a gate valve (see Photo 9) has been installed. This valve is normally maintained closed in order to prevent backflow from Lake Sainte Louise. Also, according to the Director of the Lakes and Parks Department, Lake Saint Louis Community Association, the spillway outlet pipe downstream of the pump line connection has been plugged with concrete in order to allow pumpage to flow to Lake Sainte Louise. The location of the pump base and connecting pipe lines is shown on Plate 2. At the time of the inspection, the pump was not installed and water, although the valve was closed, was flowing from the pump discharge connecting line at a rate of about 1-2 gpm. This leakage was collecting in a small pool (see Photo 10) adjacent to the pump base and entering the ground at a point adjacent to the nearby sanitary sewer manhole where it appeared that some of the flow entered the manhole through an open joint in the masonry wall. Although, according to the Director, the valve is normally maintained closed, it has been opened at times by non-authorized individuals living nearby. During these periods when the valve is open, high discharges at the 10-inch pipe have occurred and the flow has eroded to a depth of several feet, (see Photo 11) the normal bank at the point where it enters Lake Saint Louis. The location of the eroded bank at Lake Saint Louis is also shown on Plate 2.
