LAKE ARROWHEAD DAM  
FRANKLIN COUNTY, MISSOURI  
MO 30572

# PHASE 1 INSPECTION REPORT NATIONAL DAM SAFETY PROGRAM

PHASE I INSPECTION REPORT  
NATIONAL DAM SAFETY PROGRAM

DECEMBER 1978

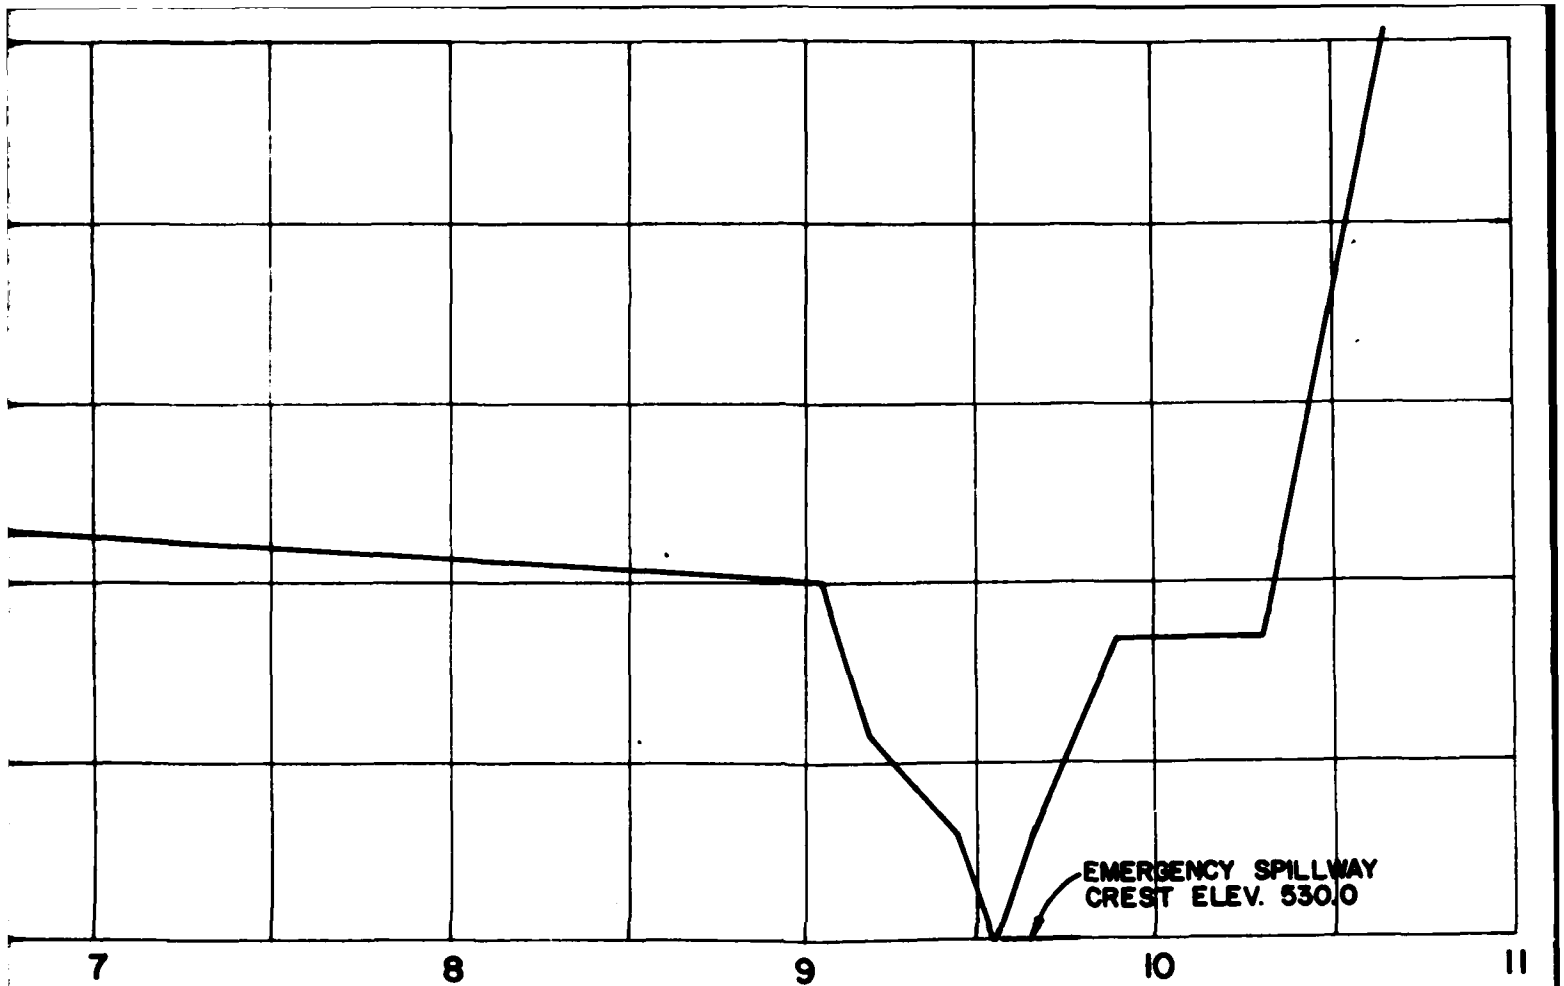
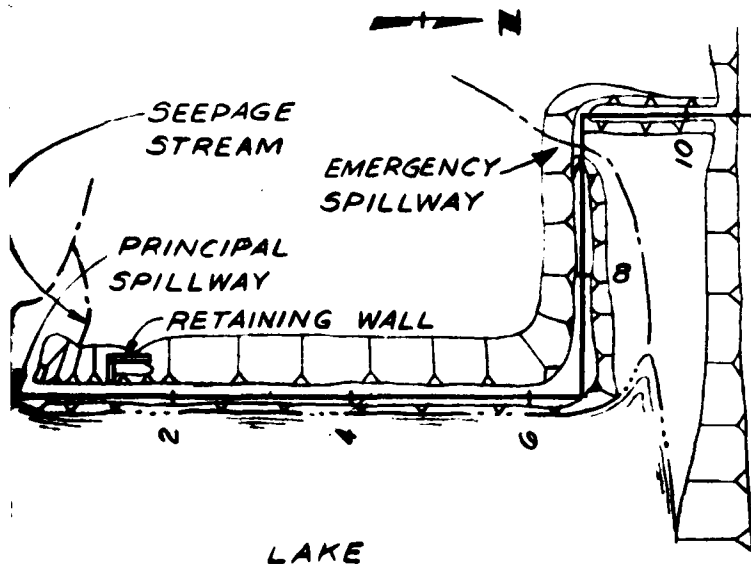
**LAKE ARROWHEAD  
DAM & SPILLWAY PROFILES**

The crest of the dam was found to be approximately 2 feet lower at a point near the center of the dam than in the area adjacent to the principal spillway. (The low point of the dam is approximately 5 feet higher than the spillway crest.) As a result, the capacity of the spillway to discharge lake outflow without overtopping the dam is reduced. Based on the criteria set forth in the recommended guidelines (see text) and since there are eight homes within the estimated flood zone, the spillway design flood for this dam, which is classified as small in size and of high hazard potential, is considered to be Probable Maximum Flood (PMF). PMF is the flood that may be expected from the most severe combination of critical meteorologic and hydrologic conditions that are reasonably possible in the region. Results of a hydrologic/hydraulic analysis indicated that the existing spillways (principal plus emergency) are inadequate to pass lake outflow resulting from a storm of PMF magnitude without overtopping the dam. They are also inadequate to pass the lake outflow resulting from the 1 percent chance (100-year frequency) flood without overtopping the dam. The spillways are capable of passing lake outflow corresponding to approximately 11 percent of the PMF without overtopping the dam. The length of the downstream damage zone, should failure of the dam occur, is estimated to be one-half mile. There are eight homes and one subdivision street within the possible flood damage zone.
