**BRONX RIVER DAM**

**BRONX COUNTY, NEW YORK  
INVENTORY NO. N.Y. 1500**

**PHASE I INSPECTION REPORT  
NATIONAL DAM SAFETY PROGRAM**

**AUGUST 1981**

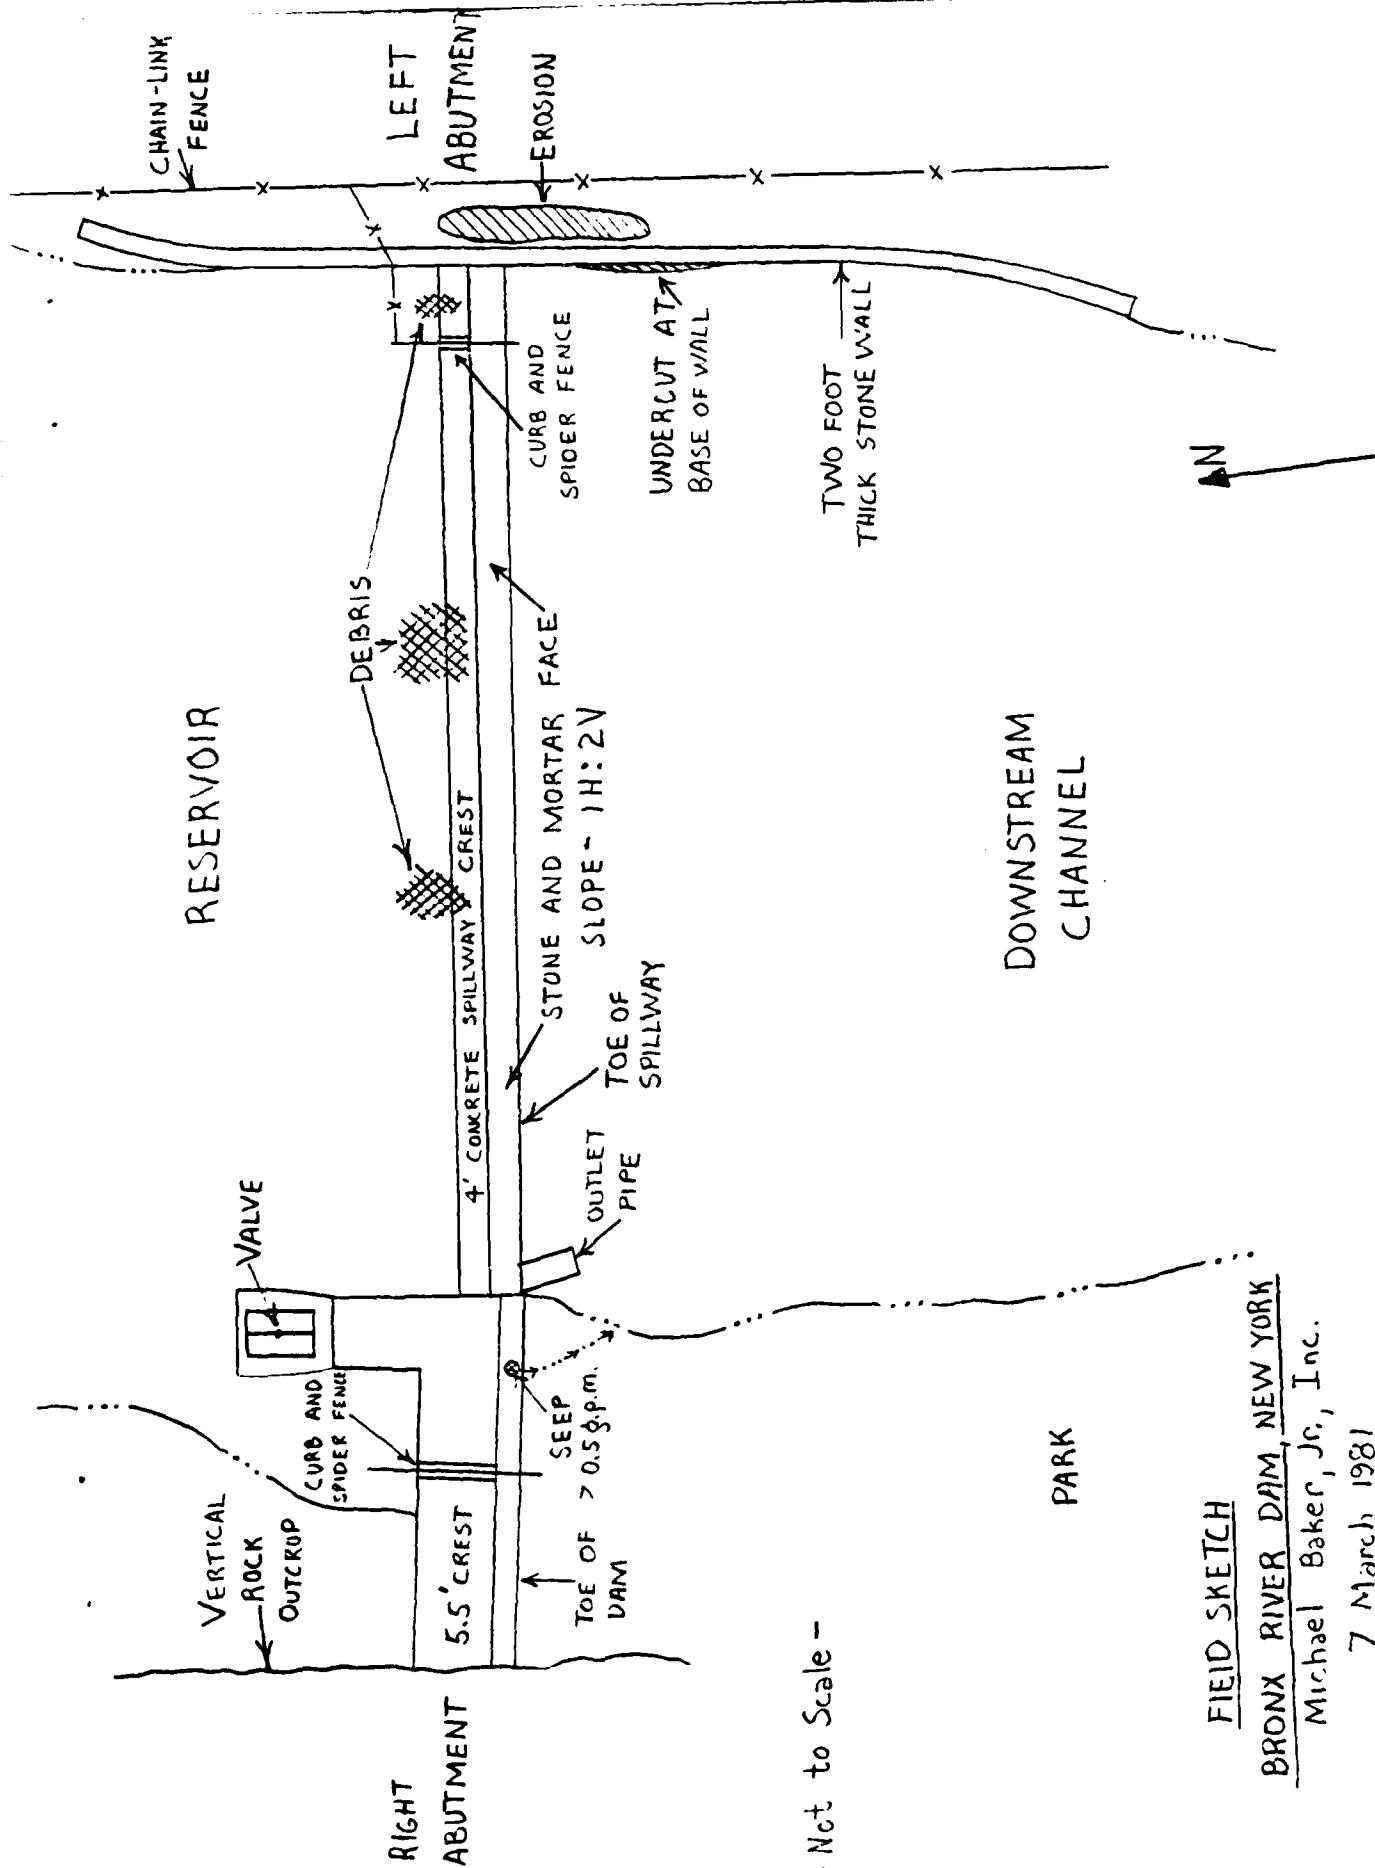
# FIELD SKETCH

d. Junctions with Abutments or Embankments Right abutment consists of  
chlorite mica schist with vertical fractures. Erosion has occurred  
behind the stone wall on the left abutment.

1. Fill beneath the left training wall and protect with riprap.
2. Fill, compact, and seed the area of erosion behind the left training wall.
3. Repair the mortar joints on the crest of the dam.
4. Clear the debris from the spillway crest.
