Structures Technical Memorandum 328

RESONANCE TESTS ON A PIPER PA-32R TAILPLANE  
BEFORE AND AFTER DAMAGE

Investigations have been carried out, on the tailplane of a Piper PA-32R aircraft, to determine the effect of damage, in the form of a split in the underside skin, on the modes of vibration of the tailplane. Details and results of the investigations are described.

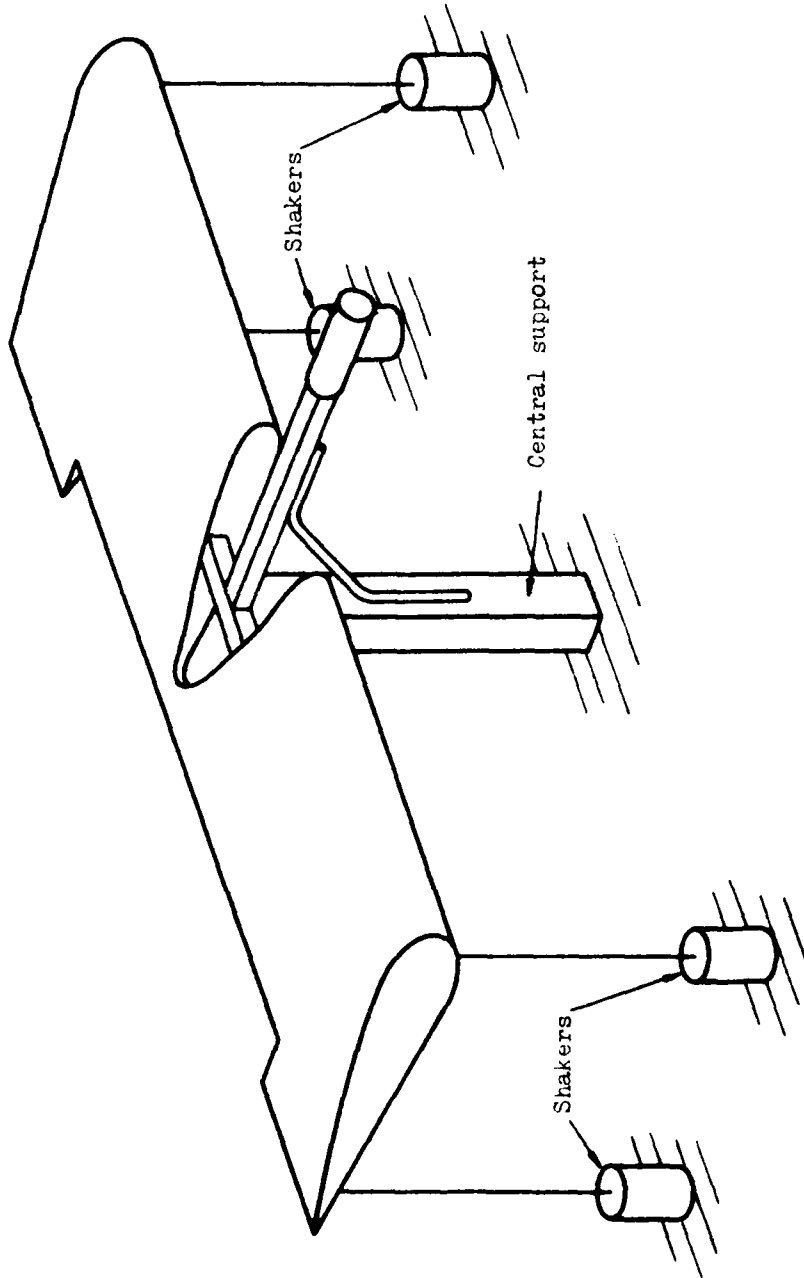
FIG. 1 GENERAL ARRANGEMENT OF TAILPLANE, SUPPORT, AND SHAKERS

An undamaged tailplane, without the control tab, was mounted on a central support in a similar manner to that in the aircraft. The tailplane was prevented from rotating by a rod attaching the control arm to the central support. The structure was excited, at the leading and trailing edges of each tip, by shakers connected to the surface by push rods. Refer Fig. 1.

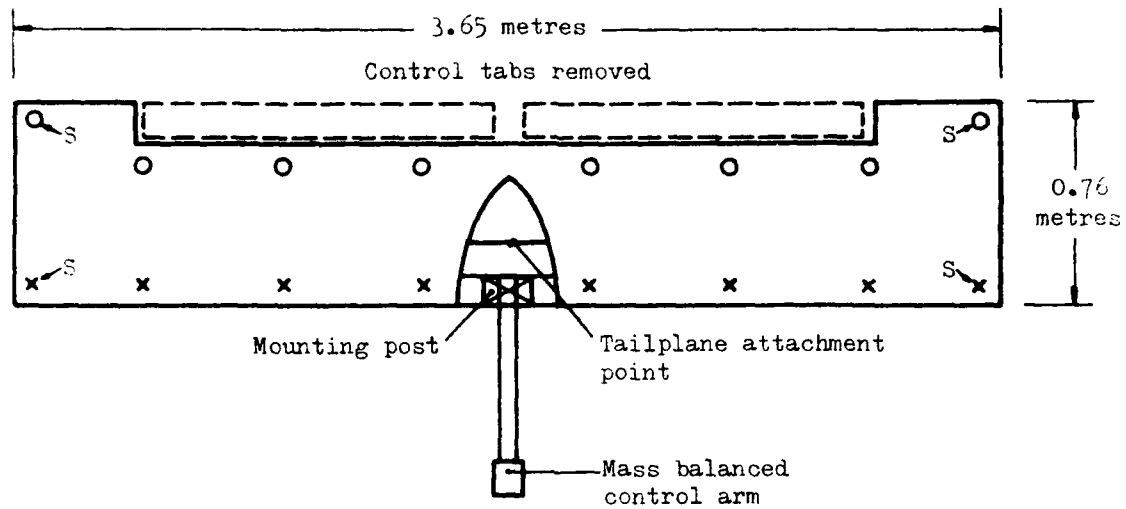
FIG.2 PLAN OF TAILPLANE SHOWING LOCATION OF SHAKERS AND MEASURING STATIONS.

At each resonant frequency, determined as described above, the mode of vibration was plotted using a travelling accelerometer on a rubber suction cup to measure the acceleration response of the structure at the sixteen measuring stations shown on Fig. 2.

O and X indicate measuring stations for plotting of mode shapes.  
 Refer to Figs. 4 to 7.  
 Shakers and fixed accelerometers mounted at locations marked S.
