DRESSER NO. 1 DAM
WASHINGTON COUNTY, MISSOURI
MO 31117

**PHASE I INSPECTION REPORT
NATIONAL DAM SAFETY PROGRAM**

MISSOURI INVENTORY NO. 31117

JUNE 1979

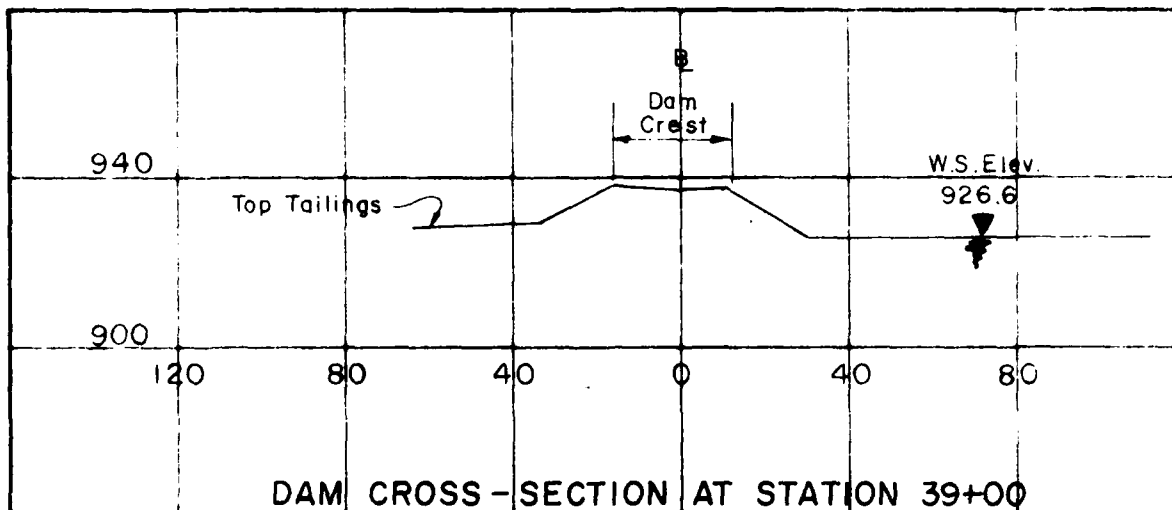
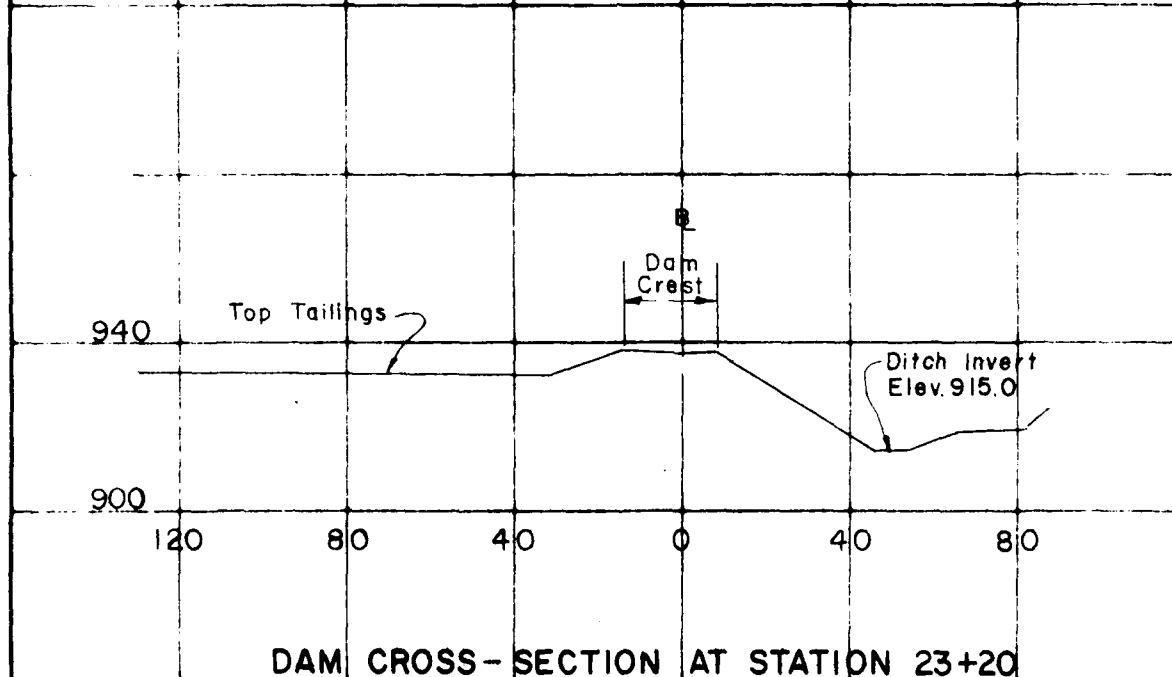
DAM I.D. NO. 31117
 DRESSER NO. 1
 DAM CROSS-SECTIONS

j. Diversion Ditches. A diversion ditch is located along the north side of the impoundment adjacent to the downstream toe of the dam. The ditch conducts runoff impounded in the upstream pond located at the west end of the impoundment to the downstream pond located at the east end of the impoundment. The diversion ditch is V-shaped to U-shaped, about 6 to 8 feet deep and about 1800 feet long. A cross-section of this ditch at Station 23+20 is shown in Plate 5A.
