SLABSTER LAKE DAM

LOUDOUN COUNTY, VIRGINIA

VA. NO. 10710

PHASE I INSPECTION REPORT NATIONAL DAM SAFETY PROGRAM

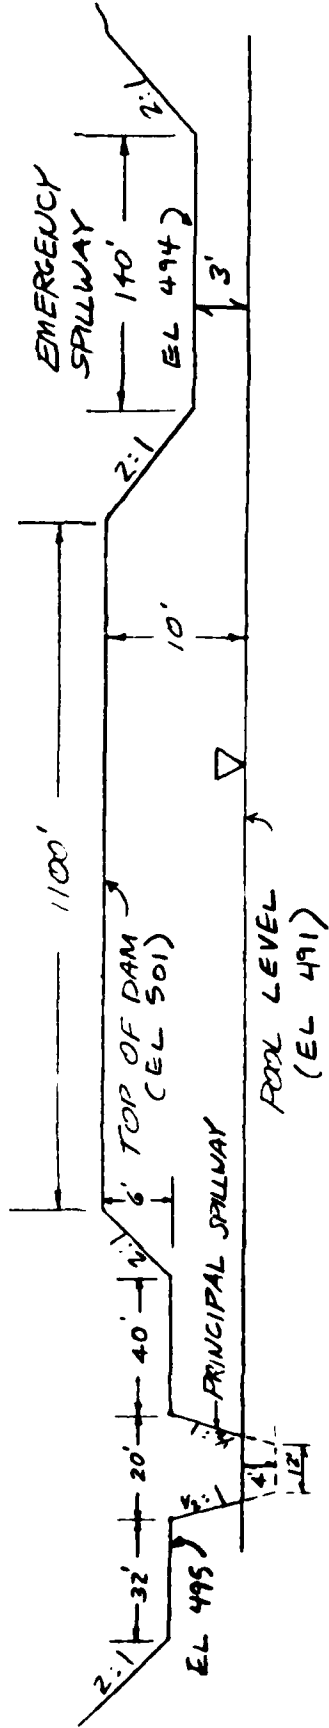
PROFILE
SLEETER LAKE
FIELD SKETCH#2
5 MAY 1981

- (A) SCATTERED IRON STAINING
- (B) 3 SMALL BOILS WITHIN 4'± DIAMETER AREA 1 1/2'± BELOW WATER LEVEL. FLOW ESTIMATED @ 5 GPM± FROM RIGHT. THE WATER WAS CLEAR. THIS MAY BE THE CHIMNEY DRAIN OUTLET
- (C) MARSHY, SATURATED AREA LOCATED AT BASE OF RIGHT EMERGENCY SPILLWAY. NO FLOW OR IRON STAINING OBSERVED

Iron stained seepage present below the lake drain discharge pipe should be monitored quarterly to detect any flow which may cause piping within the embankment. The chimney drain outlet should be uncovered and flow monitored quarterly. A staff gage should be installed to monitor water levels.
