DOVER LAKE DAM

GOOCHLAND COUNTY, VIRGINIA

VA. NO. 07503

PHASE I INSPECTION REPORT NATIONAL DAM SAFETY PROGRAM

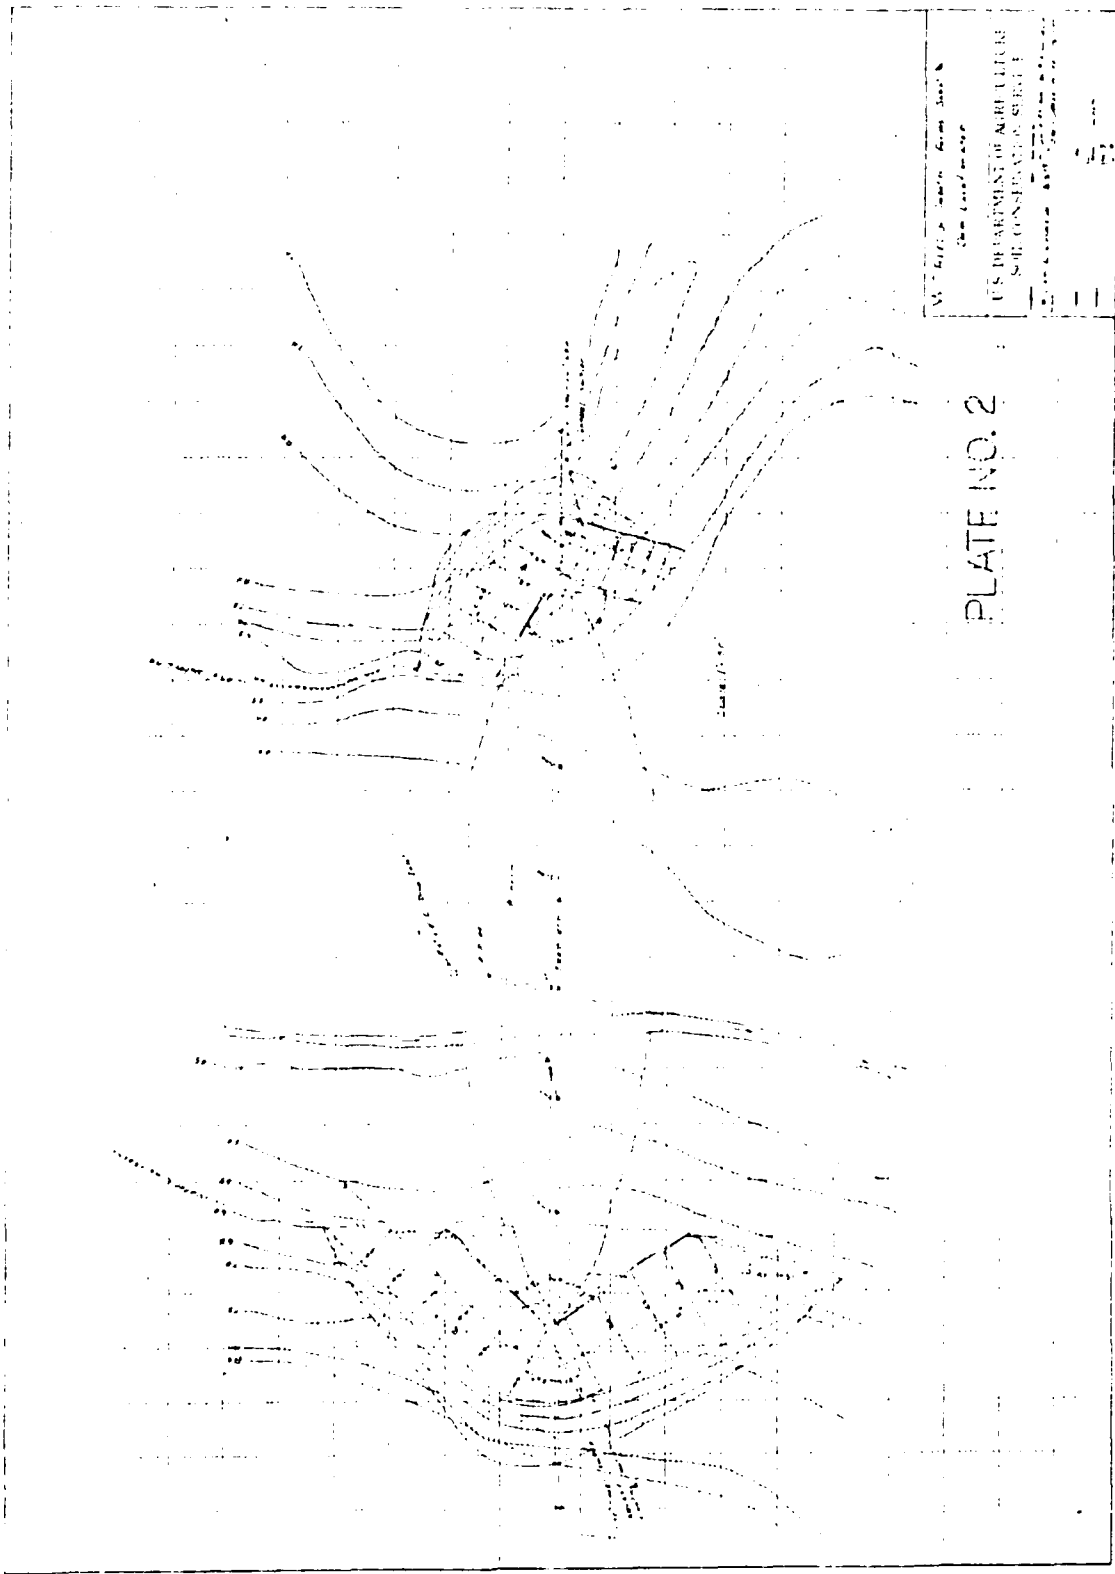
PLATE NO. 2

The principal spillway consists of a twin 48 inch diameter reinforced concrete pipe riser inlet. The riser is connected to a 48 inch diameter reinforced concrete outlet pipe which runs through the dam. The riser crest is at elevation 160 msl. A 24 inch diameter slide gate in the riser at an invert elevation of 137 msl is used to drain the lake. The 48 inch outlet pipe is 134 ft long with an invert elevation at the outlet structure of 136 msl. (See Plate 2, Appendix I).

The emergency spillways consist of two vegetated earthen channel spillways located on the right and left abutments, each having a crest elevation of 165 msl. The right spillway has a bottom width of 75 ft, 2H:1V side slopes, and is partially in a cut section. The left spillway has a bottom width of 36 ft, 2H:1V side slopes, and is entirely located in a cut section. (See Plate 2, Appendix I).

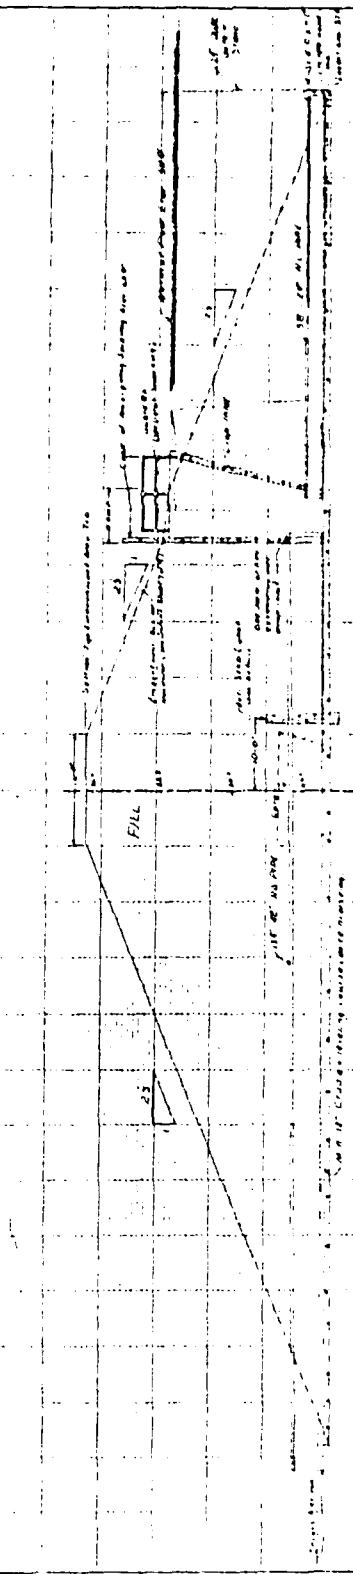
PLATE NO. 3

One reinforced concrete anti-sweep collar was installed around the principal spillway pipe, upstream of the core trench in order to control any potential piping problems along the spillway pipe. Details of the principal spillway and riser are shown on Field Sketch No. 2 of Appendix III and Plate 3, Appendix I. No internal drainage system was provided for this structure.

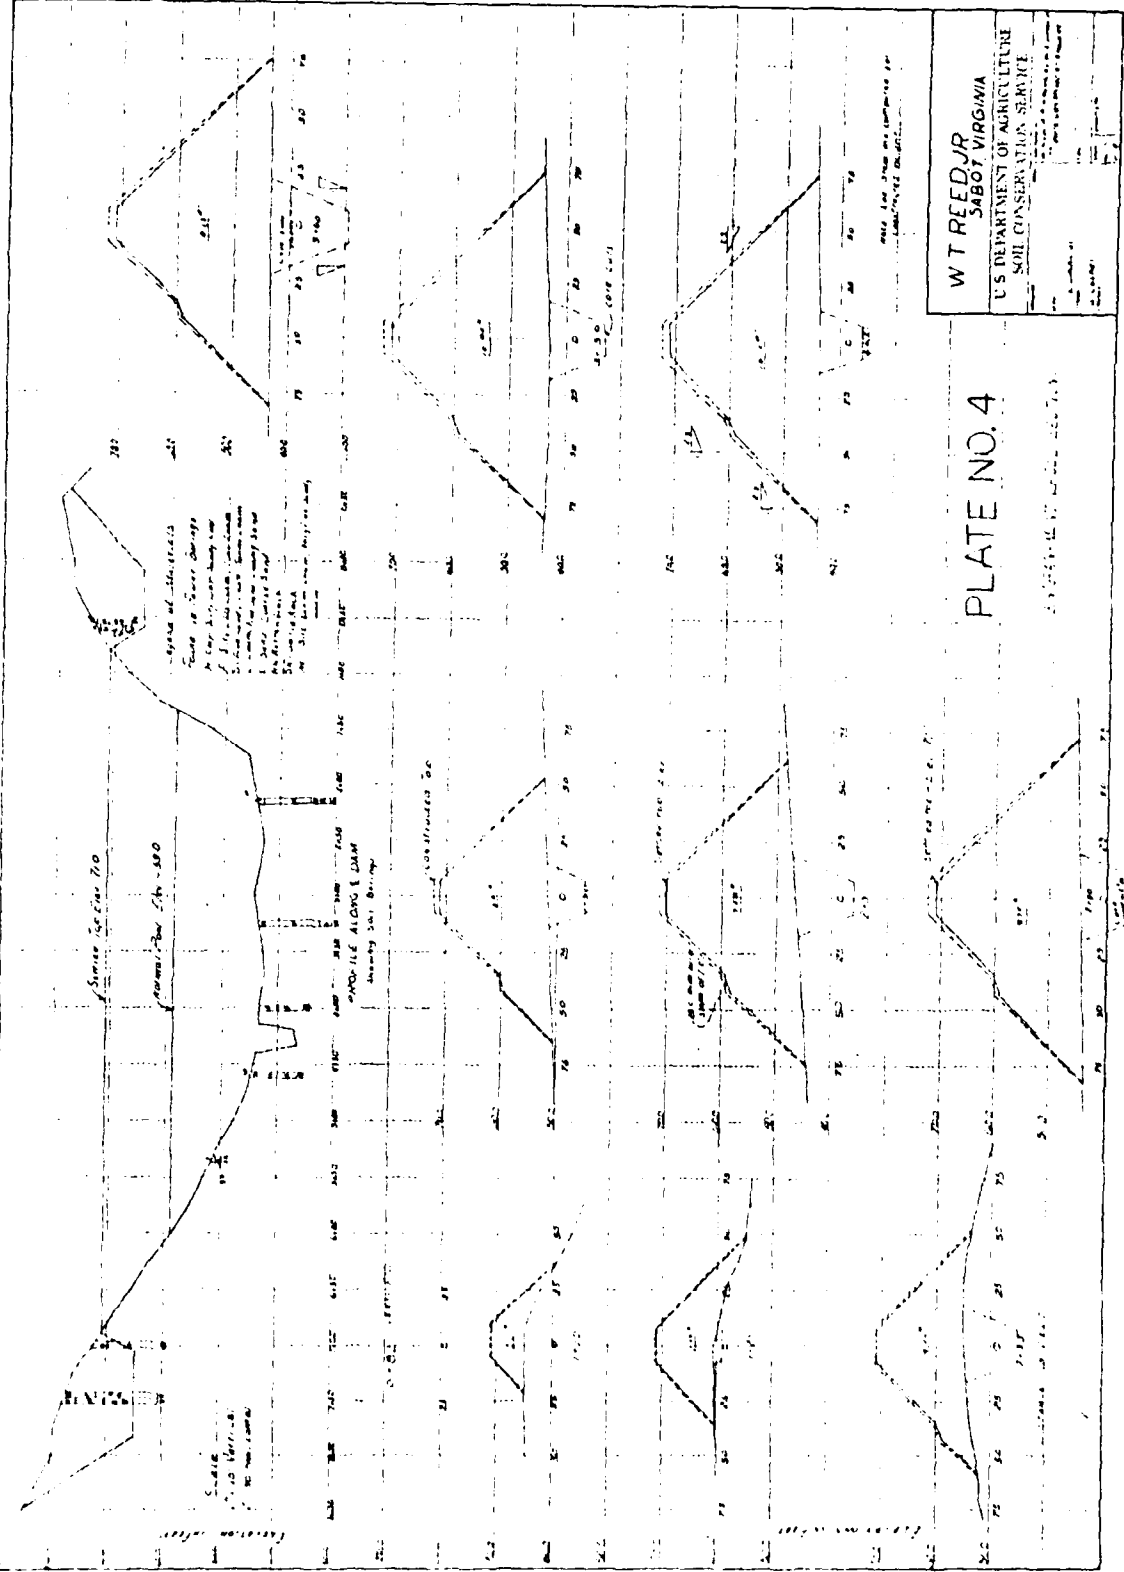
PLATE NO. 4

A geotechnical investigation consisting of 10 auger probes was conducted at the site by SCS personnel during the design phase of the project. Boring locations and a legend of the materials encountered are presented on Plate 4 of Appendix I. The purpose of the investigation was to determine the subsurface soil and rock conditions for the dam and the emergency spillways.

The potential for seepage within the foundation was apparently recognized by the designer, since design drawings indicate the presence of a cutoff trench. Design drawings show the embankment resting on natural soils with a cutoff trench extending down to or slightly into "solid rock". The bottom of the trench is 15 ft wide and has side slopes of 1H:1V. Trench depths are illustrated on Plates 4 and 5, Appendix I.

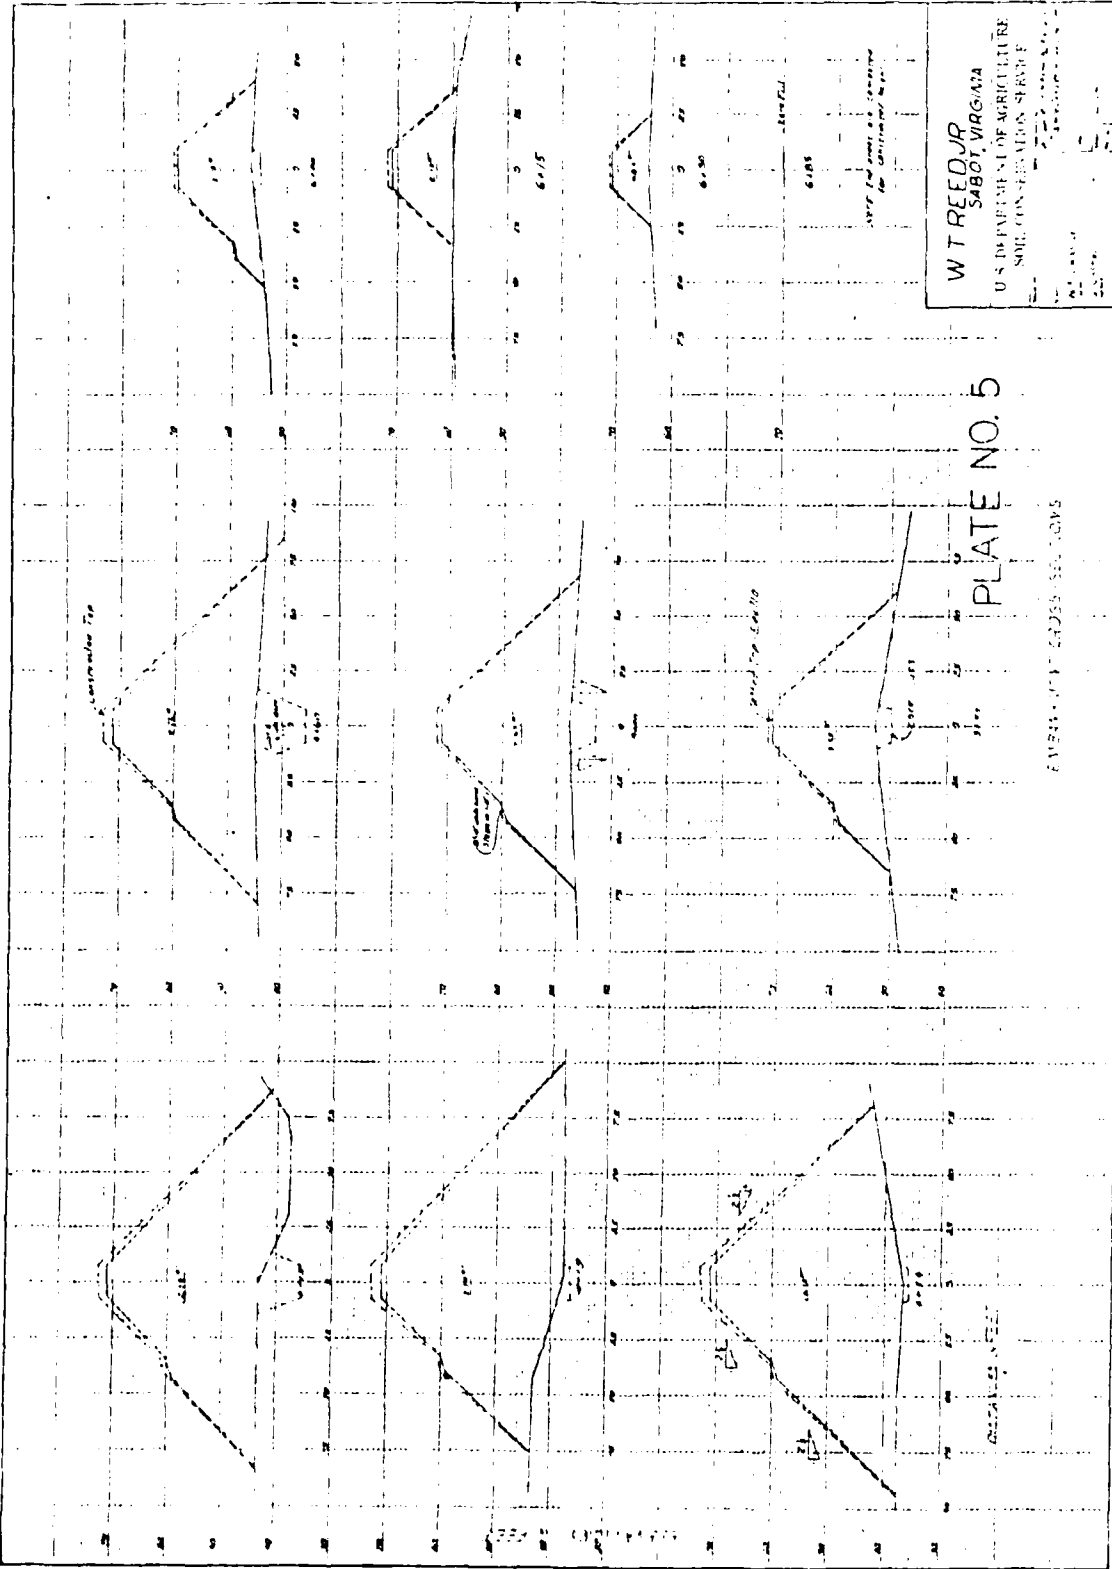
PLATE NO. 5

The dam was designed as a homogeneous, compacted earth fill embankment with side slopes of 2.5H:1V. A 10 ft wide berm was planned on the upstream slope between elevations 159 and 160 msl. A core trench was provided in design, extending 100 ft on the lines 1+25 and 6+00. A bottom width of 15 ft and side slopes of 1H:1V were planned and the maximum depth of excavation, 9 ft, was proposed at Station 4+60. Design details are presented on Plates 4 and 5, Appendix I.
