NATIONAL DAM SAFETY PROGRAM, FAWN LAKE DAM (INVENTORY NUMBER VA--ETC(U)

PHASE I INSPECTION REPORT

NATIONAL DAM SAFETY PROGRAM

4. TITLE and Subtitle Phase I Inspection Report National Dam Safety Program Fawn Lake Dam Spotsylvania County, VA		5. TYPE OF REPORT & PERIOD COVERED Final

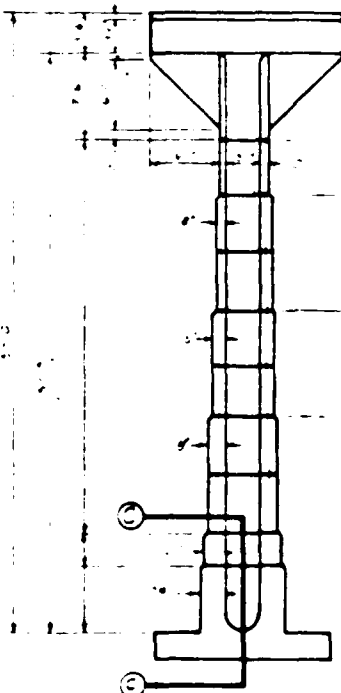
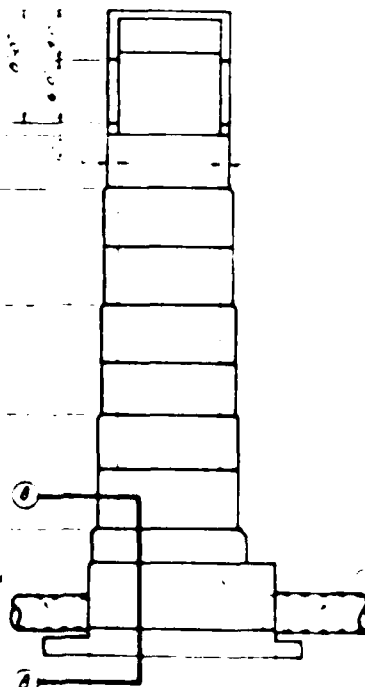
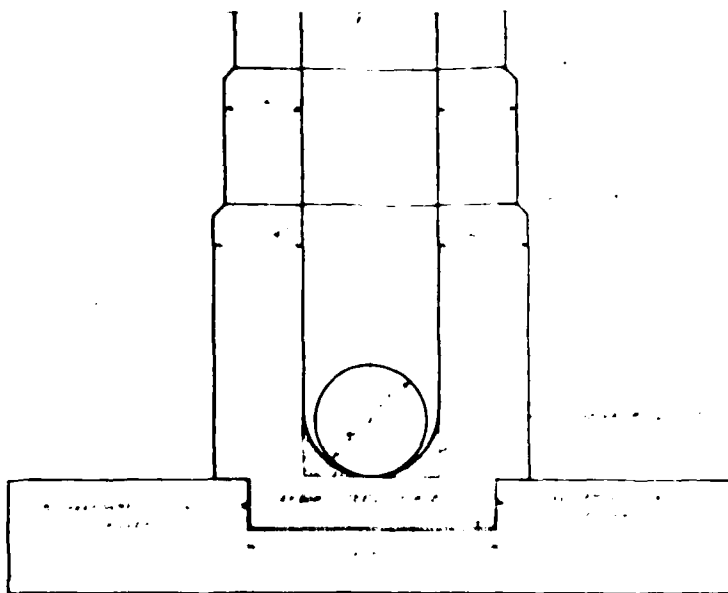
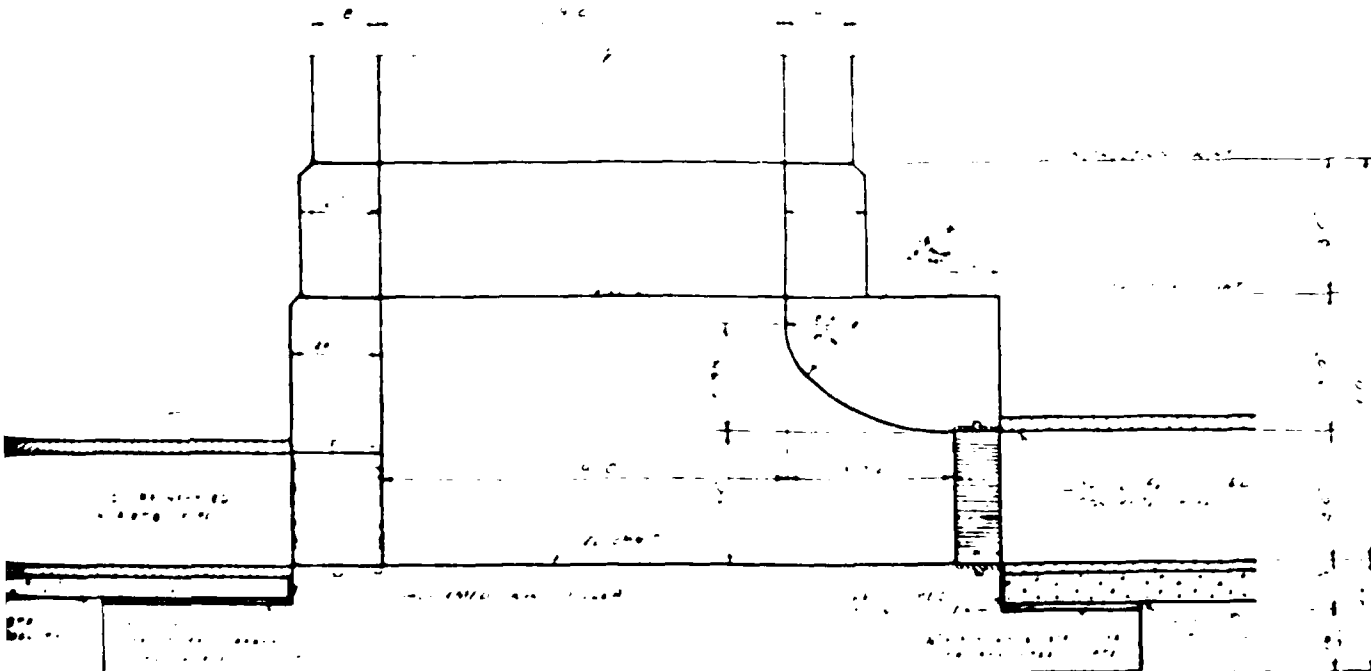
PLATE NO. 8
 RISER DETAILS
 FAWN LAKE COMMUNITY
 AMERICAN CENTRAL

The principal spillway was designed as a drop inlet structure consisting of a reinforced concrete riser, a transition section at the base of the riser, a 36 inch conduit and a plunge pool at the outlet end of the conduit. Seven reinforced concrete anti-seep collars spaced at 24 ft intervals were installed around the principal spillway pipe upstream of the drain trench in order to control any potential piping problems along the pipe. Details of the principal spillway and riser are presented on Plates 5 and 8 of Appendix I.
