**INDIAN CREEK MINE DAMS
WASHINGTON COUNTY, MISSOURI
MO 30717 & 31036**

**PHASE 1 INSPECTION REPORT
NATIONAL DAM SAFETY PROGRAM**

PHASE I INSPECTION REPORT
NATIONAL DAM SAFETY PROGRAM
INDIAN CREEK MINE DAMS
I.D. NOS. 30717 (LOWER DAM)
AND 31036 (UPPER DAM)

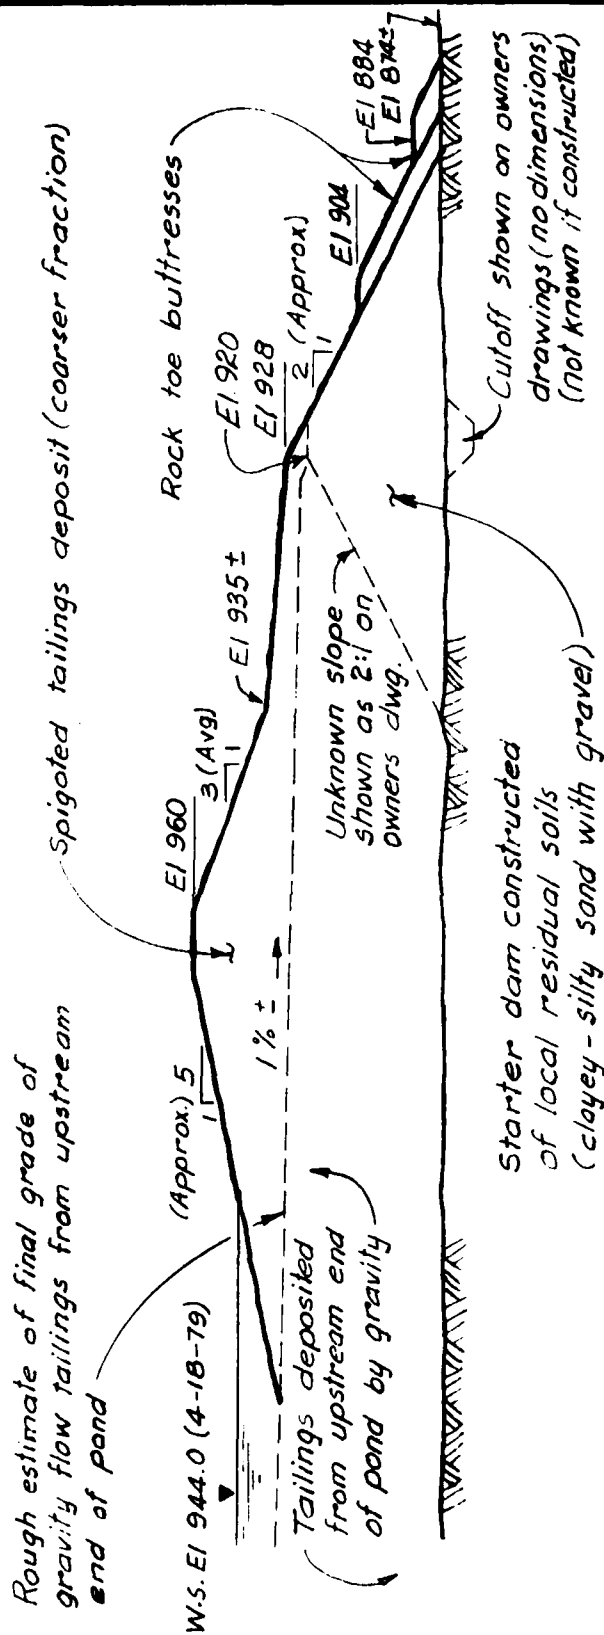
DATE _____
DRAWING NO. _____
PLATE 10

The dam consists of an earthfill starter dike and an enlargement that was built of coarse tailings placed on top of old tailings directly upstream of the original starter dike. This indicates the use of an upstream construction method. An interpretive section through the dam is shown on Plate 10. Wind erosion is causing some shifting of the fine sands composing the tailings embankment from the upstream to the downstream direction. No evidence of sliding, cracking, settlement, or animal burrows was noted.
